**FUELS INDUSTRY**  
Association of South Africa

# LEARNING FROM INCIDENT

## FLOW ELEMENT IMPULSE LINE FAILURE

# FLOW READER IMPULSE LINE FAILURE

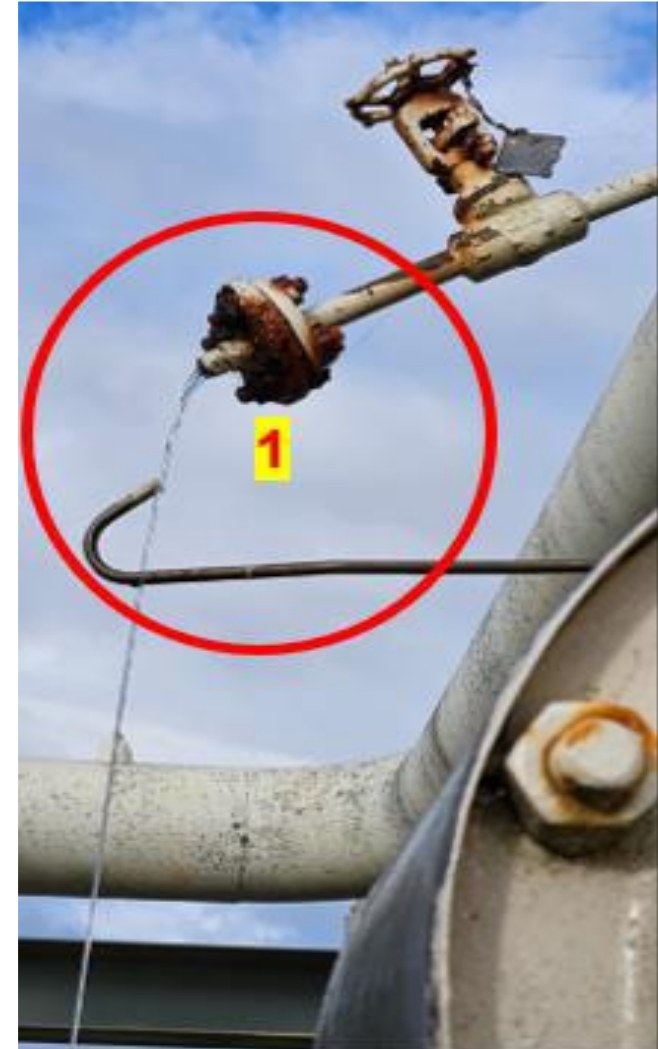
The diesel was being transferred between two tanks using transfer pumps, 51PC186A/B. During routine plant inspection, an Outside Operator spotted a product spraying out from the flow element 51FE1325 impulse line on the discharge of the pumps. The Outside Operator stopped the pumps and isolated the impulse line take-off valve, then reported the extent and severity of the incident to the Panel Operator who in turn informed the Shift Manager.

Vibration as a source of tubing failure was also evaluated where an instrument tubing connects between the stationary object (pump and motor) and vibrating object (impulse line legs). Vibration levels measured on the 51PC186B pump and motor were between 1.8mm/sec and 2.4mm/sec which was well within tolerance, however the levels measured on the legs of the 51FE1325 discharge flow meter was 13mm/sec. These levels were excessive and there was a visible movement of the instrument tubing that connects to the flow transmitter during the pump test. Therefore, the release was attributed to the metal fatigue causing the impulse line to break off due to pump discharge line vibrating at a different frequency with the pump/motor.

With an estimated 10 000 litres of diesel released from an open end of the broken impulse line and filled up the containment bund, the incident was concluded as TIER 1 PSE – *a release above threshold quantity in any 1 hour period.*

- **Asset Integrity:** Assess the vibration levels and ensure that the components in the plant are designed and supported to withstand the operational conditions.
- **Inadequate design/:** Modify layout of impulse tubing and location to minimize vibration.
- **Process Containment:** Regularly maintain and test the bunds, seals and drainage systems to ensure they function as intended.

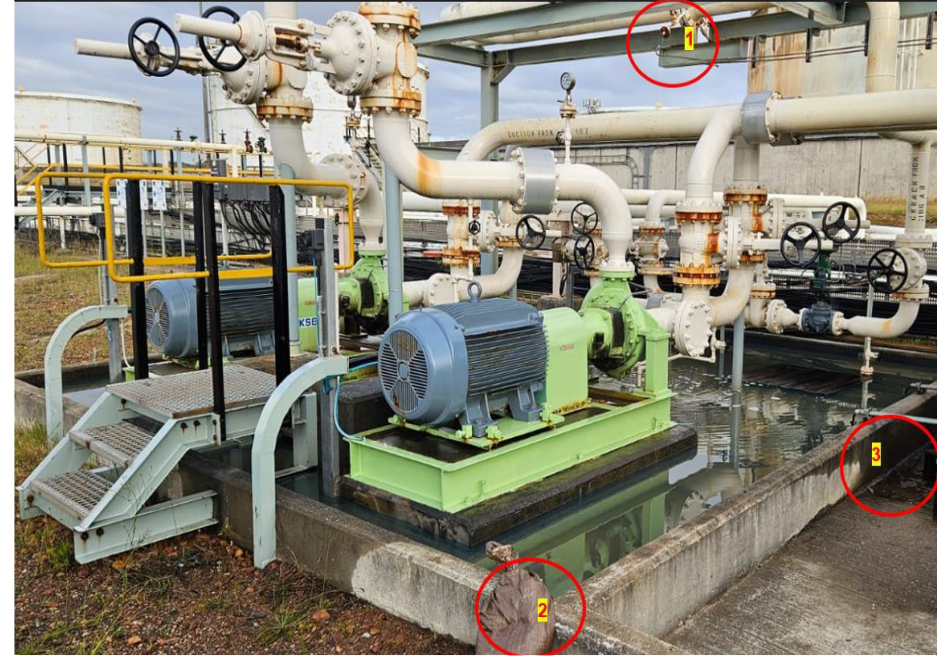
- The interconnecting oily-water drain was found blocked, resulting in the diesel product escaping the containment bund via damaged concrete wall expansion seals and entered the storm water system.
- The tundishes in the 51PC186A/B bund are too high, not allowing liquid to drain away and causing a buildup of liquids in the bund.
- Inadequate impulse line tubing support.

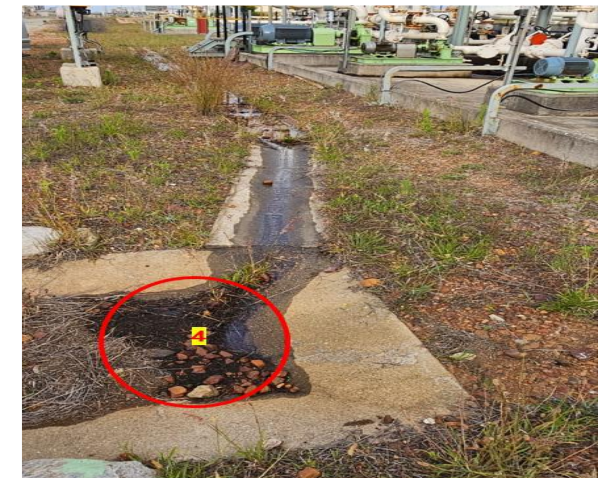
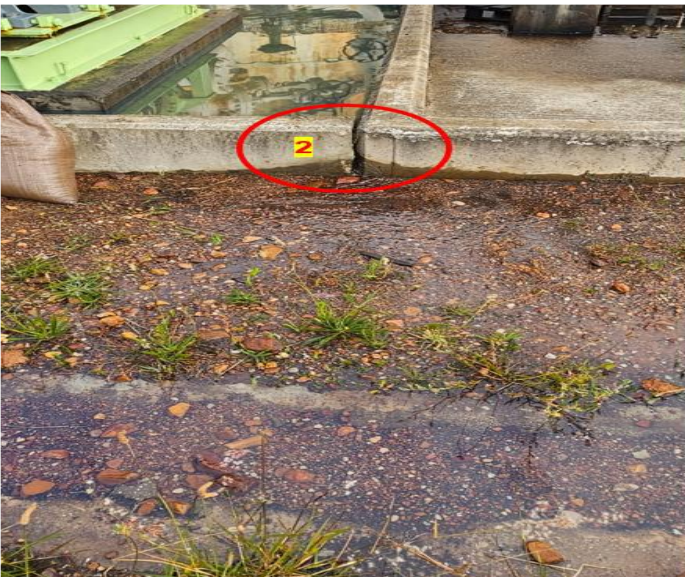
- Lack of periodic maintenance of bund expansion seals
- Lack of reporting and failure to raise job card for blocked interconnecting drains

Concrete wall expansion seal broken and diesel seeping through into the storm water drain channel
