# LEARNING FROM INCIDENT (LFI)

**SAPREF – MOGAS Leak at Underground Joint**

2024

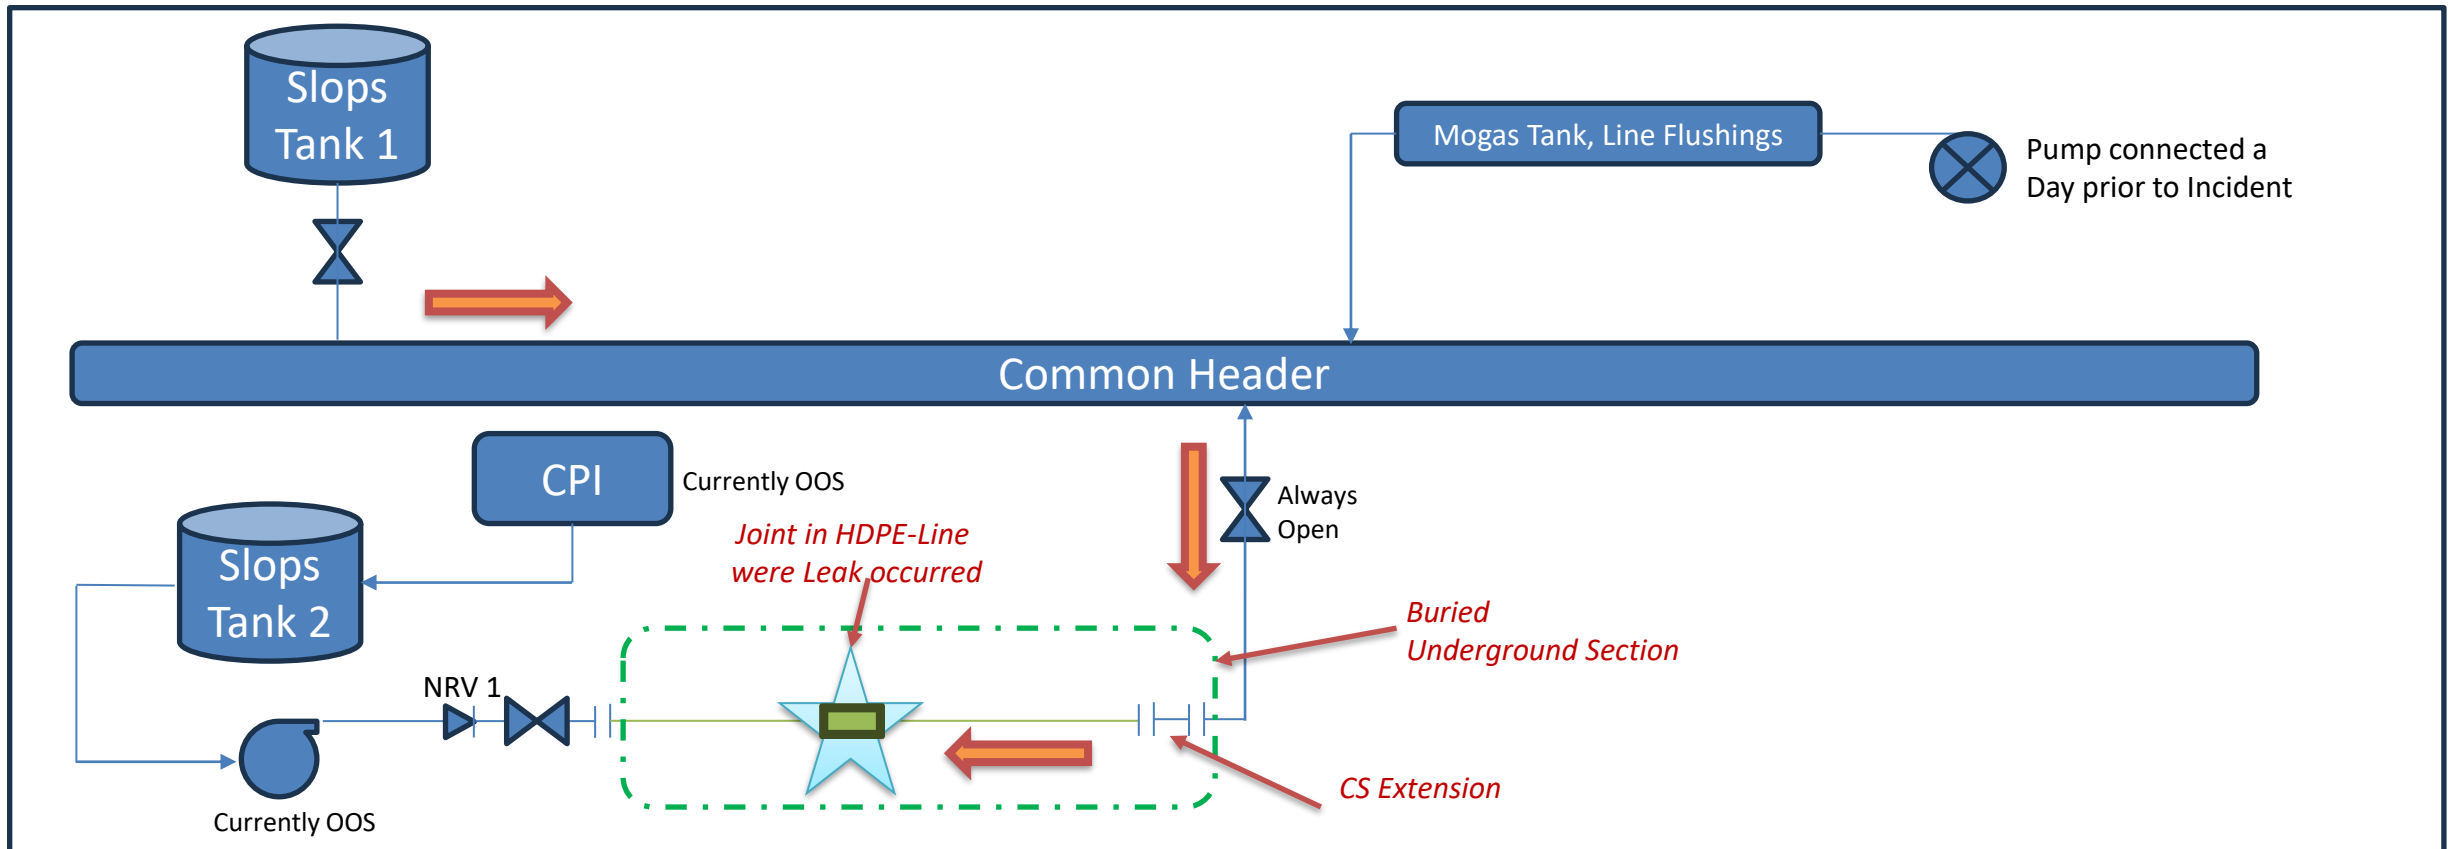
At the CPI area Mogas was detected and seen bubbling in an adjacent area to the CPI. An excavation was carried out in the area to further investigate where the leak was coming from. It was discovered that the CPI Oil Recovery Pump outlet line developed a leak on a screwed HDPE fitting joint.

The line was isolated, and the leak subsided. An LOPC > 1000kg (1117 kg) was estimated over a period of 14 hrs.

- Piping/joint integrity failure either as a result of non-compliant joint or abrasion of piping/additional stress at joint interface as a result of movement or pulsation
  - Slops was being pumped into Tank 1 with diaphragm pump a few hours prior to the incident. It is assumed the pressure from this pump weakened the joint on the HDPE Piping.
- Its also suspected NRV1 failed resulting in reverse flow of Product from Tank 1 to Tank 2 resulting in the LOPC at the failed joint.

- Investigation uncovered a general lack of understanding of underground lineups – *Ensure that teams confirm the line up before use of a system. [Operations]*

- Previous suspected failure of NRV 1, No Maintenance record found to support a repairs - *Ensure that CAIRS and maintenance records are more descriptive, giving an indication of where the repair is made and what type of repair was made – especially for lines running underground. [Maintenance]*

- There was no management process followed for the installation of the HPDE piping. There was no explanation for why HDPE was selected in this service - *Ensure that all changes (except replace in kind) follow MOC governance [All]*

- The risks around the connection of a diaphragm pump on this system was not assessed - *Ensure that diaphragm pumps are not connected where there is a possibility of non-metallic piping present in the line-up and/or to ensure extra precautions are put in place to [Operations] :-*

- (a) prevent reverse flow and,
  - (b) overpressure the system or,
  - (c) minimize piping movement.
