## HiPo: HDS1B LOPC at HP Separator (V203B) 7<sup>TH</sup> August 2019

## HiPo (RAM4+) Near Miss - HDS4 feed/effluent exchanger flange leak – 14<sup>th</sup> August 2019

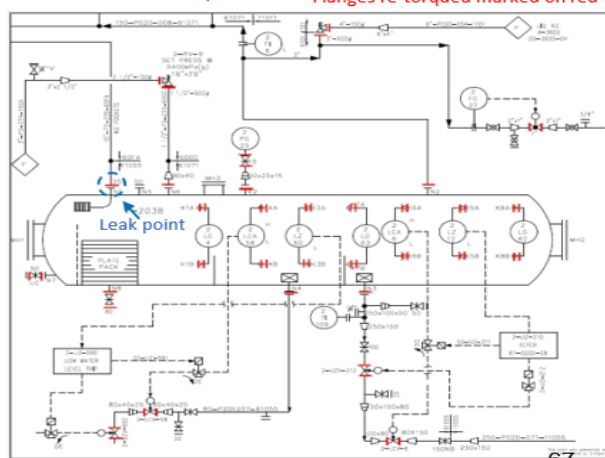
V203B - HDS1B HP Separator

At approx. 21:00 hrs on 07/08/19, a CZ operator noticed a leak on the inlet nozzle of HDS1B HP separator, V203B. The system at the time was operating at approx. 4200kPag and 190°C, in preparation for the pre-sulphiding step as part of the TA2019 start-up sequence. The leak, containing a mixture of gasoil and hydrogen, quickly escalated. The Panel person having been informed of the leak by the field operator, stopped the unit feed pumps and activated the EDP, subsequently depressurizing the unit. A fixed water monitor was also commissioned to suppress the evolving hydrocarbon vapours. The LOPC has been quantified at 81 kg. There were no injuries and no damage to assets.

- The leaking flange on V203B was inspected. The flange face and gasket were fine, but the bolts were too long and touched the sleeve, possibly resulting in them not being tight enough.

Flanges re-torqued marked on red

- A plan was developed to check and re-torque risk flanges in HDS1B HP section work (i.e. those reinstated after pressure testing or not pressure tested).
- Scope included all vessel trimmings and flanges onto and off vessels (e.g. nozzles, instrument take-offs, etc.), including control valves and RVs.
- The flange tightness assurance team checked a total of 142 flanges worked during TA2019 and proactively re-torqued them until gasket compression.
- There were 4 findings during the check that were addressed:
  - V204 stub gasket replaced due to incorrect size (i.e. too small).
  - 3 impulse lines where leaking where the nipple screws into the instrument flange. Nipples threads were sealed and reinstalled.
- After the checks were completed, the unit was safely restarted with no leaks.

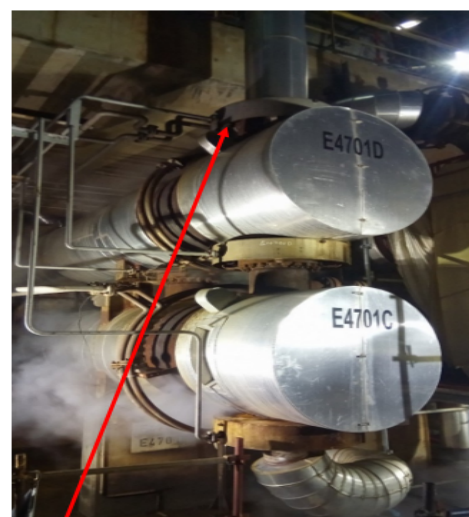
Location of Flames

At around 11h45, a small flame was observed on HDS4 feed/effluent exchanger (E4701D). The fire alarm was activated and operations commissioned steam ring (snuffing steam) around the exchanger head to extinguish the fire. The panel operator activated the Emergency Depressurising (EDP) system and unit shutdown. During this time there was high flaring in refinery. Some liquid was carried over to the North flare tip, caught alight before falling to ground and resulted in some grass fires. There were no injuries and no consequential damage to assets and environment.

- The Rota bolts on E4701D were found to be relatively loose.
- There was no evidence of thermal shocks on E4701D.

- Steam was commissioned to E4701A/B/C/D steam rings,
- EDP was activated to depressurise the system.
- E4701D bolts were replaced with normal bolts and torqued.
- HDS4 was then restarted safely and there were no leaks.

- Reinforced the conditions for activation of EDP system.
- E4701D exchanger gasket will be changed in next NZ major TAR and Rota bolts reinstated.
