# ***Fin fan plug dislodge***

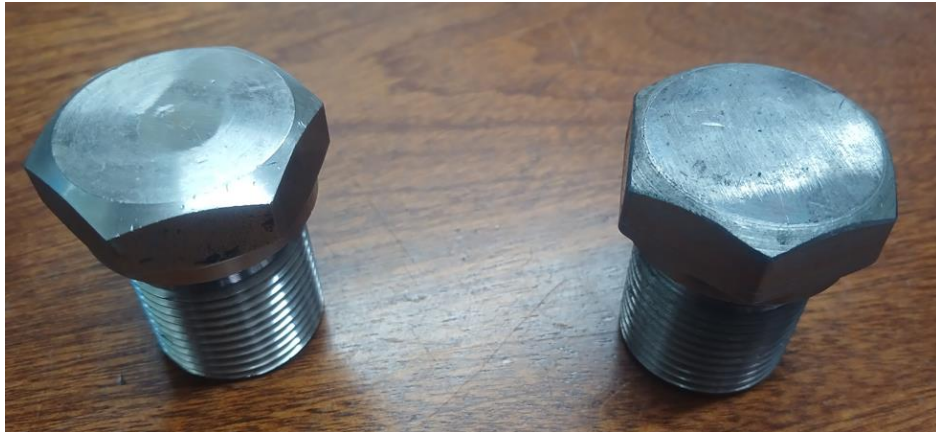
- The carbon steel and stainless-steel header box plugs has the same color when new, both plugs are shiny. See photo below.

Stainless steel left and carbon steel on right

- Artisans must be equipped with the correct tools e.g., magnetic pick-up tool to enable effective punching activities.
- Materials must be positively identifiable, ensure that all the plug heads are marked with material grades, mentioned on the QCP and material certificates are attached to the QCP.
- A QCP must be compiled to include all openings including threaded joints of the pressure envelope.
- Plugs or bolts which are not hard stamped with the material grade should not be used unless a positive material identification is conducted and stamped with the correct material grade thereafter.
- During the leak seal device risk assessment consider the probability of a catastrophic failure of the leaking component.

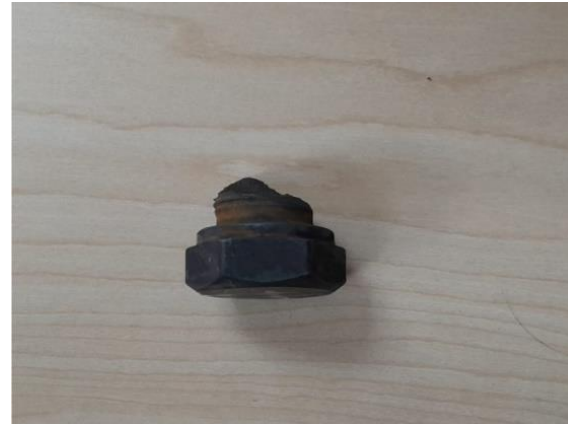
- The header box plug was found to be severely corroded resulting in a compromised integrity of a plug to header box joint.
- Incorrect plug material was installed during the box-up activities of the fin fan. Some of the installed plugs were manufactured using carbon steel instead of stainless steel. During shutdown correct plugs were issued to the service provider as part of maintenance.
- Inadequate punching after maintenance. The carbon steel plugs were not identified during the punching activities. Plugs appeared the same and as a result, it became difficult for the artisan to distinguish between carbon steel and stainless-steel plugs during punching activities.
- Inadequate quality control plan (QCP) which did not include any integrity checks for plugs installation

Top view of dislodged plug
