## Title: ULP Gasket Rupture

Reference: REX-MS-AFA-2021-007

Date : 14 October 2021

Site: Island View Terminal

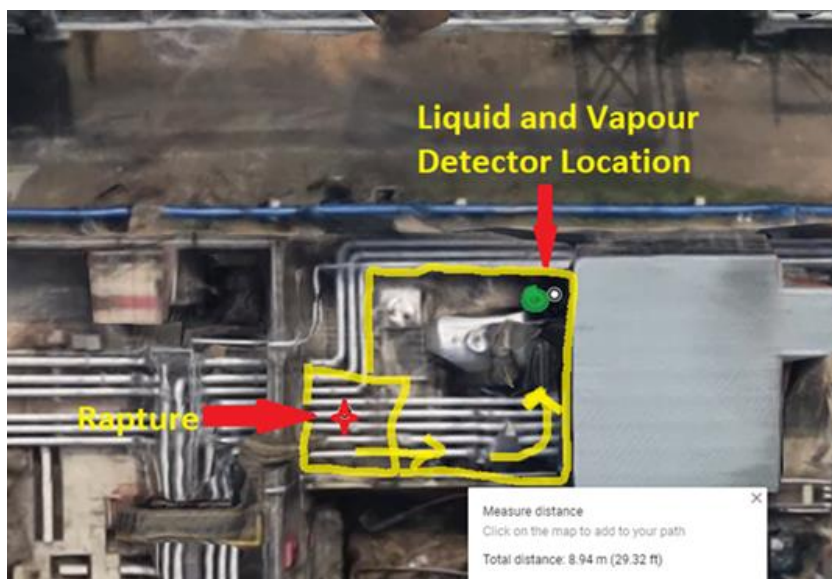
On 14/10/2021, a vapour detector alarm was triggered at the multi product pipeline pump farm at 12:31pm. On investigation it was discovered that a gasket had ruptured on a flange of the ULP 95 inlet line to Tank 642 resulting in a loss of containment of 900lt. The site responded by in line with their emergency response plans with no deviation noted.

The valves had been closed from the 3rd September until the gasket rupture took place on the 14 October 2021. The immediate causes for the gasket failure at a flange was due to the inability to relieve pressure back to Tank 432. The maintenance valve located in the T644 bund was closed and it was this valve that stopped the relief of pressure in the line back to the tank.

Image 1: Location of the ruptured gasket and vapour detector

- Inadequate thermal risk control, valves are not equipped with TRV's and lines were not drained when isolated. This means that when product expands due to the High temperature of day, there was no possibility to relieve the pressure on the line, leading to the gasket rupture.

- All critical valves must be identified and locked in the normal position and assess the possibility for relief should they be closed.
- Any manipulation of non-process valves must follow the isolation procedure

- Any valve manipulation should be critically evaluated to determine if there is a possible risk
- Sites should identify if there are any operational valves that may cause thermal pressure to build up without sufficient relief in the system.
