**FUELS INDUSTRY**  
Association of South Africa

# **SAPREF – Mogas LOPC October 2024**

# INCIDENT DESCRIPTION

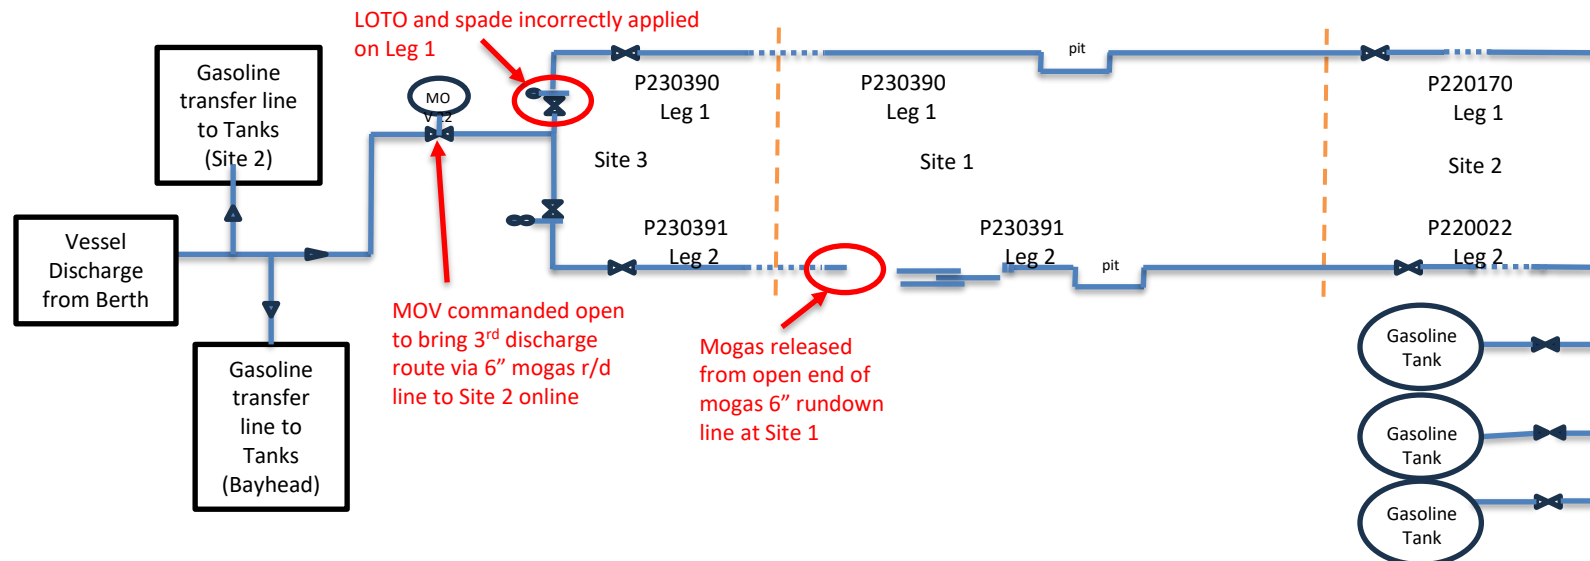
**Description of Incident:** On 16<sup>th</sup> Oct 2024, at approximately 23h35, during a planned Ship to Shore discharge of a gasoline vessel into shore Tanks that had started on dayshift, an additional MOGAS Rundown line (Leg 1) was commissioned to increase the rate. Approximately 35 minutes later, the field operator discovered MOGAS flowing out of the MOGAS Rundown line (Leg 2) that had been commissioned upstream. The discharge to this line was subsequently isolated.

Figure 1: Simplified process flow during mogas discharging

- An incorrect MOGAS line was isolated and decontaminated in preparation for maintenance activity.
- The verification of the isolations prior to cold cutting commencing was ineffective
- MOGAS vessel discharged product into an open- ended pipe resulting a release of MOGAS.
