# LEARNING FROM SULPHURIC ACID INCIDENT

# INCIDENT DESCRIPTION

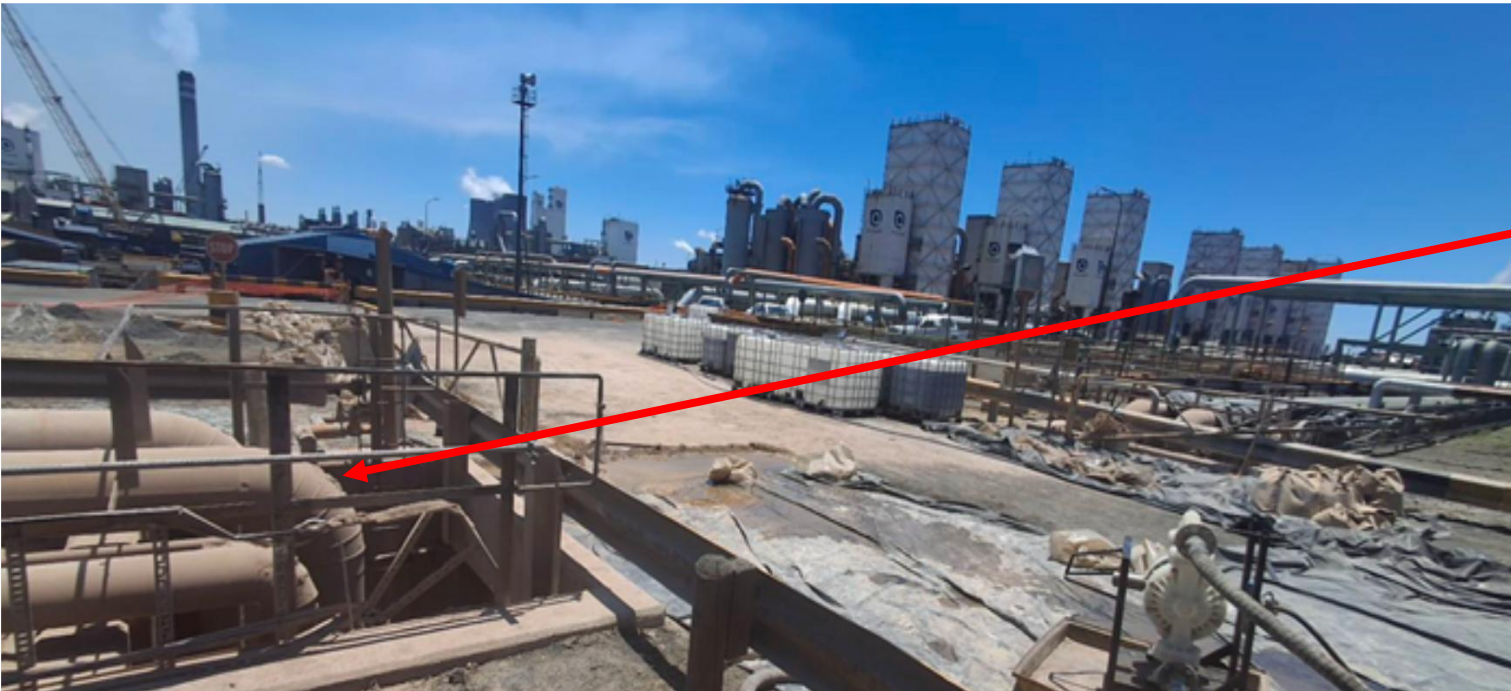
Sulphuric acid was released from a flange and accumulate inside a culvert. Rainwater mixed with the sulphuric acid inside the culvert and result in corrosion of the pipelines inside the culvert. This causes a 40-bar steam line to fail releasing the steam. Residual sulphuric acid being dispersed around the immediate environment causing 113 first aid cases and 11 incidents. There was a leaking flange due to lose bolting where PTFE and alloy 20 spool merge.

Steam line

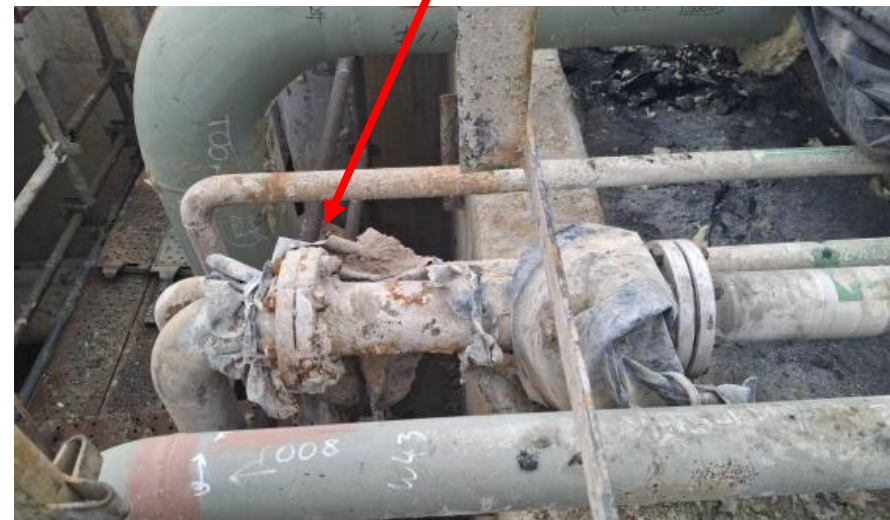
Flange that leaked

The gasket blowout resulted from the following potential root causes:

- **Inadequate Gasket Installation:** There is no installation Quality Control Plan (QCP) for this flange to verify if the gasket was installed correctly during project
- **Deviation from Design Requirements:** A lack of records indicates that the required 12-month torque verification, as specified have been performed. Missing the re-torquing schedule may have contributed to the gasket failure.
- **Design Specification Gap:** No detailed calculation methods for determining torque settings, as this is a unique flange configuration.
- **Inadequate End of job documentation handover process** - Quality control plan not available and it cannot be proven or confirm if the boxing of the flange gasket was done as required by the procedure.

- Evaluate flanges inside the culvert that might results in a leak of corrosive material and review the risk of these flanges to prevent introduction of secondary hazards that would affect other pipelines.
- Develop and make use of a QCP when working on flange joints.
- Proper hand over and end of job documentation to be in place before commission a project.
- Update maintenance strategies and ensure all requirements are addresses in the maintenance strategy.
