FUELS INDUSTRY
Association of South Africa

LEARNING FROM INCIDENT

OILY WATER DRAINAGE SUMP 2 OVERFLOW

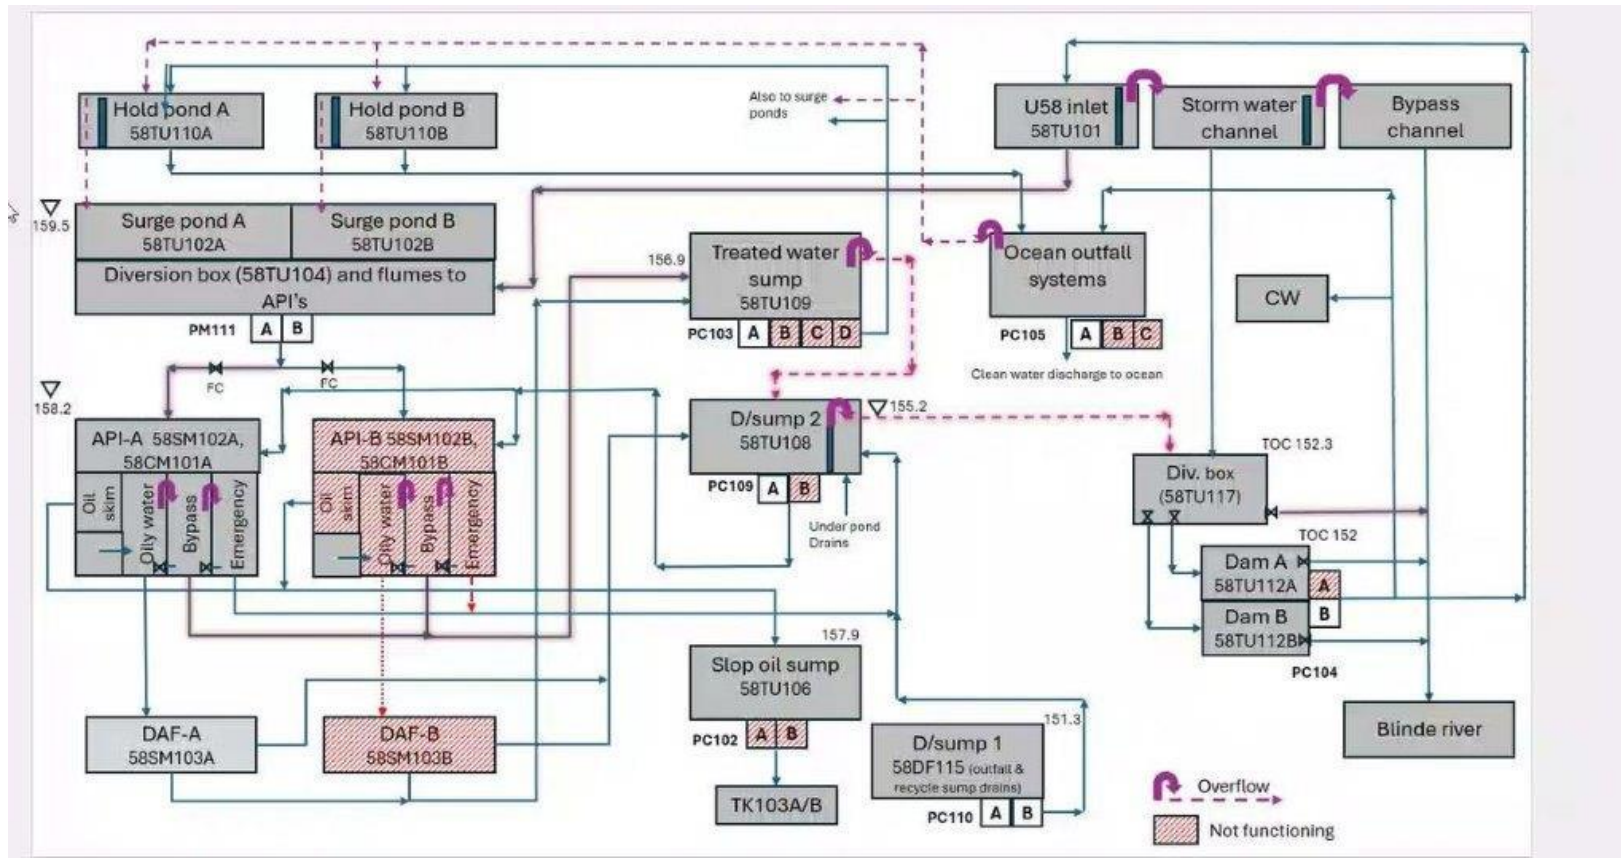
Field Operators were conducting routine inspection at the Storm Water Ponds on Monday the 24th of March 2025, when they discovered that the Storm Water Ponds were covered with Oil. The findings were reported to the Production Supervisor on shift and a search started to find out where the oil came from.
