**FUELS INDUSTRY**  
Association of South Africa

# **SAPREF – Mogas LOPC October 2024**

2024

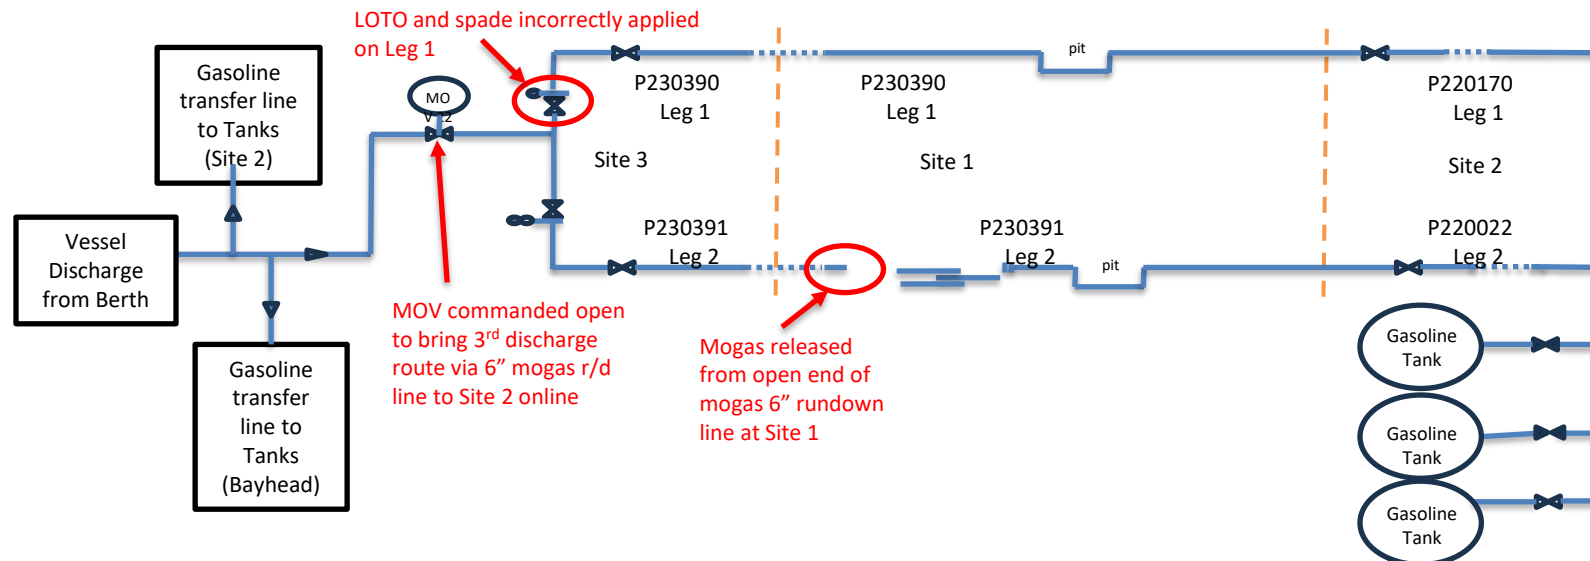
**Description of Incident:** On 16<sup>th</sup> Oct 2024, at approximately 23h35, during a planned Ship to Shore discharge of a gasoline vessel into shore Tanks that had started on dayshift, an additional MOGAS Rundown line (Leg 1) was commissioned to increase the rate. Approximately 35 minutes later, the field operator discovered MOGAS flowing out of the MOGAS Rundown line (Leg 2) that had been commissioned upstream. The discharge to this line was subsequently isolated.

Figure 1: Simplified process flow during mogas discharging
