## 1. Description of event

A spill was discovered at about 5am on the 18th April, where diesel was reported to be leaking from the pumphouse on Koeberg road, the refinery blending and shipping team as well as the refinery Fire Department were notified and deployed to the site. A high point bleeder was found in the open position and diesel was spraying from it. Traces of diesel has found its way into the nearby Theo Marais Canal as well as the Diep River via a stormwater channel and covered a 3km distance downstream. The spill has contaminated the water, wildlife and vegetation. Our contractor reported 82 barrels of product has been recovered from the site and canal using booms, peat sorb as well as super suckers.

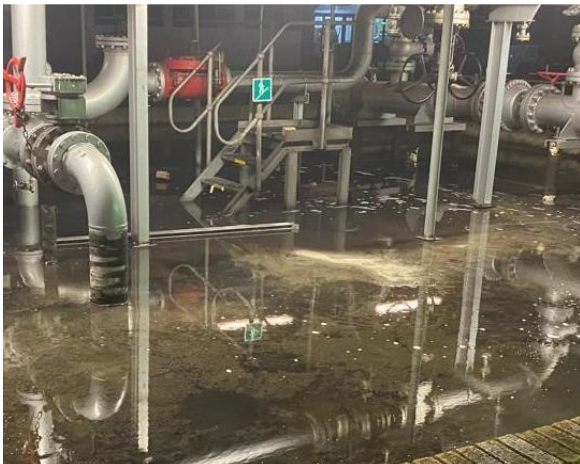
Gooseneck valve station  
bunded area covered with  
Diesel

Evidence reviewed thus far reveals: The Gooseneck valve was not intrusively locked out and tagged out (LOTO), the open bleeder valve was not tagged prior to handing the equipment over to the maintenance crew.

Maintenance had handed the equipment back to operations without having the permit signed off.

The Pre-Start Up Safety Review (PSSR) paperwork was not completed and therefore there was no confirmation of the bleeder valve position prior to putting the line in service.

Astron Energy Fire department was deployed and isolated the open bleeder valve.

A bar plug has been placed on the bleeder valve.

Operations and maintenance to ensure the systems that will be worked on by maintenance are intrusively locked out and tagged out before the work can commence. The Pre-Start Up Safety Review (PSSR) must be completed and line ups confirmed before commissioning equipment.

Permits must be closed out and signed off by the responsible parties when maintenance is completed.
