# **LEARNING FROM INCIDENT (LFI)**

## **LOPC AT A RETAIL SITE**

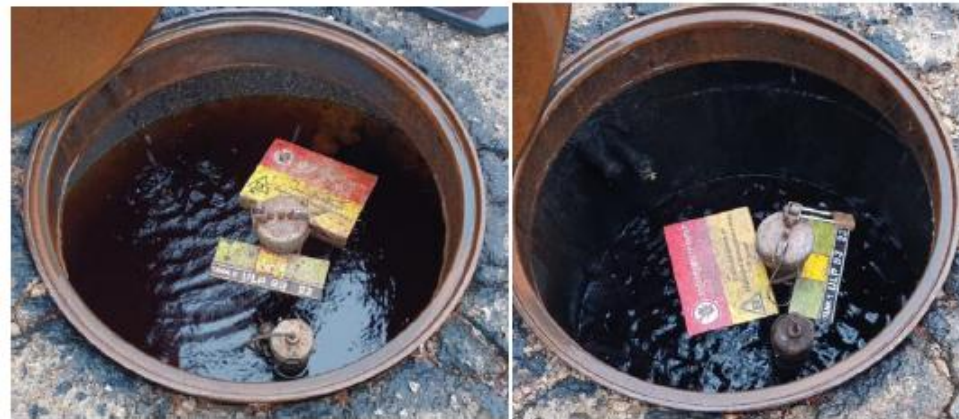
- An ULP93 LOPC incident occurred due to tank overfilling at a Retail site at around 01h38 am.
- Upon arrival, the BVO met with the site representative and informed him that he was delivering ULP93.
- Manual dips were taken, showing sufficient ullage for both Tank 1 and Tank 2. The site's ATG system on the other hand displayed much lower ullages for the tanks, in both instances, almost 70% less than the manual dips (the tanks were in fact almost full).
- Even though the discrepancy was noted, both the BVO and the Site representative relied on the manual dip readings and proceeded to offload into Tank 1 then Tank 2, resulting in overfilling of both tanks.
- There site had no active report of any faults on the ATG

Tank 1&2 manholes filled with ULP93 and water

- Delivery procedure not adhered in that:
  - manual dips were incorrectly taken and not verified (incorrect dip stick used)
  - discrepancy between manual dip and ATG was not flagged and reported
  - Tank manhole and dip hatch not closed after dipping and during delivery (which allowed product to escape containment into the manhole)

- Inadequate execution of preventative maintenance by the contractor (site overfill prevention was not in place, it had been removed earlier and never replaced).

- Conduct safety standdown with all Transporters to refresh on the offloading procedure requirements and the functionality of the overfill prevention systems.
- Develop a communication memo to all Retail sites to refresh on the offloading procedure requirements.
- Design specific training for Offloading Marshals and Territory Managers (beyond just the procedure).
- Train the Territory Managers as trainers on the training specifically designed for Offloading Marshals (practical, on-site).
- Reinforce random checks for preventative maintenance by the Technical teams.
- Contractor to revisit all sites and ensure inspection and maintenance of overfill systems is done correctly.
- Consider linking overfill prevention to an audible alarm.
