## Group Technology SHE Incident Flash Notification and Preliminary Incident Report

| Department / Area / Project | Sasolburg, High Pressure Steam Header Replacement Project | | |
| Date of incident | 18 June 2020 | Time | 12:35 |

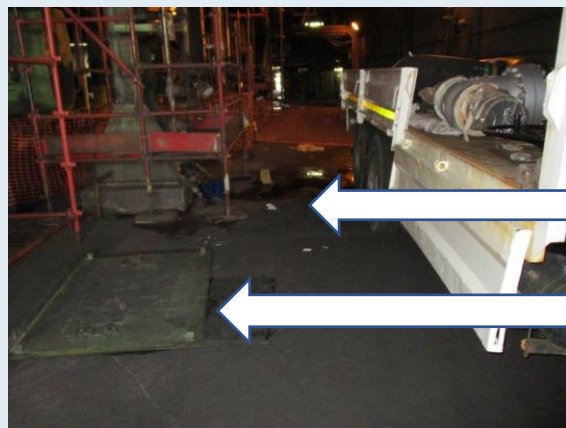
- Uncontrolled release of the cover plate
- Injured employee was positioned directly underneath the suspended load in the drop zone
- Barricading and control of the ground level drop zone not adequate and effectively managed
- Inadequate communication between the first floor and ground level teams – (multi-level work management)

Position of the injured employee on the ground floor

Air hoist steel cover plate that fell from first floor

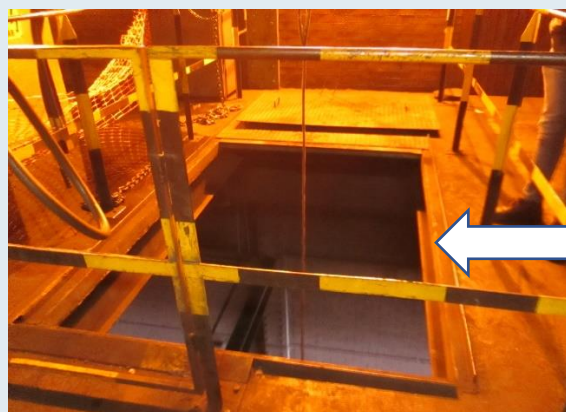
Air hoist access opening on the first floor from where the cover was lifted and moved before it fell to the ground level
