# Incident Learning: What happened?

# Direct Root Cause

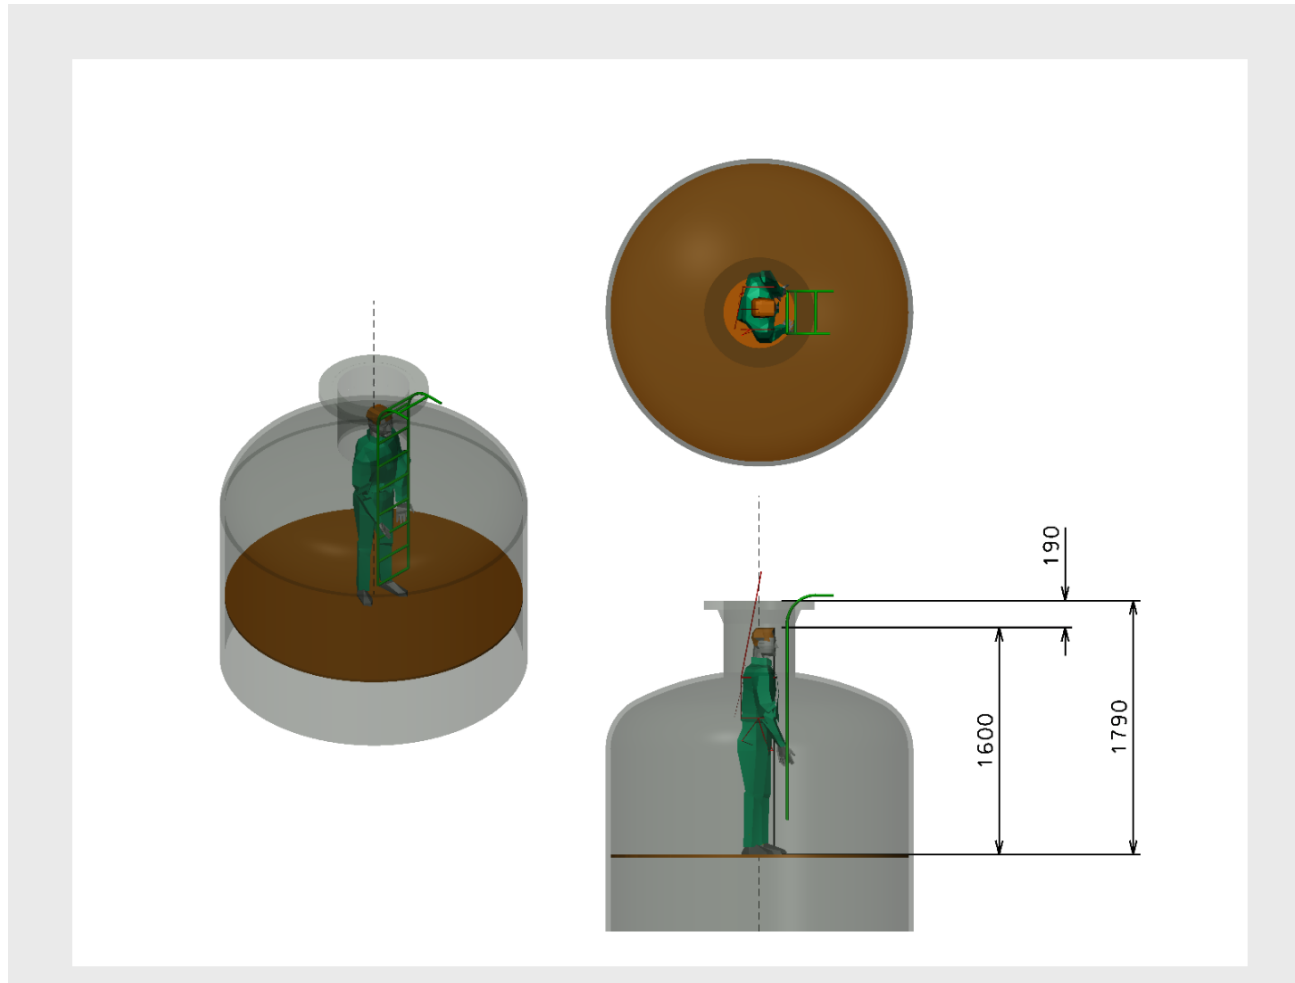
- Two Employees (Mechanical Fitter (MF) and Advance Process Controller (APC)) lost their lives during maintenance activities in the plant
- The task was removing a hold down grid inside the top section of the vessel, to allow for the unloading of catalyst.
- It is unclear of how the nitrogen got introduced in the vessel which created an inert vessel entry
- After finishing the task, MF prepared to go out of the vessel and at that moment MF was reported to have removed the mask and collapsed
- APC most probably tried to rescue MF and was also overcome by the flowing nitrogen
- Both employees were declared dead within the premises

The investigation team concluded the root cause was the Failure of the Permit to Work and Confined Space Entry processes to prevent the vessel entry whilst the vessel was not appropriately spaded, and subsequently introduced nitrogen into the vessel, due to the lack of appreciation of the dangers associated within an oxygen deficient environment.
