# SASOL – LEARNING - FATALITY

- On 14 April 2023, while replacing roof sheets on the Polypropylene bagging warehouse, a service provider team was adjusting the sheeting to rectify misalignment. Secured and partially secured roof sheeting in the team's work area had been loosened as part of rectifying the sheeting's misalignment. In the process of walking to his work area, the now-deceased stepped onto an unsecured roof sheet and fell approximately 8 meters onto the concrete floor below. Because he was not tied on to a lifeline or transfer line, his fall to ground was not arrested. As a result of the fall, the person succumbed to his injuries

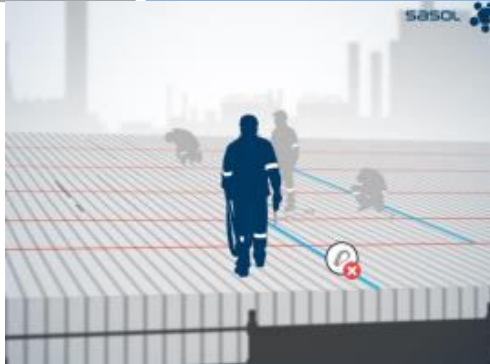
The now-deceased person stepped onto the roof from the access scaffold and started walking on the roof without hooking the lanyard onto the life line or transfer line.

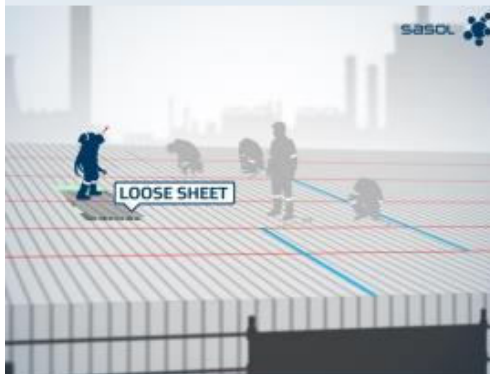
He proceeded to walk on the loose roof sheeting to his work area.

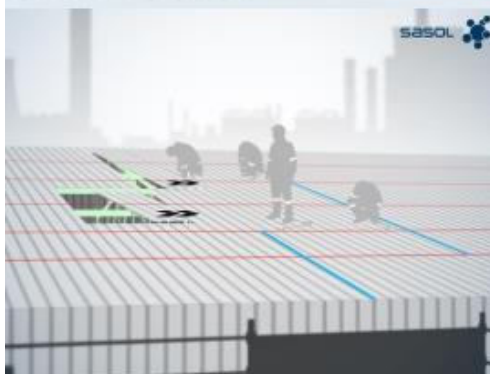
A loose roof sheet tilted inwards and he fell through the roof to the cement floor below.

1. The deceased did not hook his lanyards onto the lifelines and/or transfer lines.
2. The deceased fell when he stepped onto a roof sheet that was unsecured, which then tilted and gave way.

1. Controls and assurances required for roof work and use of lifelines
  - Implement effective engineering solution(s) that will ensure team members cannot access certain working areas (like roofs) without being hooked on and they remain hooked on to prevent falling from heights.
