# Safety Alert

## Enterprise Fatality: Forklift Mechanic Fatality

Location: PASAR Copper Department, Glencore

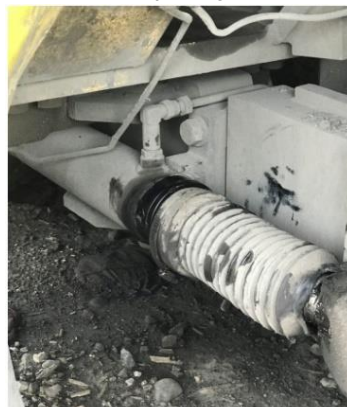
An incident occurred at around 6:42 AM on 30 July 2022 at the Copper departments Mobile Pool Parking area. A Ravago Mechanic was investigating an oil leak, observed on the rear right cylinder of a Ravago Rental Forklift, and was fatally injured.

Oil Leak in Steering Cylinder

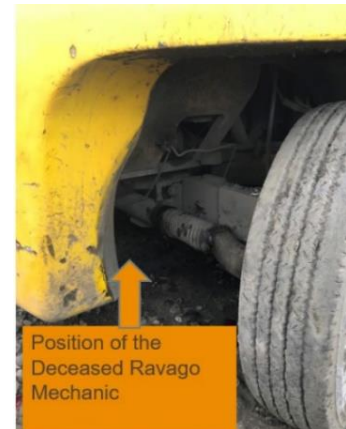
Initial investigation findings indicate that the Forklift Operator was instructed to turn the wheels by the Mechanic. In between the instruction and action, the mechanic positioned his head between the wheel and the counterweight, resulting in the fatal injury.

Position of the Deceased Ravago Mechanic

- Barricaded and secured the incident area
- Mobile Pool Operations exercised stop work and held stand down meetings for all mobile pool operation workers, Managers, Superintendents and Team Leaders
- Released Stop Work guidelines for Superintendents and Team Leaders
- Informed the local law enforcement authority
- Provided support to the immediate family of the deceased
- Initiated incident investigation

- Keep your body out of the line of fire of moving equipment
- Follow acceptable procedures for the task.
- Ensure there is effective and clear communication when performing high risk work
- Ensure the people involved in the activity are qualified and adequately skilled
