# LFI: **Hand Injury (LOF)** @ Blending & Storage

# IOD **FAC** – 3 June 2024

## - Unit 51: Blending & Storage -

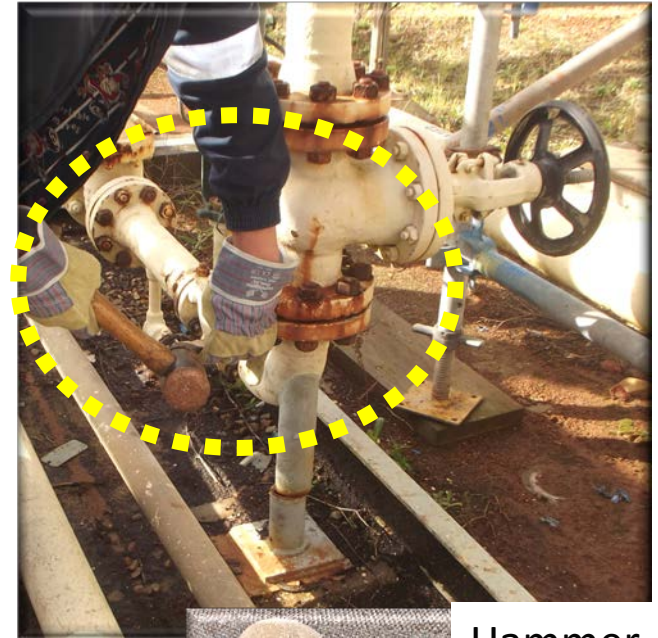
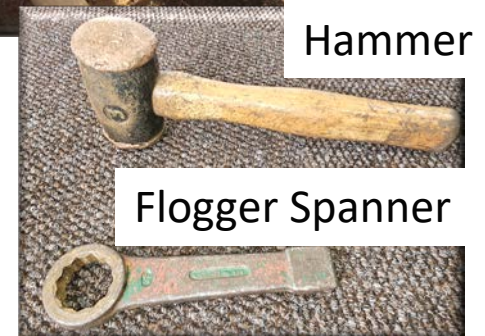
- o COE Apprentice Fitter was tightening bolts on a 3" flange.
- o The injured was using a flogger spanner and copper hammer to do the tightening.
- o The injured accidentally hit himself on the left hand resulting in a superficial laceration on the left index finger.
- o The injury did not report the injury when it happened at 10am. The Supervisor was present at the job site.
- o The injury was discovered later at 14H30 by the Occupational Health Practitioner when the colleague visited the medical station for random testing.

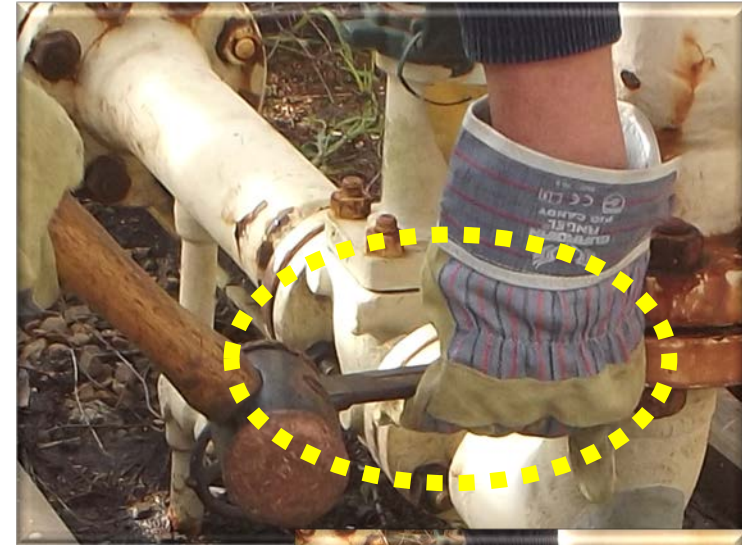
- o Tightening the nut below the flange – thus flogger spanner must be held tightly in place to prevent it from falling out.
- o *Hitting the nut tight moves the flogger hand away from the hammer – i.e. the left index finger starts to move into the line of fire.*
- o If flogger spanner is not repositioned, the available space for hammering will also be reduced.
- o *Thus the left index finger was caught in the Line of Fire of the hammer.*
- o **Direct Cause:** Substandard technique given the specific orientation (vertical pipe direction) and site location of the flange.

Flogger Spanner moves backwards as it is hit.

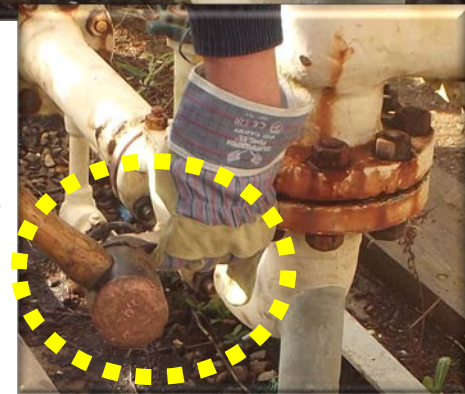
Smaller available area to hit on.

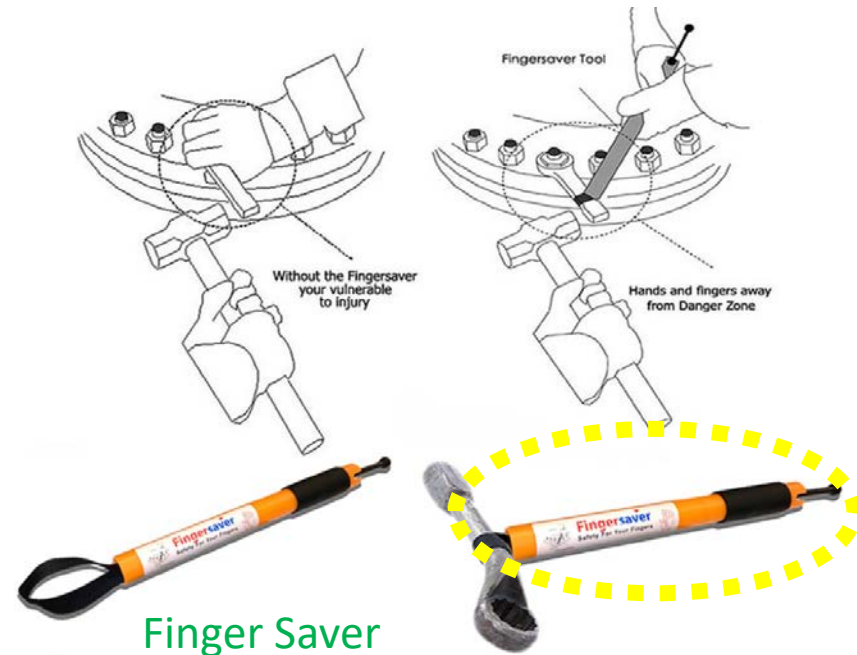
- o Following procedures / practices / standards for the job: flogger spanner not repositioned prior to injury
  - deviation by individual.

- o Jobsite Environment and Layout: congestion and restricted movement.
- o *Protective Systems: industry best practice not used*
  - *i.e. using a finger saver holding the flogger spanner.*
