# Incident Learning: First Aid

**DATE OF INCIDENT** : February 13, 2020

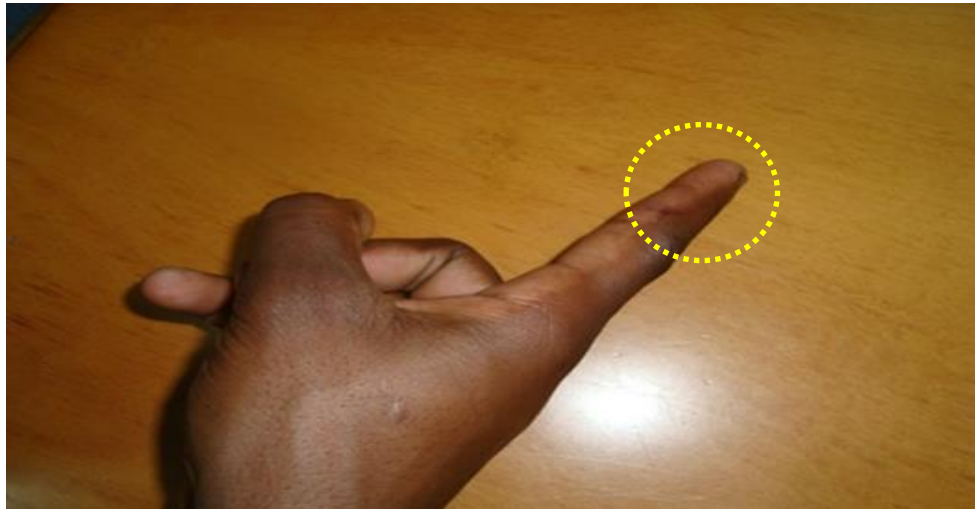
A flexible lance operator was high pressure water cleaning PFE-214A bundle tubes on the floating head side of the exchanger, as the lance operator was retracting the flexible lance from the exchanger bundle tubes, a steel gasket on the exchanger face which had been covered by sludge dislodged and struck the employee on the index finger.

- The equipment to be worked on was not adequately assessed during the site visit to identify possible hazards and controls to be implemented;

- When conducting a Job Safety Analysis, ensure the work area is visited and the relevant competent persons give input
- During the permit to work issuing process, site walks are to be done in order to assess the status of equipment and hazard identification, which ensure adequate controls are implemented;
- Ensure the Total safety task instruction [TSTI] is done at the work site with input from all persons involved with the task;
