LEARNING FROM INCIDENT (LFI)

Fall from Height

19th January 2024

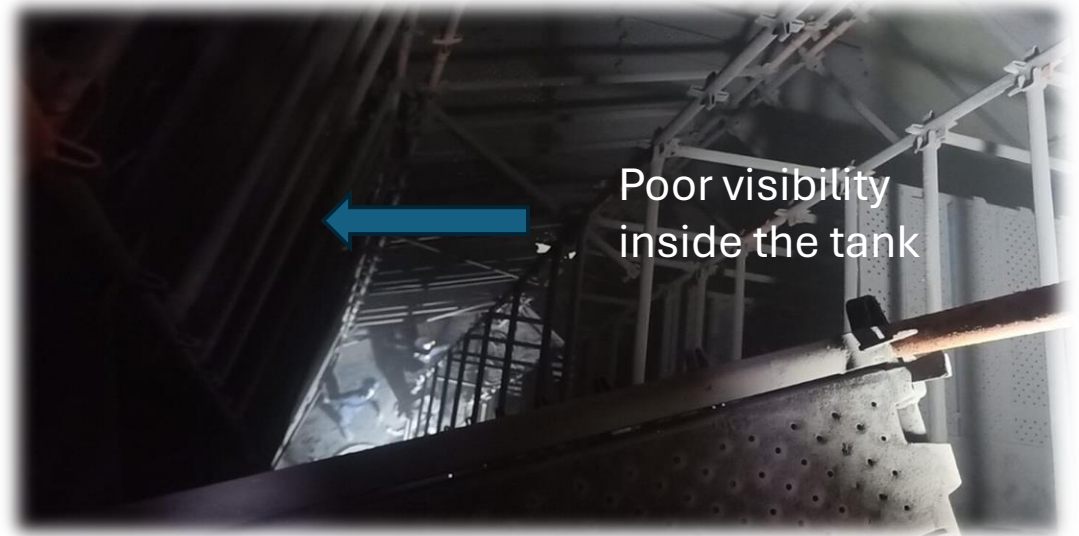
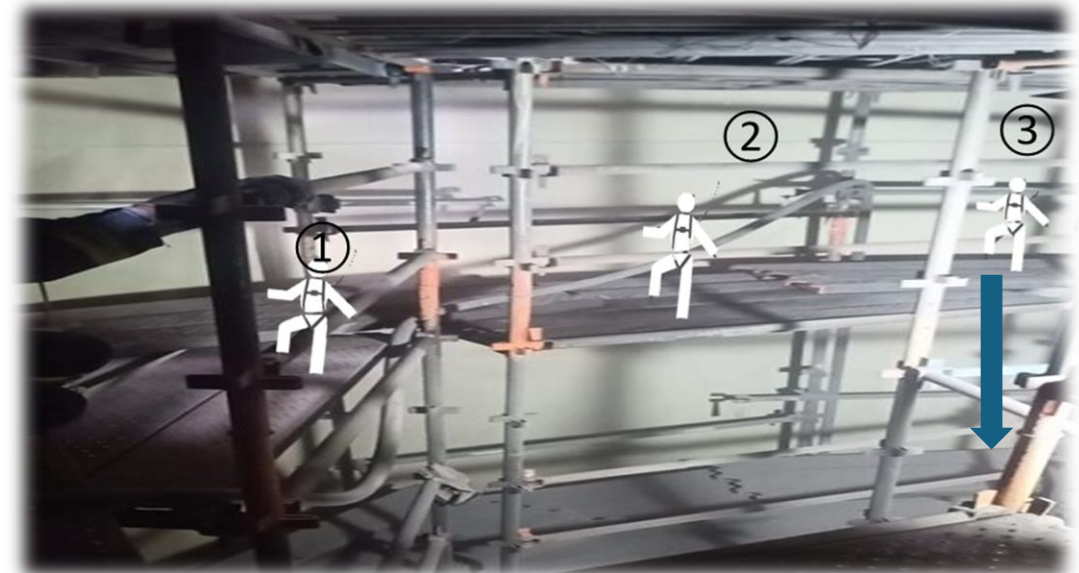
- Three workers were conducting housekeeping on platform 7 of 8 inside of the tank.
- Conditions inside the tank; relatively dark, dusty and with poor visibility.

- Once platform 7 sweeping was completed, worker No. 1 (operating the hose) and worker No.2 (supporting the hose) moved to the level below (platform 6) whilst IP was holding the light for them until they both were at platform 6.

- When workers No. 1 and 2 reached platform 6, IP handed over the light to the hose operator (Worker No. 1) from the 7th platform.
- Worker No. 1, took the light from IP and tied it to the scaffold ledger and then continued with task.

- IP goes down to platform 6 (**no one was directing the light for IP**), gets to platform 6, unhooks his lanyard, and tries to re-hook it to the missing ledger (previously removed to prevent the hose from getting tangled) then he falls to the bottom of tank (approximately 10 meters).

- Workers 1 and 2 felt the scaffold shake, then realized Worker No.3 had fallen.

Immediate Cause Finding / Gap	Comments
<p>1. The scaffold platform was unsafe to be used because the ledgers had been removed by the supervisor, (who was also the scaffold inspector)</p>	<p>a) Review roles and responsibilities and ensure there is independence to avoid conflicting interest between inspector and supervisor, consider an independent scaffold contractor / inspector.</p> <p>b) Initiate Performance management for supervisor for violating the HSE procedures (Personal Optimising violation)</p>
<p>2. The worker did not secure the harness leading him to fall from a height.</p>	<p>a) Review lighting requirements and make specific recommendations for confined space entry, consider the use of lights in hard hat, and possibly the housekeeping process that affects visibility.</p> <p>b) Consider consequence management for IP for not hooking lanyard on harness (Personal Optimising violation)</p>

Underlying Cause Finding / Gap	Recommendation
<p>1. Improper management of subcontractor resulted in subcontractor deviation from HSE plan.</p>	<p>a) Contract User to ensure there is detailed HSE project implementation and interphase plan in place inclusive of clear roles and responsibilities amongst relevant HSE, HSEBP, Contractor HSE, in the implementation of the approved HSE Plan.</p> <p>b) Reinforce compliance to HSE requirements particularly inspections by safety agents, Approving authority, and site management in confined spaces.</p>
<p>2. Inability to perform assigned tasks safely is a lapse in the safety system of work.</p>	<p>a) To reinforce compliance to safe systems of work requirements through training and audits to ensure sites are conducting joint site visit and verification of controls prior to approval of PTW by RA/AA.</p>
