**FUELS INDUSTRY**  
Association of South Africa

# LEARNING FROM PSV INCIDENT

2024

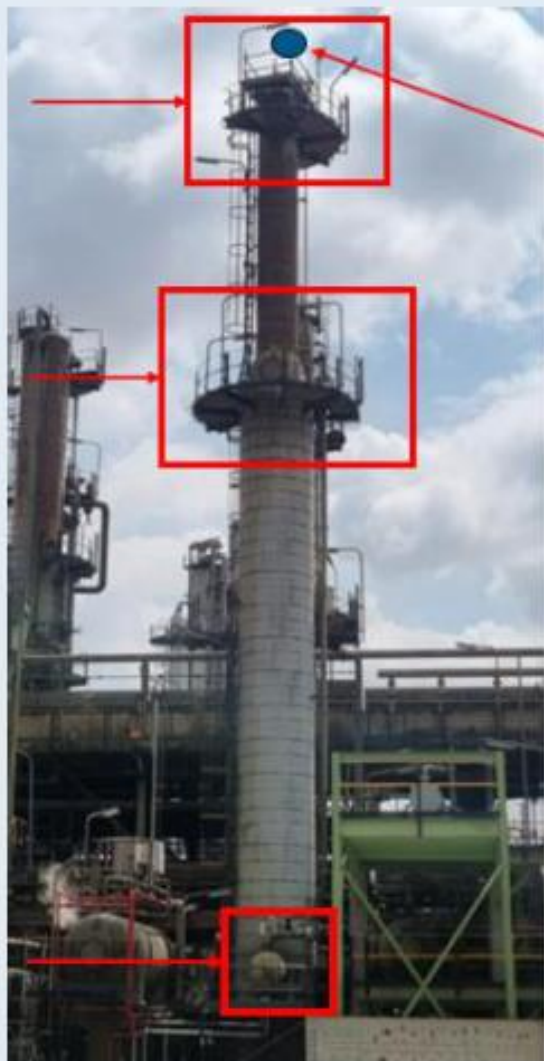
Top platform  
where person was  
exposed

Second platform  
where first line  
break was done  
on the feed line

Reboiler

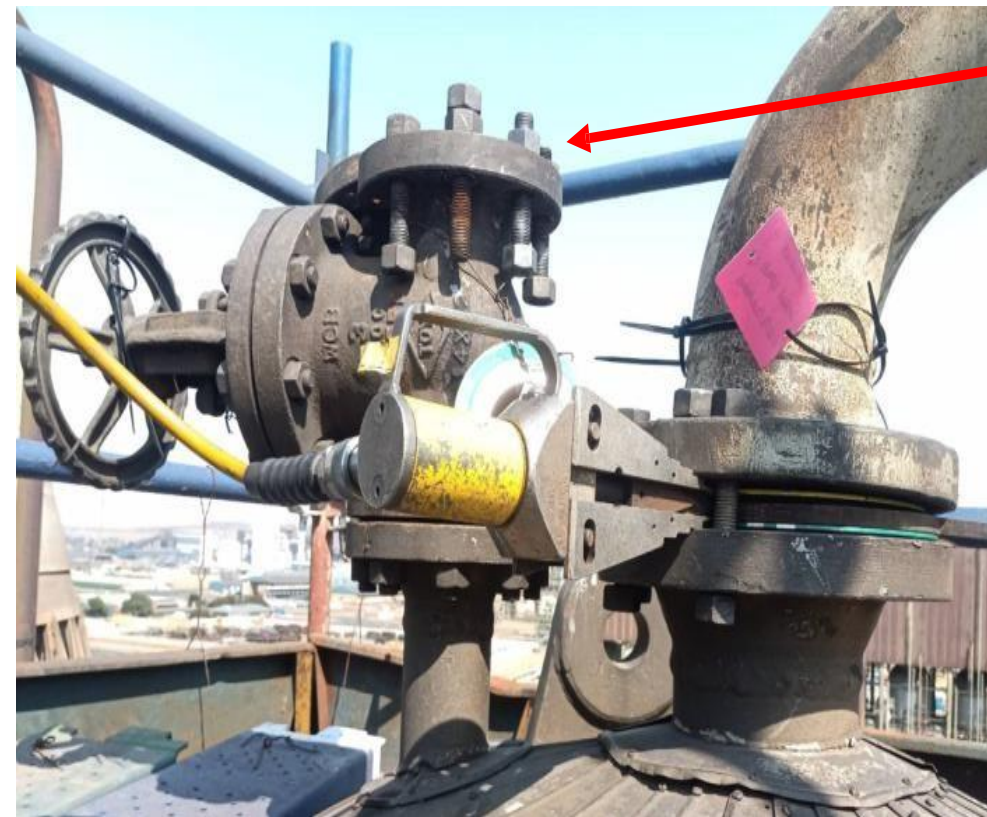
Position of injured  
person
