**FUELS INDUSTRY**  
Association of South Africa

# **LEARNING FROM INCIDENT (LFI): Struck Against (HiPo cohort Artisan Apprentices)**

2024

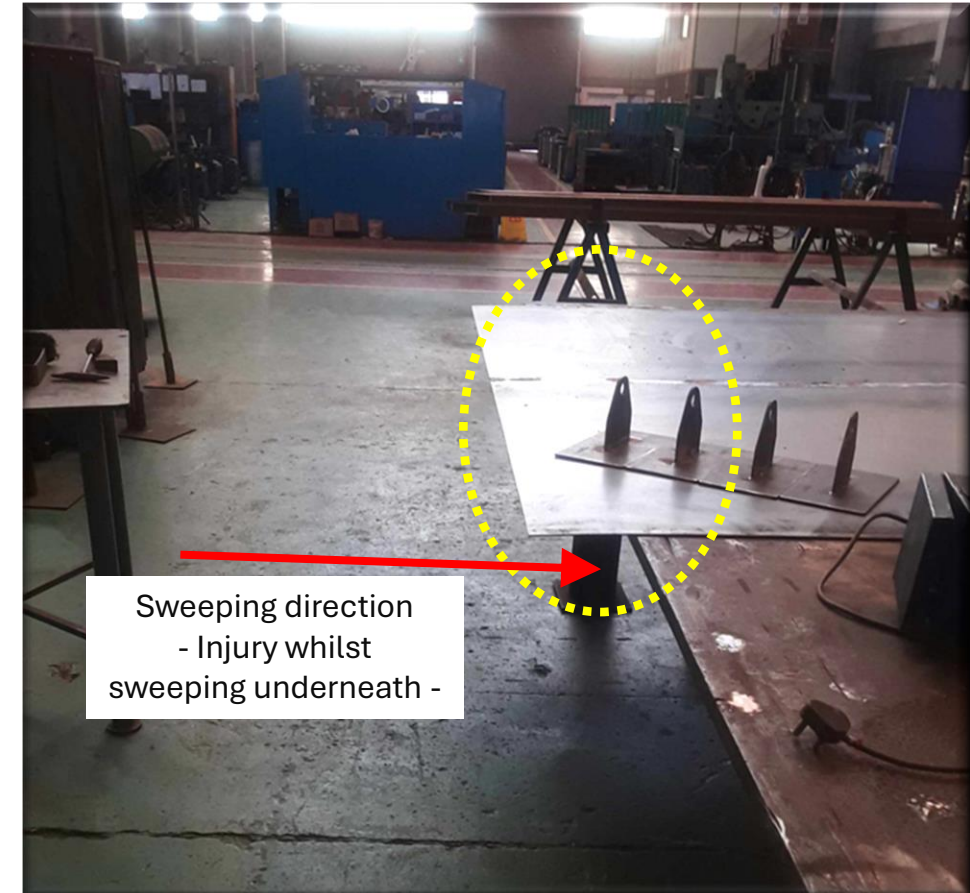
- Boilermaker apprentice sweeping the workshop floor (daily housekeeping) around the large workbench used for welding metal plates of coffer dam together.
- *Welded plate dimensions larger than bench' longest side – thus a hazard for consideration when sweeping the floor.*
- Whilst sweeping underneath the work bench – and turning the broom to pull the debris backwards - then hit finger against the edge of the metal plate – FAC laceration to the index finger.
- *Injured not wearing safety gloves during this task – but has pair of pigskin gloves close by atop next work bench.*

Coffer dam metal plates – welded joints  
- plates larger than bench thus protruding edge is hazard -

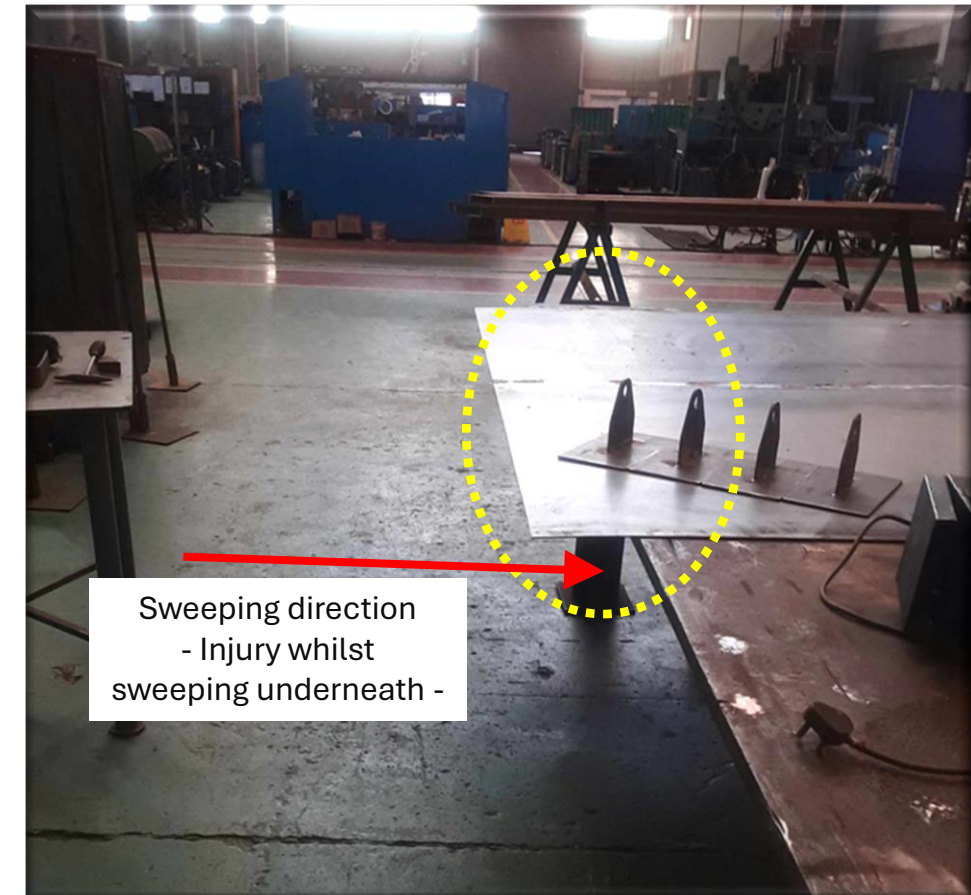
- Violation of PPE rule – PPE requirement within demarcated work area.
- Hazard Identification and Recognition:
  - *protruding edge not effectively recognised as hazard for sweeping at and below the work bench.*
- Not aware of the critical safe behaviour for the task at hand:
  - *Focus not only on the moving broom, but also the hands that are moving broom handle and the surroundings – look out for objects in the way – struck against stationary object hazards.*
- Competency – lack of coaching on skill.

Coffer dam metal plates – welded joints  
- plates larger than bench thus protruding edge is hazard -

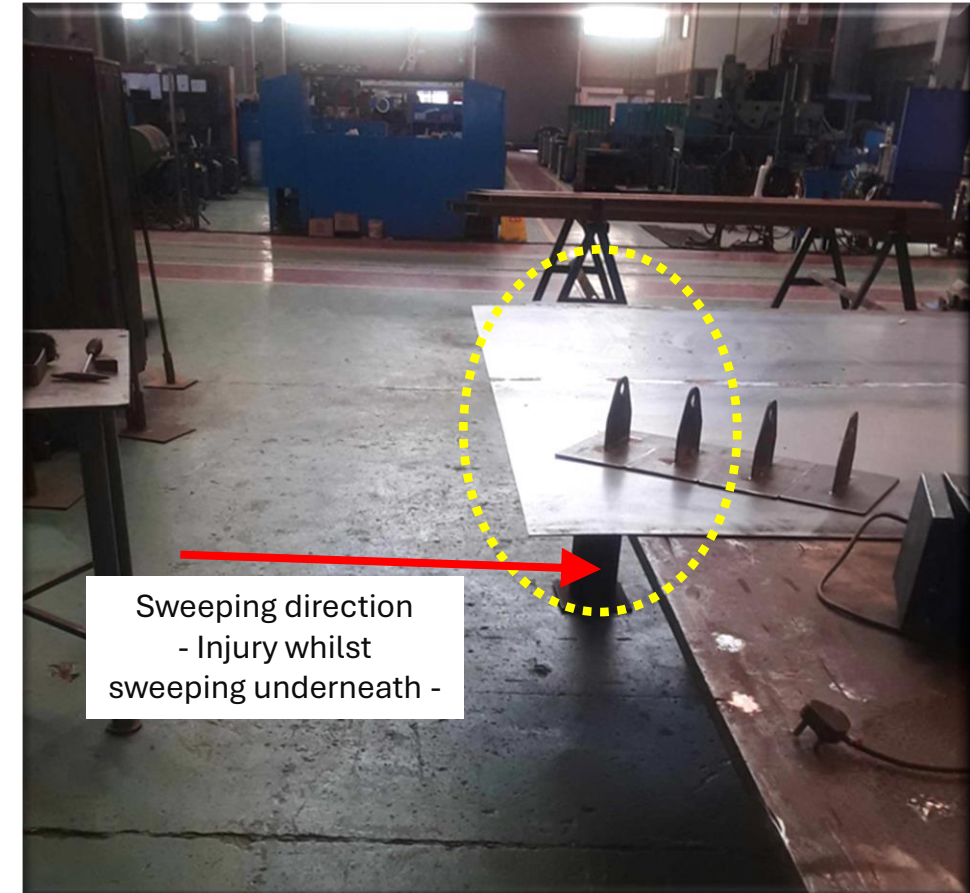
- Inadequate training provision / effort – on the job coaching by Trainer
  - Baseline risk assessment discussion prior to executing a task.
- Inadequate hazard/risk management – Learner Apprentices.
  - *Apprentice Trainers not facilitating the on-the-job training schedule of Apprentices with Supervisors – the Baseline Risk Assessments of tasks in the workshops.*
  - *Inadequate reinforcement of critical safe behaviours.*

Coffer dam metal plates – welded joints  
- plates larger than bench thus protruding edge is hazard -

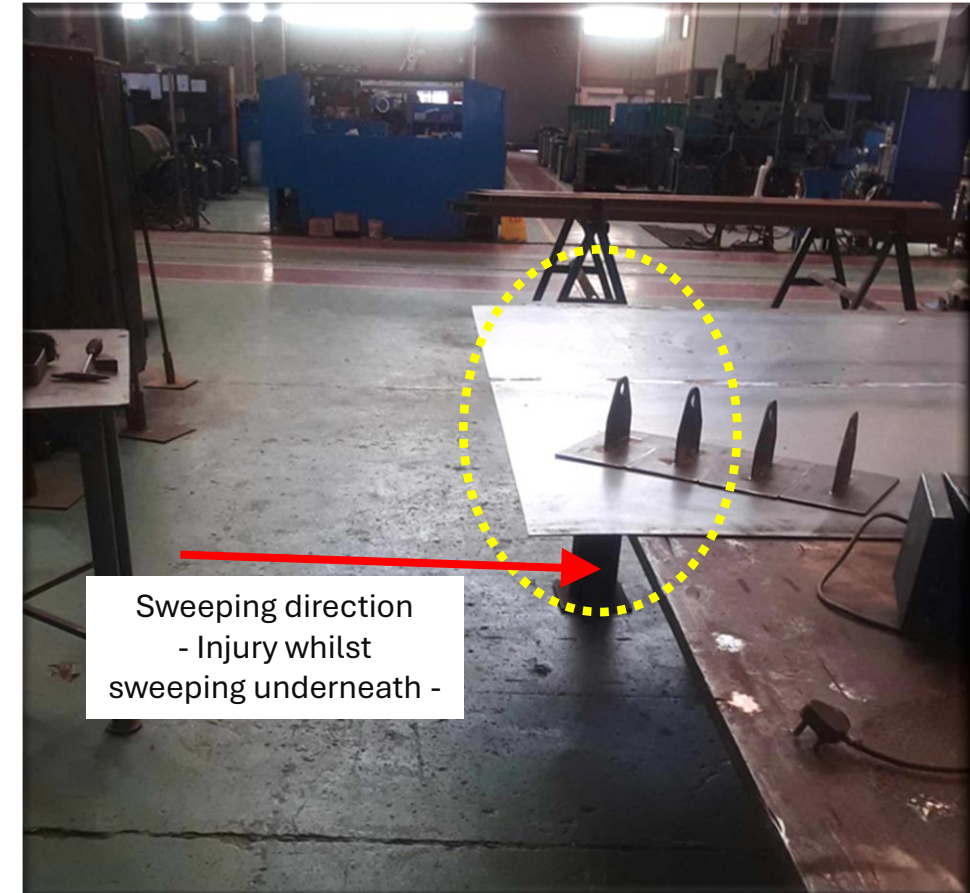
Coffer dam metal plates – welded joints  
- plates larger than bench thus protruding edge is hazard -

- Learner Apprentices require an on-the-job training plan (i.e. Portfolio of Evidence to meet occupational qualification requirements).
- *Learner Apprentices: first be coached on the practical Baseline Risk Assessment of a particular task by their Trainer at the workshop. Thereafter they may be assigned to perform that task under qualified supervision.*
- Safety Discussion with all Apprentices:
  - Important that all practice the HIRA habit before performing any task: i.e. what are the Hazards/Risks of the task - what can go wrong – what can cause it – what must be done to prevent it.
  - The PPE requirements of a task is mandatory – violation thereof will result in progressive discipline.
