# LEARNING FROM INCIDENT (LFI) – FALLING OBJECT HIPO

2024

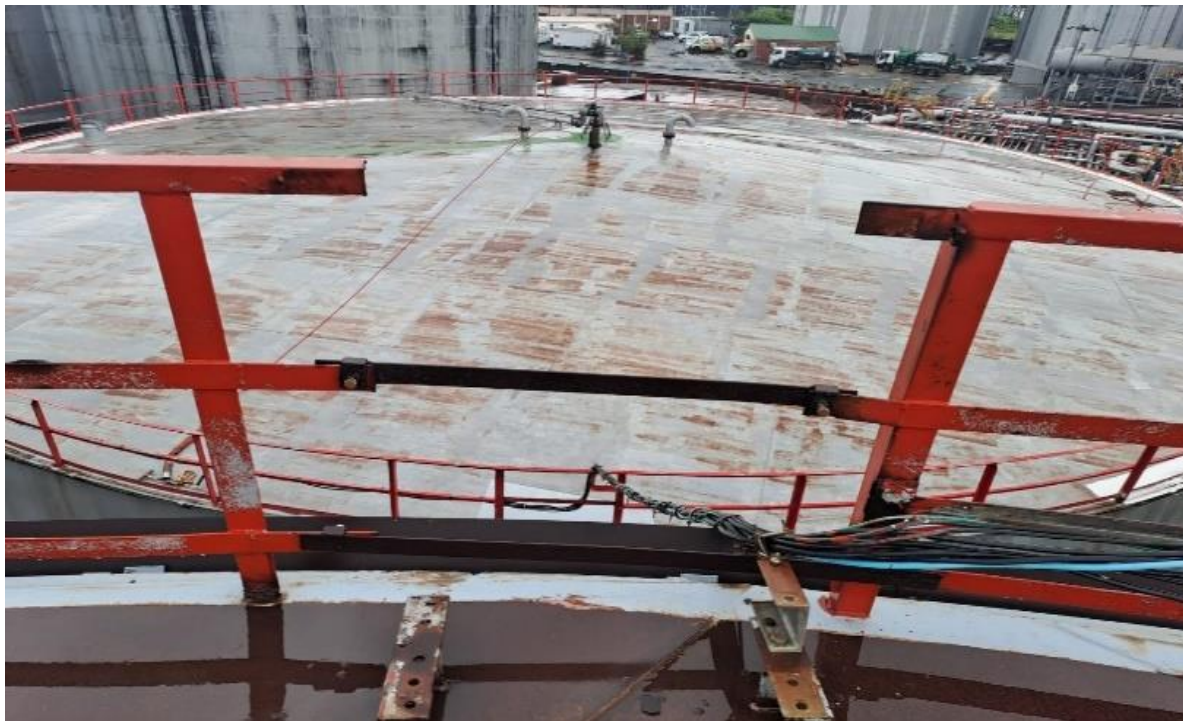
During lap rounds, operator reported finding a piece of handrailing was on the floor. It was a Handrailing piece (approximately 5kg) that came from the top of the tank. It was realised that the piece that fell (approx. 16m height) was a temporary piece installed after the sky-bridge was removed. This may have caused a fatal injury.

- When the sky-bridge was removed and a temporary piece was installed, that piece was never painted/ galvanized to preserve the piece from corrosion. Due to this corrosion, the piece ended thinning out to a point of this failure where it broke off.
- U-clamp was of mild steel and stainless-steel bolts were used; and this accelerates corrosion. This to be considered for future handrail bolt up standard.
- LFI gaps closure: This was a repeat incident – 2 similar incidents were reported in 2021. Full close out of incident investigations findings and actions to be done.

- Ensure that all handrails' installations are protected against corrosion before installing so that they last
- Operations and Tankage Maintenance inspection checklists to include Handrails and to be loaded as a controlled document.
- Confirm standard of handrails bolts up.
- Gaps and recommendations from similar incidents previous reports to be addressed to prevent a repeat incident.
