## SHE Incident Initial Learnings

Operating entity and division	Shondoni Colliery, W100 Conveyor Trajectory.
-------------------------------	--

Date of incident	8-Oct-21	Time	14H22
------------------	----------	------	-------

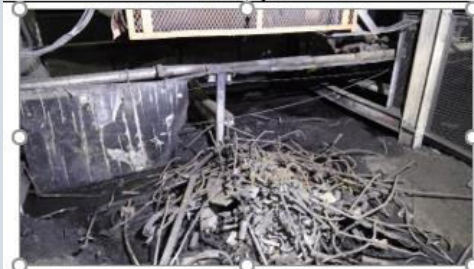
<p><b>Primary Magnet on W100 – Picture from discharge end of magnet conveyor also indicating tramp iron removed by magnet conveyor</b></p>	<p><b>Primary Magnet on W100 – Picture from tail end of W100 conveyor side</b></p>

<b>Preliminary causes or learning</b>	<p>The detailed incident investigation is still underway, and no preliminary causes can be listed at this stage, it is however suggested for all Sasol Mining operations to:</p> <ul style="list-style-type: none"> <li>• Inspect all magnet installations to verify cleanliness in these areas and to ensure that no buildup of material, debris and / or foreign materials are present in these areas.</li> <li>• Verify that support structures are appropriately aligned with remaining conveyor structures in the areas below these magnet installations and, ensure that these structures are bolted in position to prevent / mitigate the risk of misalignment.</li> </ul>
---------------------------------------	---

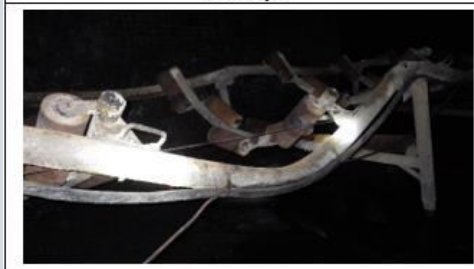
<p><b>Damage to support structures of W100 Conveyor</b></p>	<p><b>Side wall burning &amp; smouldering of coal adjacent to W100 Conveyor</b></p>

- Consequences** (describe all e.g. nature of injuries, damage and/or loss)
- Personnel injuries most due to smoke inhalation.
  - Damage to W100 Conveyor installation, air crossing infrastructure, wire mesh installation and other infrastructure such as water reticulation lines.
  - Production interruption due to rescue and in-loco investigation activities and Section 54 stoppage by the DMRE.
