Incident Learning: What happened?

An employee was trapped between two vehicles while attempting to jump start one of the vehicles

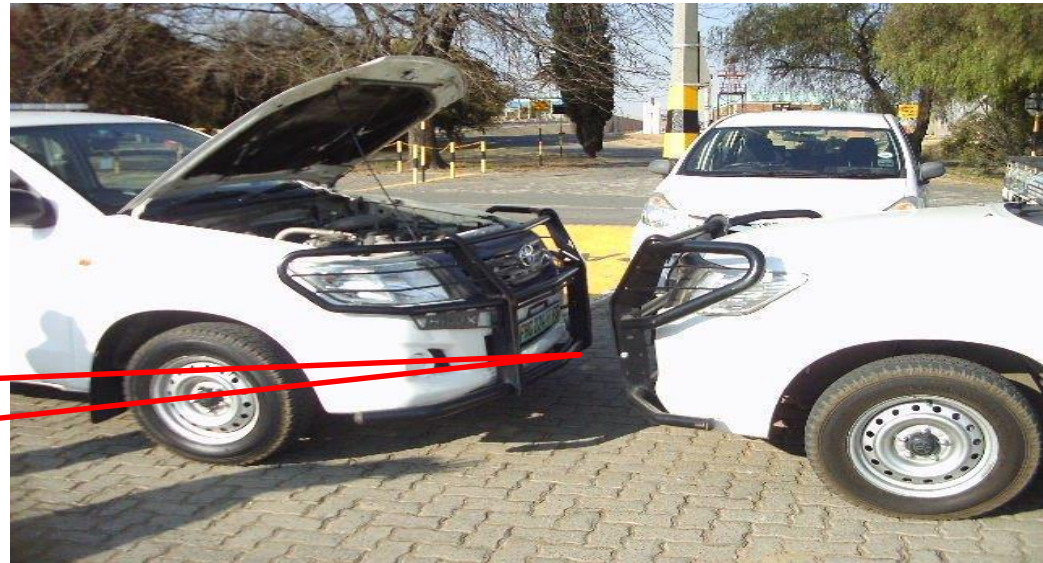
Place where the injured was standing at the time of the incident.

- Line of fire – the vehicle was still engaged in gear when the driver lifted his foot from the clutch pedal. The hand break was not yet engaged.
- Line of fire – the distance between the two vehicles was insufficient to compensate for any forward movement of the vehicle
- Lack of safe work procedure – No clear guideline on the jumpstarting of vehicles

- A portable battery pack should be used rather than jumpstarting using two vehicles and jumper cables
- Always be aware of the hazards around the task at hand and recognise the impact it can have
