# Incident Learning: What happened?

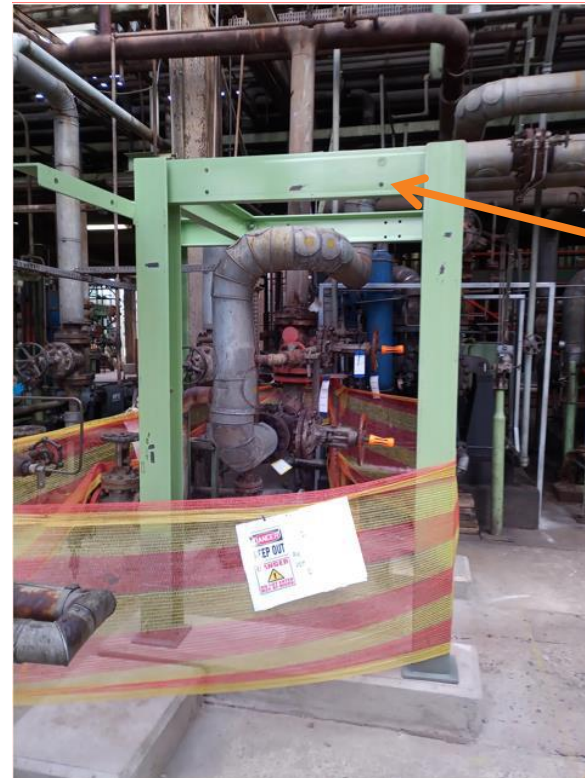
- The injured person bent down to pick up a nut when the upright moved. The cross channel detached from the structure being erected and moved downwards. While getting up, the injured got struck on the mouth after retrieving the nut from the container on the ground, sustaining a laceration.
- A method statement was in place
  - The pre-task risk assessment was used
  - A valid Permit to Work was in place
  - All supporting documents were available
  - The activity was done several times prior to the incident
  - The Chargehand was with the team at the time of the incident

Crossbeam  
which  
detached  
and fell

- Management system failure - Inadequate job scoping. Failure to identify the need for additional platforms for employees to install structures.
- Change in the height of the structure Did not consider the change in controls required.
- Method statement did not address over-reach.
- Did not identify a way to communicate between employees in a double hearing protection area in the method statement.
