# Incident Learning: What happened?

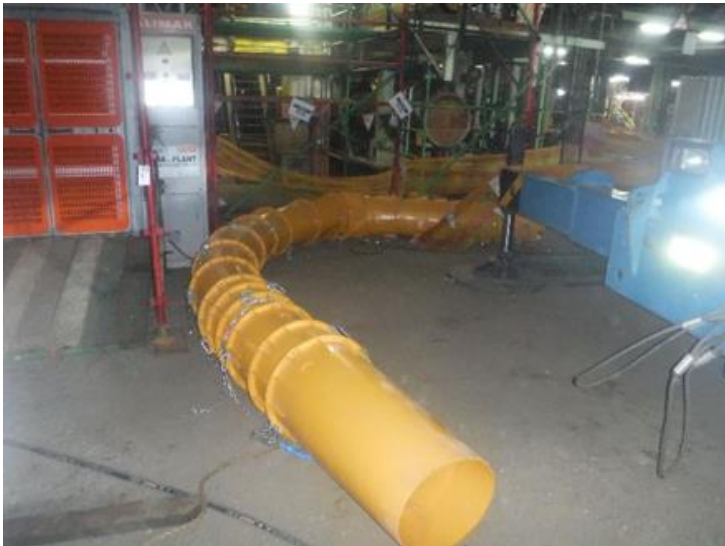
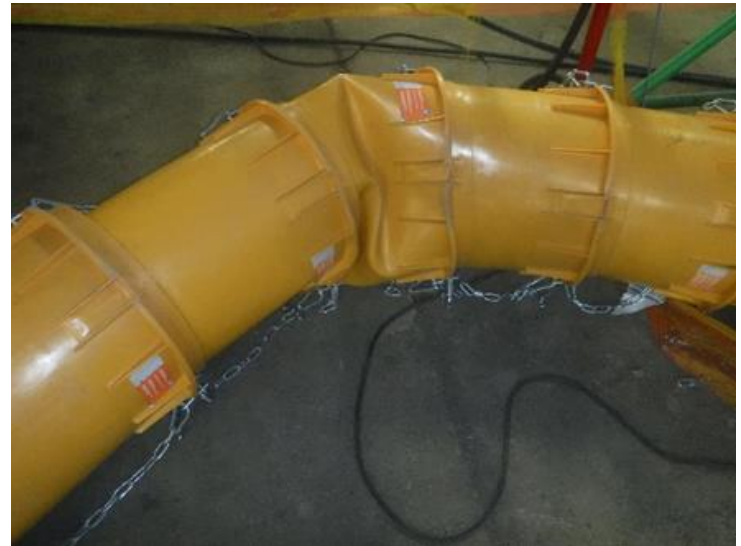
Riggers were instructed to install a bucket rubble chute. Mechanical and rigging teams assembled the chutes on ground level in preparation for a lift. The rigging team executed the lift of approximately 38 chutes. While executing the lift the attachments between chutes 4 and 5 deformed and dislodged resulting in the load falling to ground level. No injuries were sustained.

- Rigging method not followed and slinging method not done correctly.
- First lift consisted of 10 chutes as per supplier requirements and the second load exceeded the supplier requirement by lifting 38 chutes.
- When changes in design occur ensure that the MOC (management of change) process is followed.
- Ensure certified lifting equipment is used when conducting rigging work.
