## COMPRESSOR HIGH POTENTIAL INCIDENT - LFI

Time: 08H10      Date: 25/5/2023

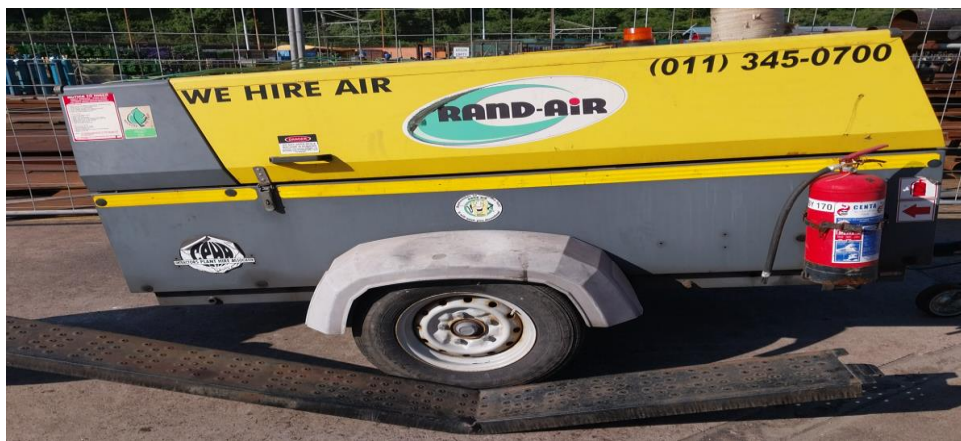
- Workers were setting up to work in one of the tanks; a diesel driven compressor was lifted by the Hyab truck and placed onto the scaffold platform. There were other equipment on the scaffold - gang box, diesel driven mobile generators and other equipment.
- The compressor was disconnected from the Hyab hook and was being pushed into its position when the scaffold board buckled, and the compressor wheel dropped down about 300mm.

- Scaffold was overloaded (5000 kg equipment) was placed a green tagged scaffold.
- Low risk vehicle entry permit used instead of Medium risk (which requires a Rigger to oversee the activity) – this was work over live line and lifting into a process area risk not identified.

- Gap in how each step from RAMS is used
- Workers not aware of load bearing scaffolding.
- Gap in understanding of Lifting and hoisting activities by Mechanical teams.
