Learning from Incident: Internal Floating Roof Collapse

Date:	24/10/2024
Location:	Crude Oil Tank Farm Durban
Equipment:	Crude oil storage tank with a Geodesic roof and internal aluminum floating roof
Description:	Following the crude filling, the internal floating roof (IFR) was found to be submerged.
Consequence:	The storage tank needed to be taken out of commission to repair the sustained damage.
Potential Consequence:	Due to the high volume of crude oil vapours there were a potential of fire and air pollution.

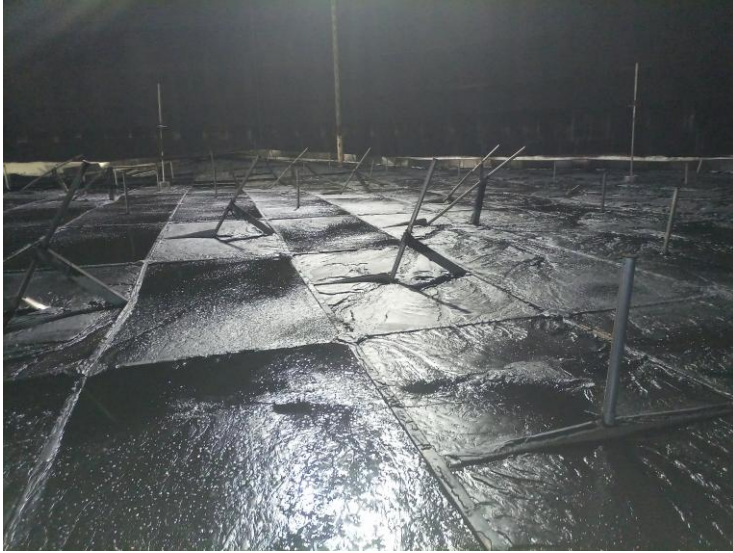
IFR roof legs

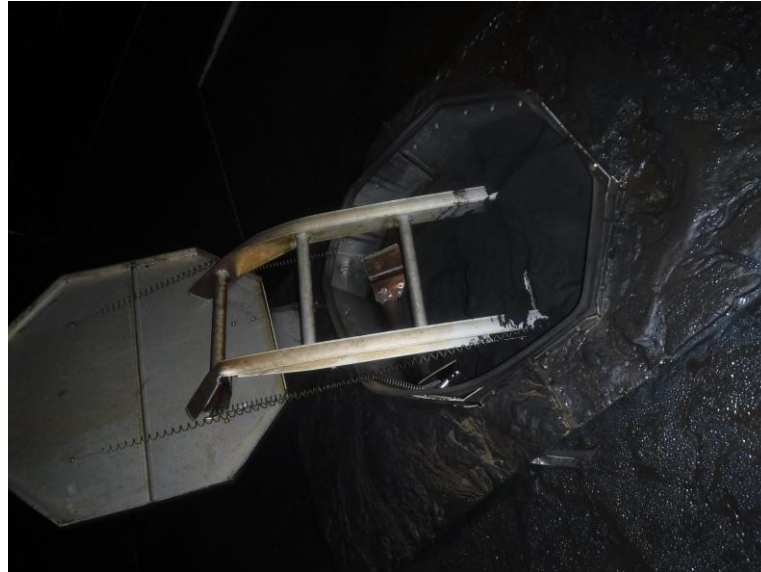
IFR man way

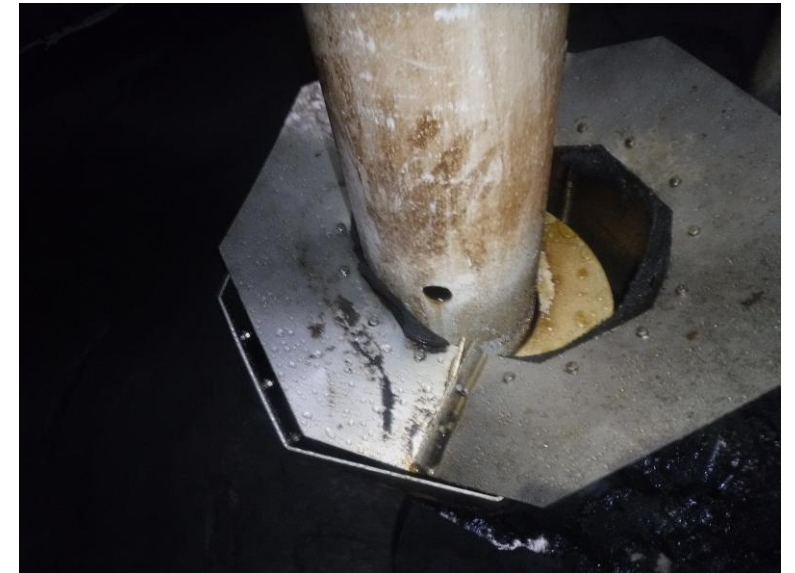
Stillwell and seal

- A severe rainstorm occurred post-decommissioning. No water leakage was detected, confirming the geodesic dome's integrity.
- Stillwell Inspection:
 - A large scratch was noted on one stillwell, indicating possible interference, which could have occurred before or after the incident.

- A bent sliding plate was observed on the other stillwell seal. The presence of a roof leg next to the stillwell seal, which should not be there, likely caused interference. This interference bent the sliding plate, restricting IFR movement and allowing crude onto the roof.

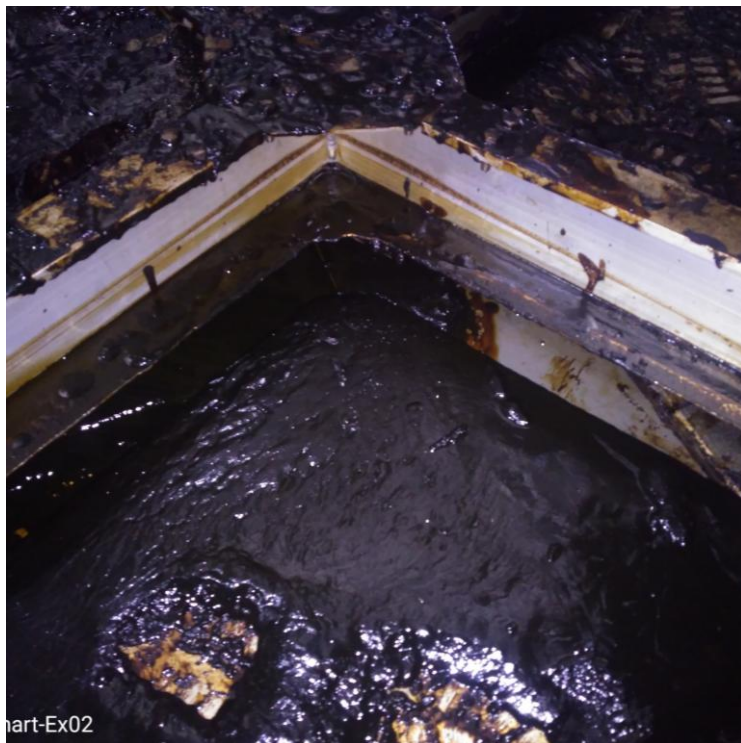
- No distinct crude smells were reported during inspections.
- Two IFR plates had failed welds, not located near any roof legs. These failures could have occurred either before or after submersion.

- Failed Weld on IFR Plate:
One of the two IFR plates with a failed weld, which is not close to any roof leg.
- Roof Leg Interference with Stillwell Seal:
Note how the sliding plate, which is not supposed to be constrained, is bent.

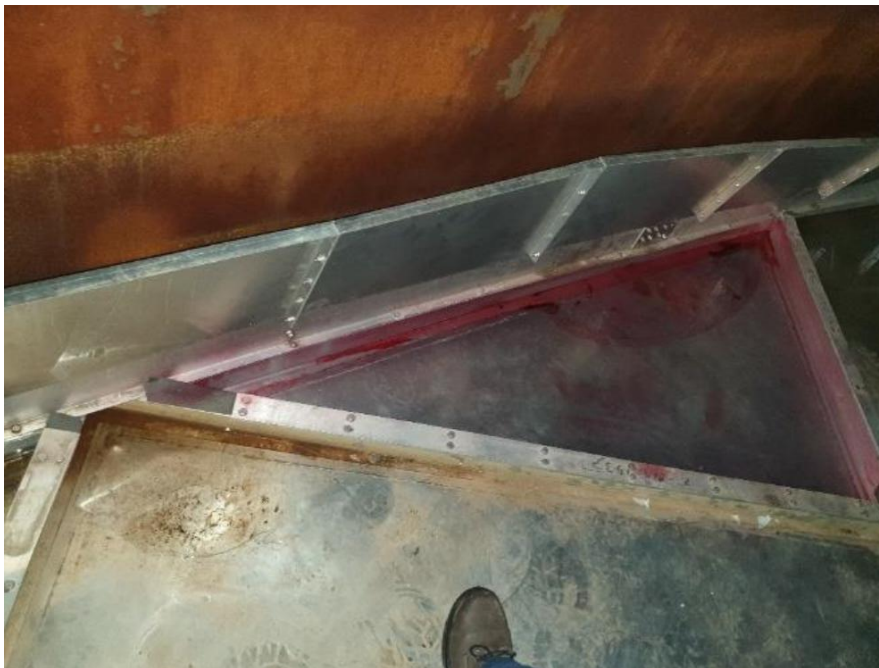
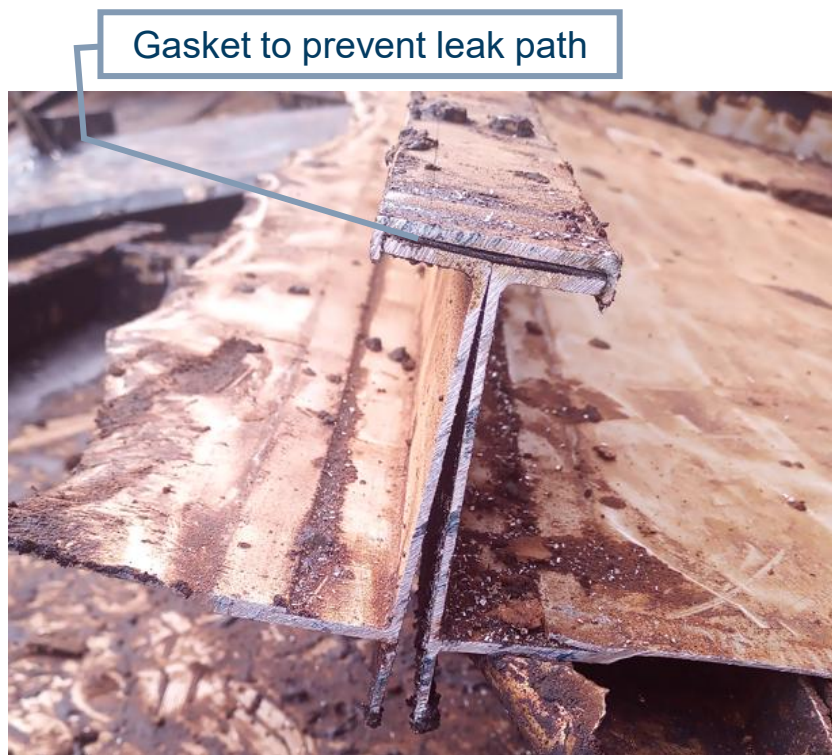
- IFR Panel Leak Defect: The IFR panel leak defect was not communicated correctly. The sealing strip is not installed throughout the length of the joint, meaning the leak path will not seal all the way.
- Illustration of the Joint: Below is a picture to illustrate the joint. Note the bottom section is bolted during normal installation.

- Full Contact IFR Considerations:
 - Since the IFR is made of aluminum, the components are lightweight and less durable than carbon steel. Attention should be given to the diffuser to mitigate any unnecessarily large forces.
 - The sealing strips of the IFR plates are essential components. Special consideration should be given to these joints to ensure proper sealing.
- The interphase between the stillwell seals and the IFR is critical. Any possible restrictions should be removed, and adequate tolerance should be provided.
- If any deviations from the design are noted during the construction phase, the designer should be informed to assist with a solution.
