LEARNING FROM INCIDENT (LFI)

Mamello Shelle (SDSA)

Falling from height incident – during canopy light installation

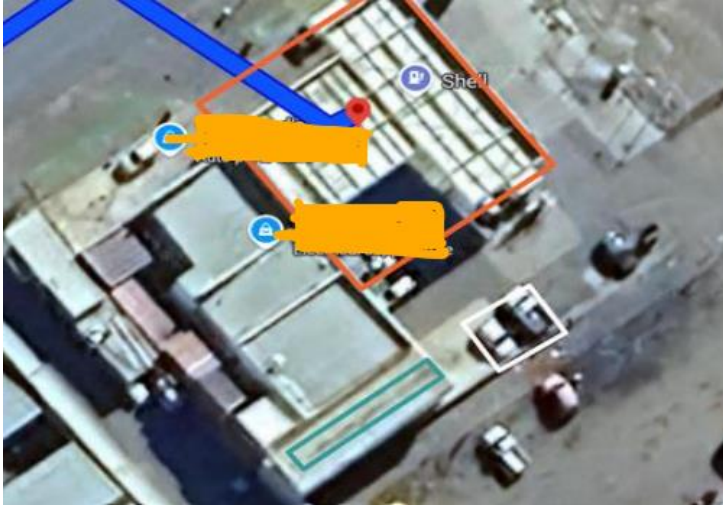
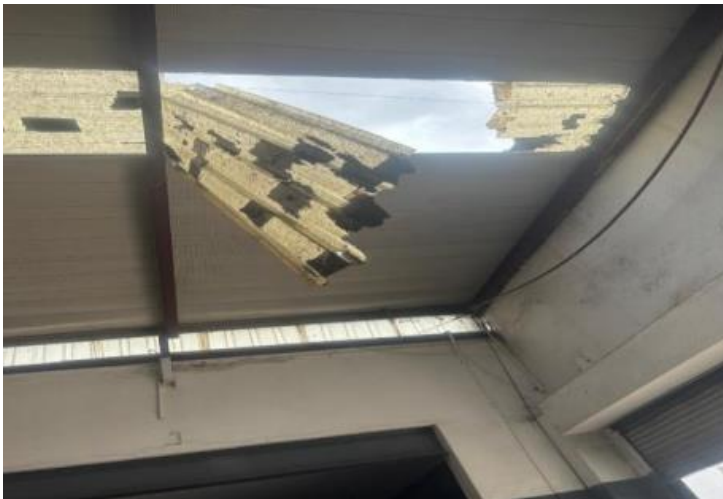
- The team was working on the roof installing canopy lights
- There was a team member that was still working on the canopy when the rest of team vacated the work area and locked the gate.
- The member attempted to get the attention of colleagues by working across the canopy to the side where they were parked. This was outside of the work area and that part of the roof was not assessed.
- The team member accidentally stepped onto a fragile roof surface which collapsed.
- The technician sustained injuries to the hand/wrist requiring surgery.
- There were no anchor points or lifelines in place at the point where the fall occurred because it was outside of the working area.
- The technician was not supervised at the time of the incident.

- Always remain inside the **clearly-marked permitted work areas**.
- Do not enter any **unauthorized areas** without first assessing the hazards and implementing suitable control measures.

- Clear identification, mitigation and communication of hazards incl. **fragile surfaces**. Enhance work planning and Last Minute Risk Assessment (LMRA)

- Ensure clearly defined **access/ egress point(s)**
- Install permanent anchor points and lifelines where applicable.
- Always have a **spotter/ supervisor** available when someone is working at height to provide supervision, assurance and **emergency support**, following Shell and local regulatory requirements.

- Ensure **clear communication** for each key stage of the work with all key stakeholders on site.
- Ensure task-specific emergency response actions are integrated into Job Hazard Analysis (JHA), which should cover the whole site but not just the immediate work area.
