LEARNING FROM INCIDENT (LFI)

INCIDENT DESCRIPTION

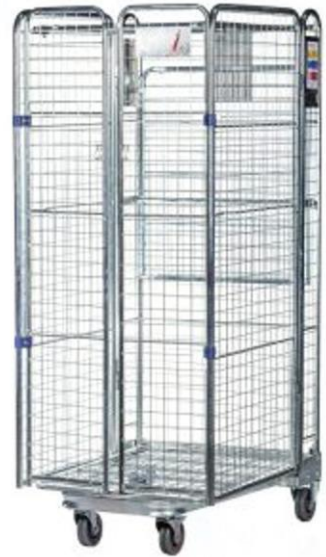
Rolltainer

- On 31 March 2025 at around 10:30am a delivery took place at a retail site to deliver dry stock for the convenience store.
- A 3rd party employee (injured person – IP) of the delivery company positioned a rolltainer filled with dry stock on the tail lift which is located at the back of the delivery vehicle.
- The IP remained on the tail lift while another 3rd party employee of the same company started lowering the tail lift.
- While the tail lift was being lowered the rolltainer started veering off the tail lift. The IP jumped off the tail lift in an attempt to stop the rolltainer from falling from the tail lift, but they were unsuccessful.
- The rolltainer toppled over and fell on top of the IP.

- Dry stock deliveries can lead to hand, finger, foot or crush (pinch) injuries, and/or muscle strain.
- To avoid these:
 - Dry stock should be packed with the heaviest items at the bottom of the handling units (rolltainers) at the packaging depot.

- Use the prescribed manual handling procedure when moving handling units.
 - Wear the approved hand protective gear when handling deliveries.
 - Handling units must be pushed with store team members standing behind the load, facing the direction of travel, moving at a steady walking pace and taking care to ensure their route ahead is clear.
