**FUELS INDUSTRY**  
Association of South Africa

# Sasol – Exposure to gas. September 2024

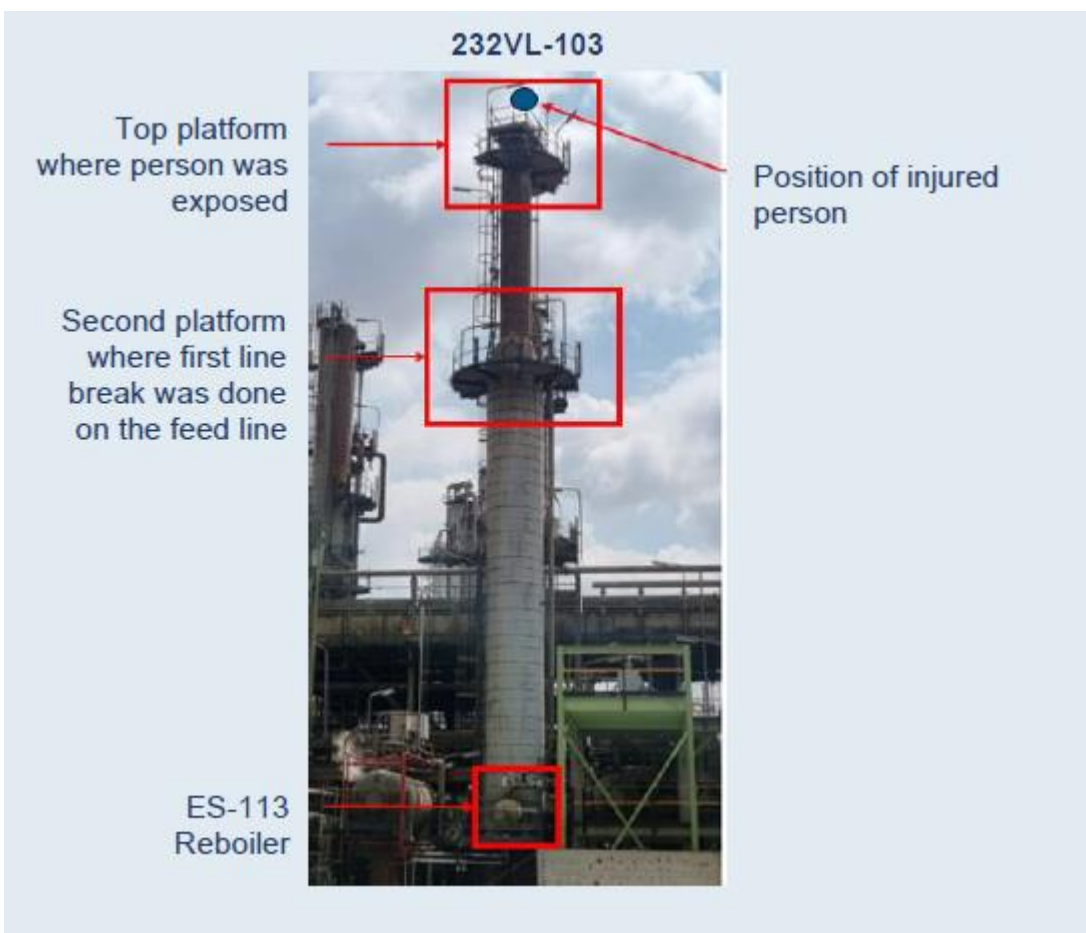
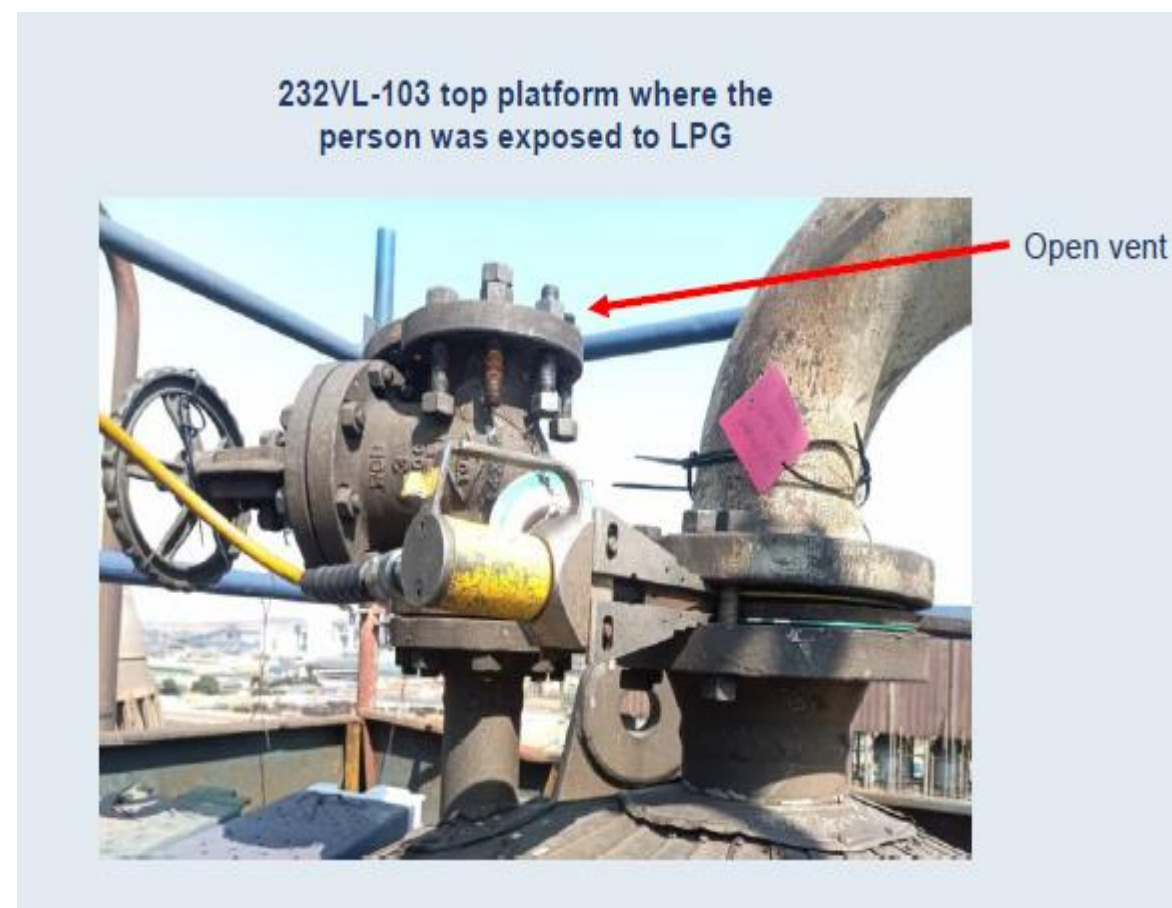
**Description of Incident:** A mechanical team was installing gaskets on a 6" slip plate of 232VL-103 overhead line when one of the team members was exposed to LPG.

- Prior to U232 shutdown, inadequacies were identified regarding safe making standards from the U090 incident and interim philosophies were established for the shutdown. However, the interim safe-making plan was for the LPG system and not specifically for 232VL-103 column.
- No procedure or instruction could be obtained that guides employees not to use globe valves as an effective process isolation method.

Insufficient first level of assurance conducted and recorded by management since February 2024.

- There were visible signs that something was wrong. Two triggers provided indications of this: fumes from 232ES-113 and the feed line being iced up, which led to LPG leaking into the system, and the work was subsequently not stopped.
- The safe maker/standby did not stop and evacuate the service provider team working on the overhead line next to the open vent on the top platform, when product was noticed in the feed line during first line break.
- After a serious process safety incident, the previous day, which led to the need for the work on 232VL-103, the appointed production foreman did not regard this activity as high risk and requested the acting production foreman to issue the permit.
- The service provider team did not stop the work even though they could smell LPG in the work area

- Improvement to safe making standards must be considered when preparing for similar activities to avoid repeat incidents. (Learnings, corrective and preventive actions from June 2024 U090 gas exposure process safety incident)

- Ensure safe makers/standby personnel are suitably trained with emphasis on their roles in terms of stopping work when product leaks are detected.
- The likelihood of leakage of valves during safe making should be managed (tested and confirmed), e.g. globe valves tend to have a higher probability of leaking through.

- Safe making complex systems must include additional safe making risk mitigations, such as, PDAs, marked MFDs, procedures, drawings, etc.
- There is a common perception that cold work permits involve low risk activities only, which can create a false sense of comfort among permit issuers and safe makers. A safe maker must be able to confirm that risks or hazards have been adequately addressed and eliminated, as outlined in section 3, e.g. by ensuring a gas test is conducted. Residual product, post safe making, must be managed correctly.

- All levels of supervision and management should develop, implement, and adhere to a schedule for first-level assurance, if not already in place. The focus of first level assurance should be on identifying overall compliance and systemic issues.

- Appropriate management intervention to be applied where non-compliances to procedures/standards are identified.
