# Sasol – Exposure to gas. June 2024

# INCIDENT DESCRIPTION

**Description of Incident:** Two service provider mechanical fitter employees were exposed to some fumes while installing an end blank on a pipeline where a pressure safety valve (PSV) was removed.

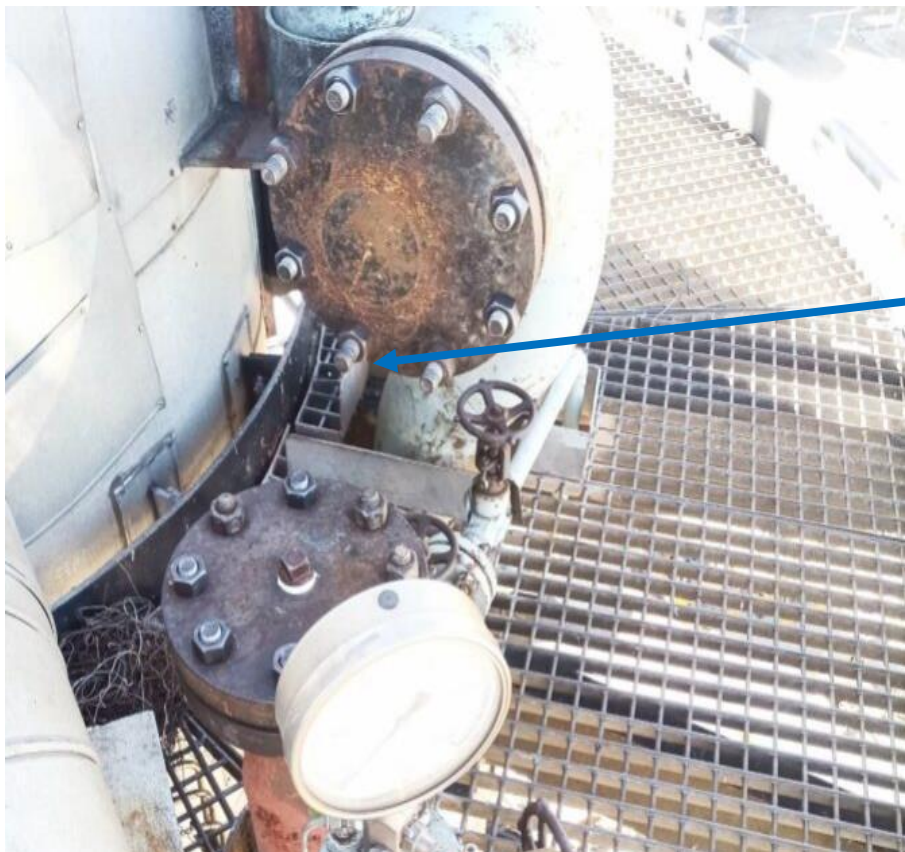
Position of PVS that was removed.

The permit was prepared only considering the safe making on the inlet side of the PSV. The outlet side of the PSV was neither blocked in nor isolated from the flare header.

- The area safe making checklist was utilised to verify safe making before the permit was issued. It indicated that the equipment was isolated from the process, however, the PSV was not isolated from the flare system.

- Ensure that equipment is isolated from the process on both ends before execution of maintenance activities., depressurised and purged with nitrogen. Remove a vent or drain end blank/plugs and ensure the system is LEL free before opening flanges.
