# Sasol – Sulphuric acid. Jan 2025

# INCIDENT DESCRIPTION

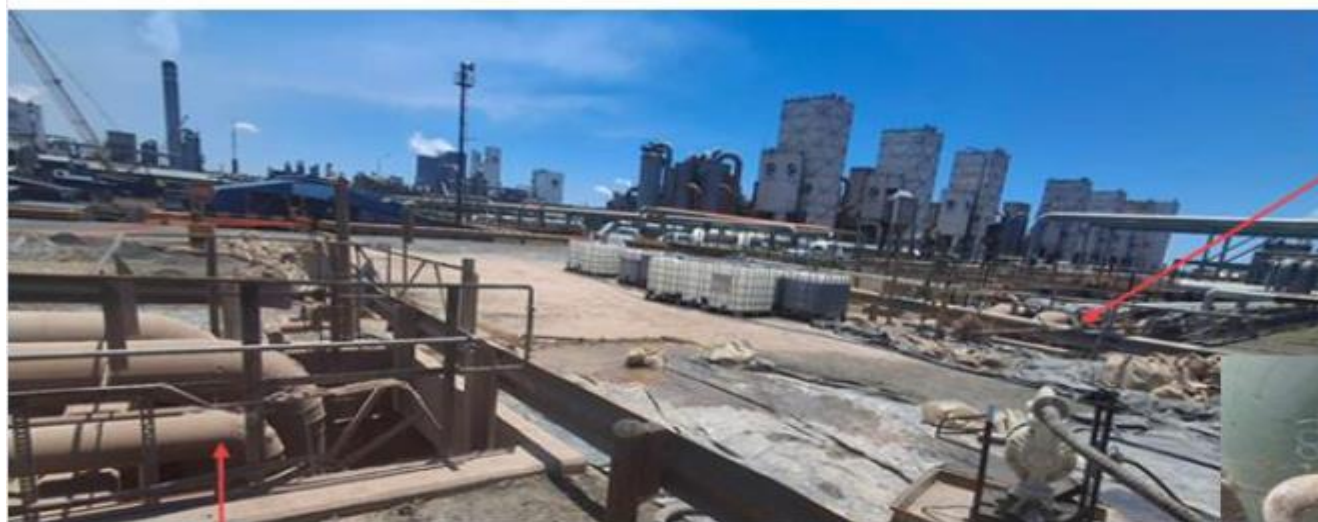
**Description of Incident:** A leak from a sulphuric acid line resulted in a nearby 40 bar steam line failure. This resulted in residual sulphuric acid being dispersed around the immediate environment.

Sulphuric acid pipeline

Sulphuric acid leaked flange

The gasket blowout resulted from the following potential root causes:

- Inadequate Gasket Installation: There is no Quality Control Procedure (QCP) for for flange F10 to verify if the gasket was installed correctly during 2018 project.
- Deviation from Design Requirements: A lack of records indicates that the required 12-month torque verification, as specified in the ISO drawing – SDY-250-0804PT2 on Note 7, may not have been performed.
- Due to PTFE's low recovery rate, the subsequent re-torquing, performed after missing the scheduled interval, may have contributed to the gasket failure

- Evaluate flanges inside the culvert that might results in a leak of corrosive material and review the risk that this may introduce of impacting other pipeline integrity
- Review the minimum QCP requirements used by SO and P&E to determine if it is adequate or not.
- Compile culvert flange list of all flanges inside culverts to prioritize removal and develop a plan to relocate flanges to a safe area where any potential acid leakage will be easy to identify without delay.
- Ensure adequate understanding of the escalation protocol from area to works emergency.
- Do consultations with the gasket OEM and PTFE lined pipeline OEM to confirm if the gasket is required for this application (Alloy 20 vs PTFE lined)
- Investigate from the gasket OEM and PTFE lined pipeline OEM to confirm if the correct gasket (width, size and material type) is used for this application (Alloy 20 vs PTFE lined )

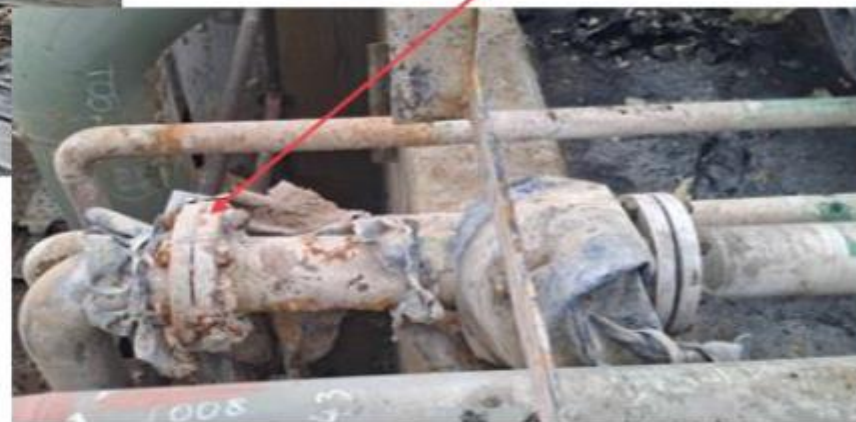
Steam pipeline(leaked inside the culvert)
