**South Africa NOV RBA - Service Champion Injured By Falling Object (Solar Panel from canopy roof)**

### SOUTH AFRICA NOV CO RBA - SERVICE CHAMPION INJURED BY FALLING OBJECT (SOLAR PANEL)

JULY 2024

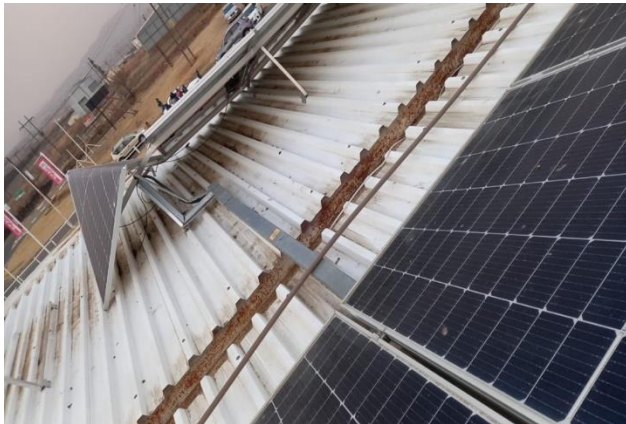
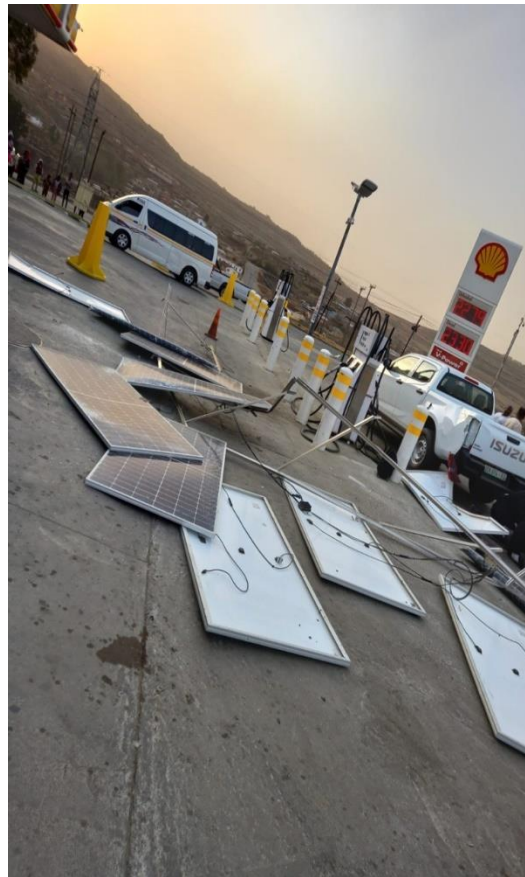
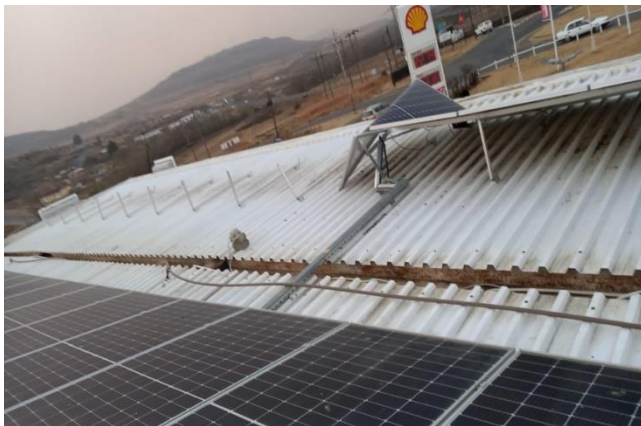
## IMAGES - EXTENT OF DAMAGE

- On the 07<sup>th</sup> of July 2024, at approximately 16:37 PM, during extremely strong windy conditions, solar panels on the canopy roof of the Sedibeng Service Station in the South African city of Qwa Qwa came loose and one of the rows fell.
- The solar panels fell onto the forecourt where the Service Champion was refuelling a customer's vehicle. Fortunately, the panel only slightly injured him in the leg as it hit the back of the bakkie/vehicle first.
- The injuries were treated in hospital by suturing the wound. In addition to the injuries of the Service champion,, the customer's vehicle was also slightly damaged.

- Maintenance Program - Market to develop a maintenance strategy with supplier for solar panel for adequate health checks.
- Winds in this location were more than 142km/h leading this row of solar panels to get "Dislodged from the roof"
- The solar panel installation were deployed by an approved supplier and covered other sites in the last 2 years.

- Work with supplier for making safe other sites and providing the additional barriers for similar risk sites (With high wind speed risks)
- Service Champion Big Rules "I promise to stay forecourt safe". High wind speed to be factored in the risk at sites.
- ERP readiness at sites and its importance during such incidents.
- Intervene when you spot an unsafe condition or act. Report proactively.
