**FUELS INDUSTRY**  
Association of South Africa

# **IOGP Process Safety Events – 2023 (SAPREF)**

2024

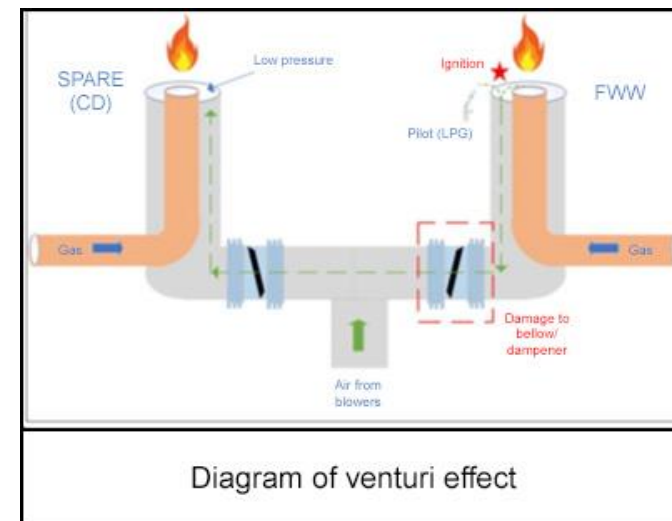
May 2023, facility in Australia, during a planned shutdown an internal combustion event occurred inside the air assist system of the Stage 1 warm wet flare which resulted in damage > \$100 000.

As part of shutdown work scopes, the main flare air blowers were taken offline leading to no positive pressure within the air annulus of the flare warm wet (FWW) and spare first stage flares. These two air assist flares were communicating through common air ducting and open dampers. A venturi effect (created by a low-pressure point at the spare first stage tip) drew hydrocarbon from the flare warm wet gas riser/pilots into the air annulus towards the spare flare. A flammable atmosphere was then created and ignited at the flare warm wet tip, leading to a deflagration (causing flare warm wet tip damage) followed by a detonation which caused the flare warm wet bellows to rupture.

- The air assist system design was modified, and operating mode changed at different times before facility startup.
- The risk of hydrocarbon ingress into the air assist system was not identified during design reviews.
- ***Vendor engagement during front-end design and safety reviews/HAZOP specifically for novel or complex systems is important.***

- Risk of hydrocarbon ingress into a flare air assist annulus was identified in a prior event with lessons potentially not clearly articulated.
- ***Operating procedures to provide key vendor parameters and a clear line of sight to operational risks.***

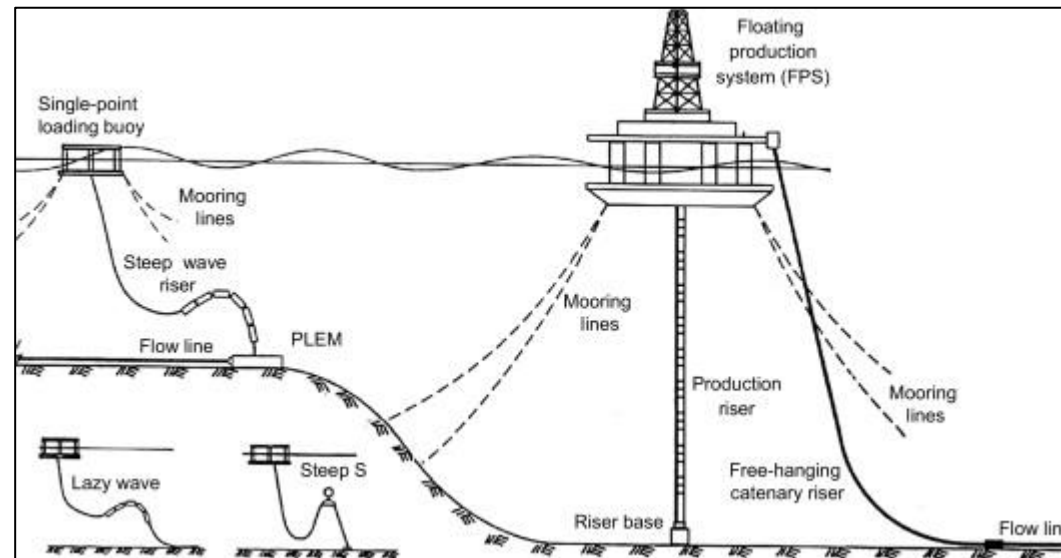
September 2023, facility in Malaysia, Hydrocarbon was observed released on a subsea pipeline through a small opening on flexible riser close to the flange connection to Pipeline End Manifold (PLEM) elbow.. The release was above the threshold quantity in any 1-hour period.

- Leak was due to fatigue on the flexible riser.
- Investigation concluded surrounding changes arising from operational activities contributed to the failure of the riser.
- ***Be more vigilant and alert on the surrounding changes and to immediately report any abnormalities..***

- ***Review the adequacy and frequency of inspections, testing and preventive maintenance in ensuring equipment integrity.***
