Learnings From Incident

REGEN Incident

2024 – REGEN Incident

Injury To Left Hand at Hydrogen Booster Compressor 17th May 2024

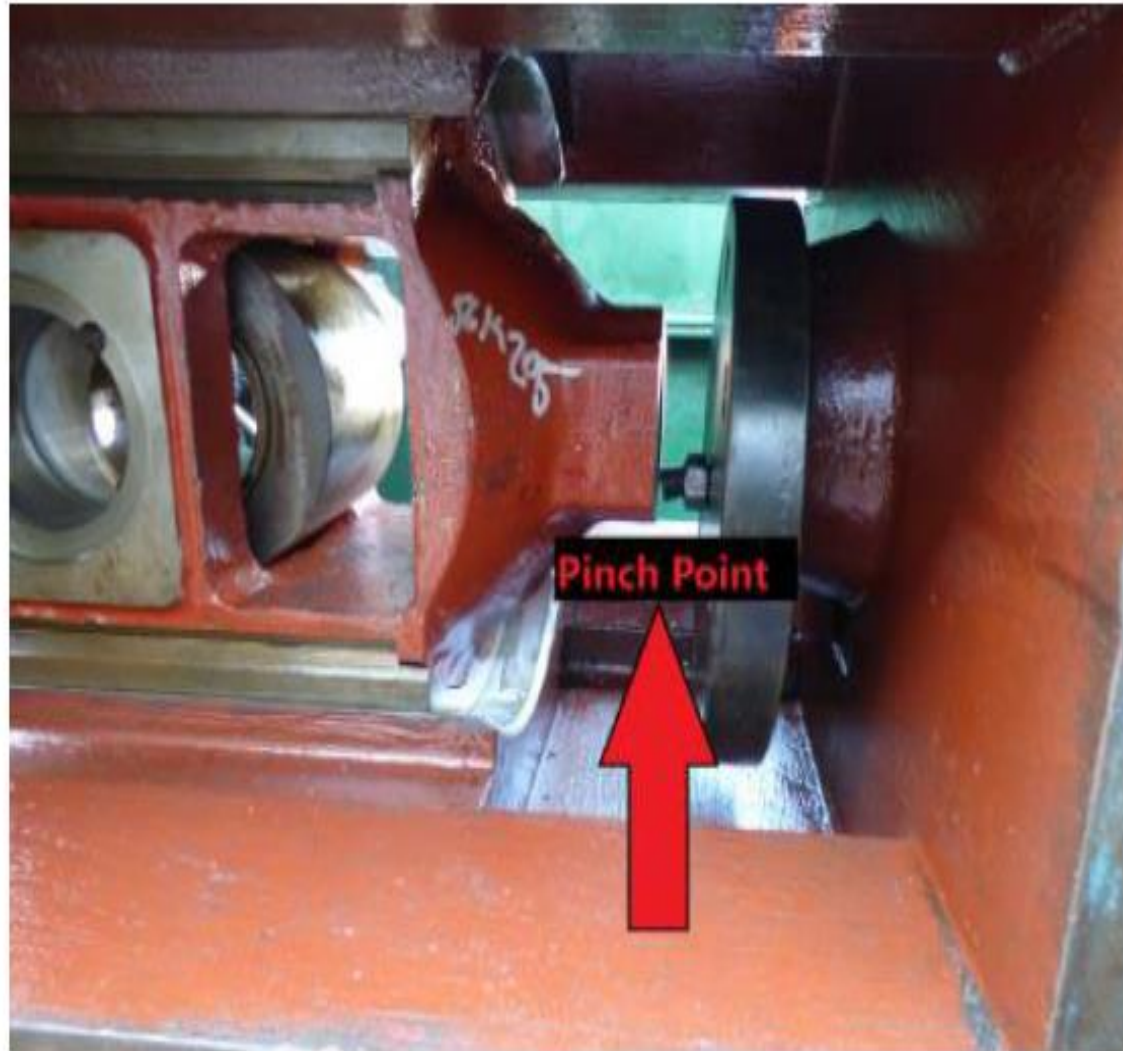
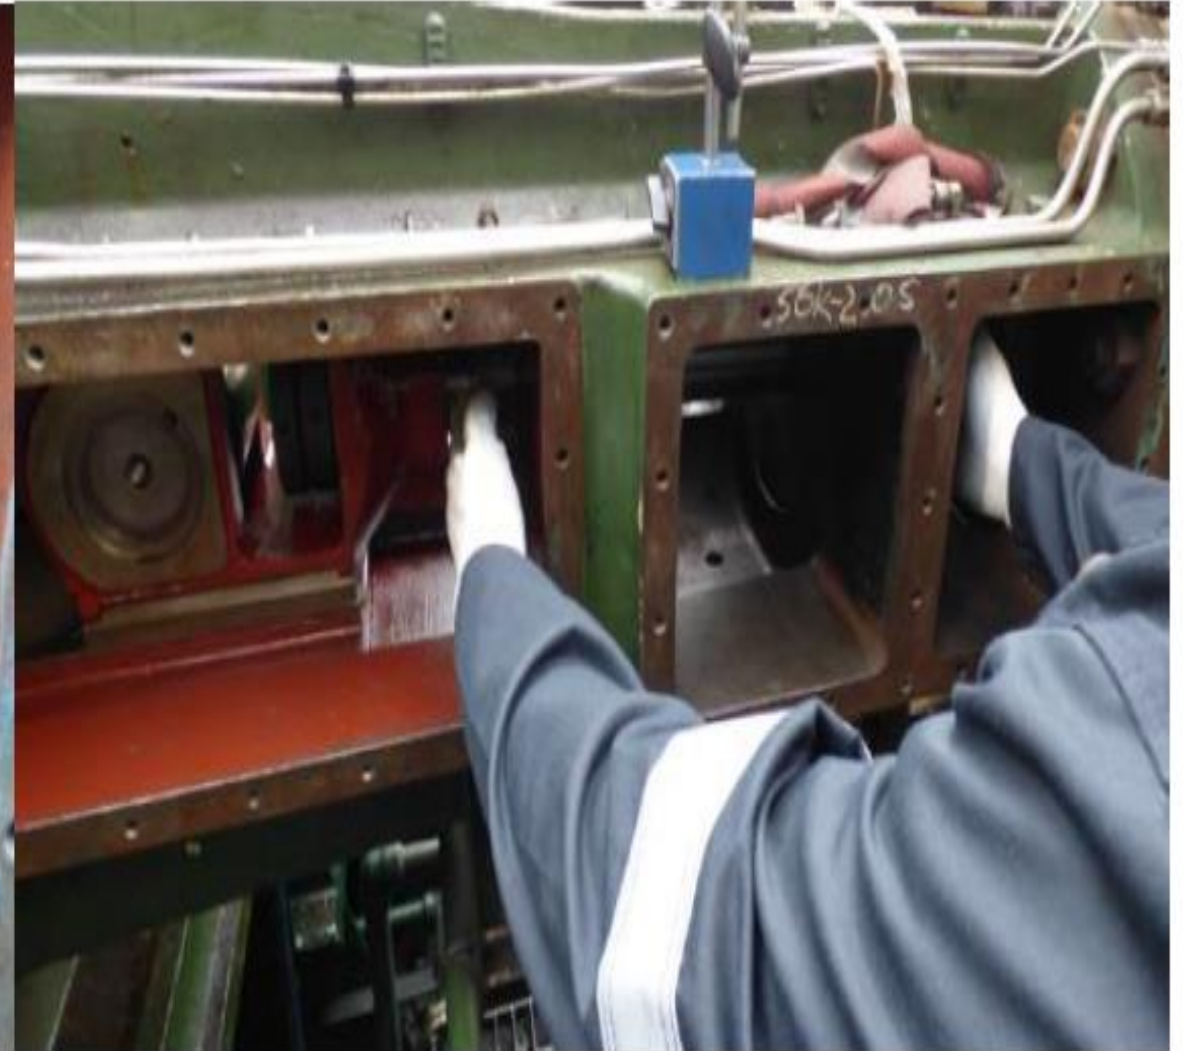
Sketch (Photograph)

- ❑ The performance of 8 000 hours service on hydrogen booster compressor include the following:
 - ❖ removal of gudgeon pin,
 - ❖ Performance of cylinder measurement,
 - ❖ Plate removal in the two-compartment distance piece.
- ❑ The employee got injured while removing a bolt from threaded bar within the stuffing box and the two-compartment distance piece.
- ❑ One colleague inadvertently (accidentally) engaged an air valve from closed to open position, which energized the system and engaged a pump which resulted in a crank shaft movement.
- ❑ The piston moved and wedged the insured's hand between the crosshead resulting to an injury to the left hand.
- ❑ Emergency protocol was activated and Injured lost the left index finger.

- ❑ Safety Isolation:
 - ❖ There were no safety isolation of the air supply to the compressor.
 - ❖ It was not highlighted in the Task Risk Assessment (TRA).
 - ❖ Not indicated as applicable on Intrusive Form.

- ❑ Contractor to review and update the TRA and procedure for performing the 8 000 hour or Similar Service.
- ❑ Roles and responsibilities to be clearly defined – Supervisor / Assigned person to be responsible for operation of air supply.
- ❑ Lock-Out and Tag-Out of air supply to pump. When not required for service activity.
- ❑ Workers shall be trained on updated procedure.
