# Incident Learning: Medical Treatment Case

**DATE OF INCIDENT** : December 6, 2019

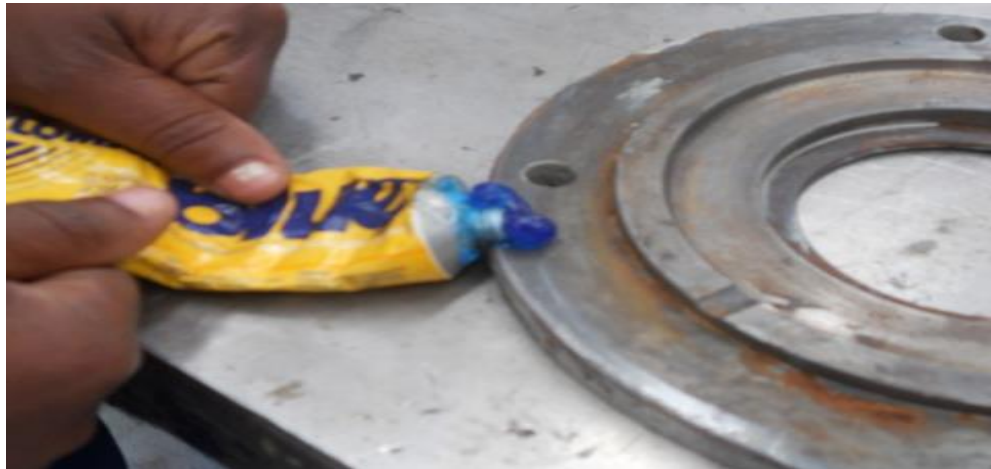
A Rotating fitter (IP) was assembling a pump bearing housing and was applying gasket compound to the cover. While pressing the gasket compound tube, the compound squirted under the IP's safety glasses and into the right eye, resulting in an irritation to the right eye.

- The eye protection was not fitted correctly to adequately protect the IP's eyes.

- Always follow the manufactures recommended PPE as stipulated in the Safety Data Sheet [SDS].
- Ensure PPE fits correctly and is adequate for the task being performed;
