OME SHE Learning

Learning number CES – HSI APR 235

Operating Entity CES: CDF - Outbound Logistics

Date of incident 26 April 2022

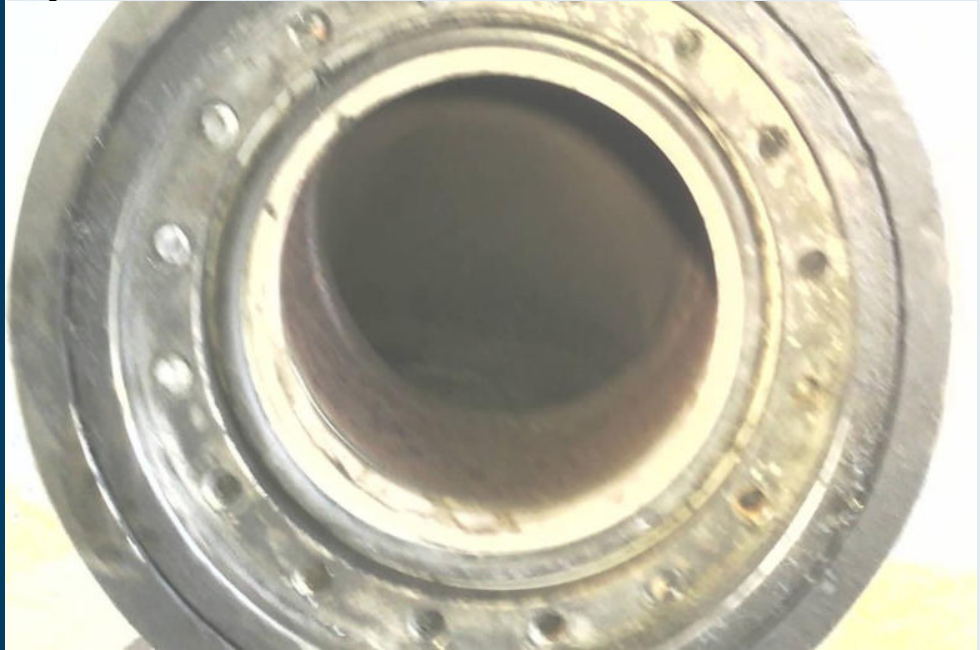
- UC1 - Damaged (Torn and deformed) face o-ring
- UC2 - Damaged of ball bearing race
- UC3 - Failure of the bolts connecting the flange to the bearing module
- UC4 - Grease that dried up within the swivel coupling resulting from inadequate maintenance system (ineffective inspection with run to failure) in place for the swivel joints
- UC5 - Use of one bolt from a different manufacturer is not in line with the accepted practice in Sasol
- UC6 - Failure in PSSR, punch out and/or QA for initial installation
- UC7 - External force resulting in overload as part of normal operation
- UC8 - Maintenance system failure

Flange from swivel where bolts shreaded off

1. All equipment failure incidents and activation of safety control devices to be managed as potential safety incidents
2. All equipment and components damaged during an incident to be preserved for investigation purposes
3. Formalise Service Level Agreement engagements with all service providers
4. Adopt standard Management Systems as used across Sasol
5. Involve technical subject matter expert as early as possible in incident investigation process
6. Formal process to be followed in tracking closure of corrective actions to be centralised
7. Equipment identified as defective should be immediately isolated
8. Ensure proper maintenance strategies are implemented
