SASOL – MEDICAL TREATMENT - REFINING

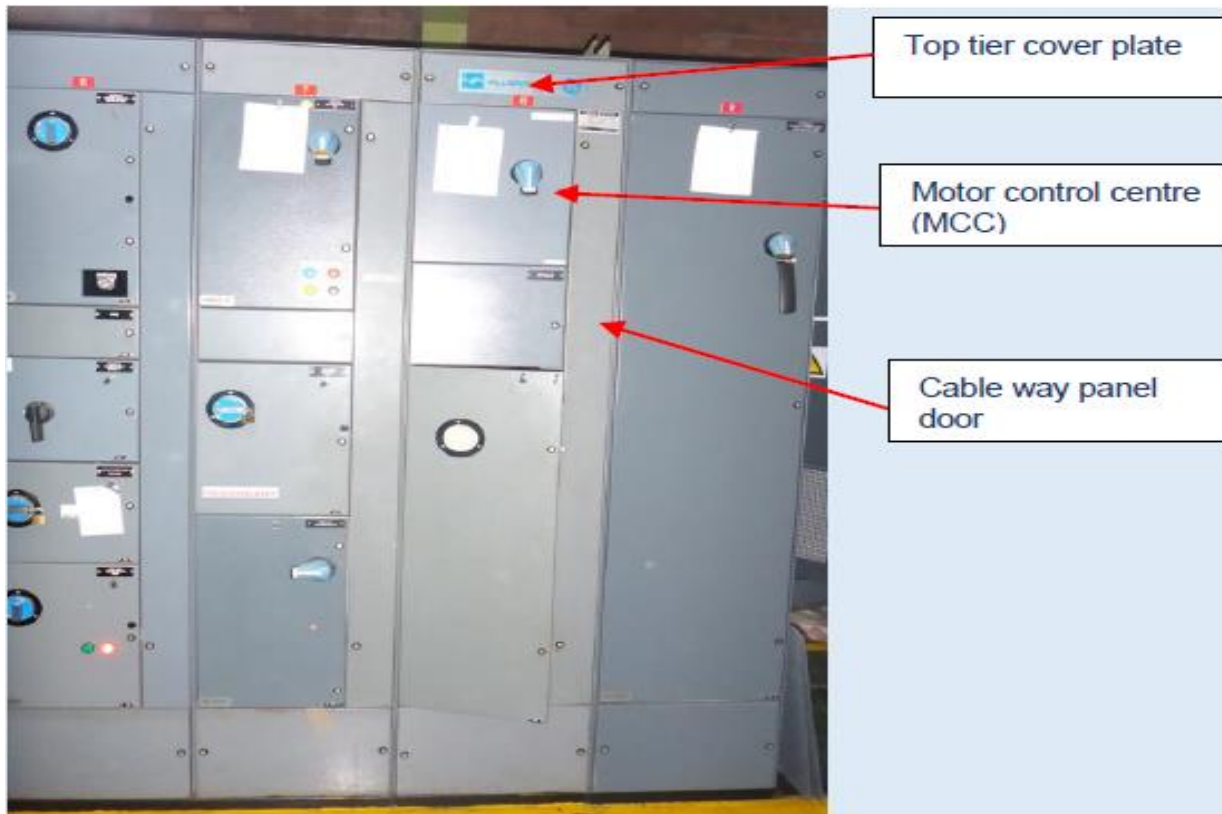
The employee opened a cable way panel door on a LV (low voltage) switchboard when the top tier cover plate dislodged and hit him on the left side of the scalp causing a laceration.

- Top tier cover plate not secured causing it to fall when the panel door was opened.
- PTRA didn't identify possible hazards - Substation PTRA does not include checking panel covers.
- TRA inadequate - Opening switchgear panel doors didn't include possibility that adjacent panel covers could fall.
- Human factor (unintentional action) - Incorrect replacement of cover plate after work was conducted.

- Communication to artisans to inspect top tier cover plates to ensure correct installation as per original design (ensure two hinges are intact).
- Discuss incident with electrical artisans and technicians to ensure awareness with regards to potential hazard.
- When opening panel doors ensure adjacent panel covers are secured
