# Incident Learning: What happened?

## Medical Treatment Case

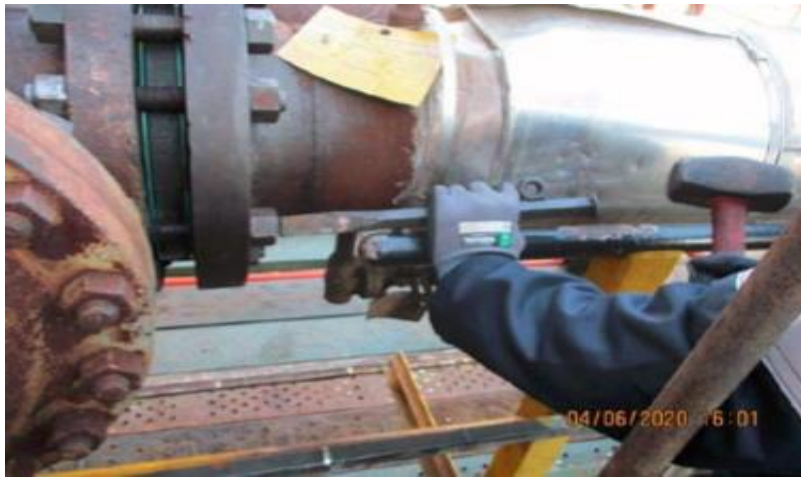
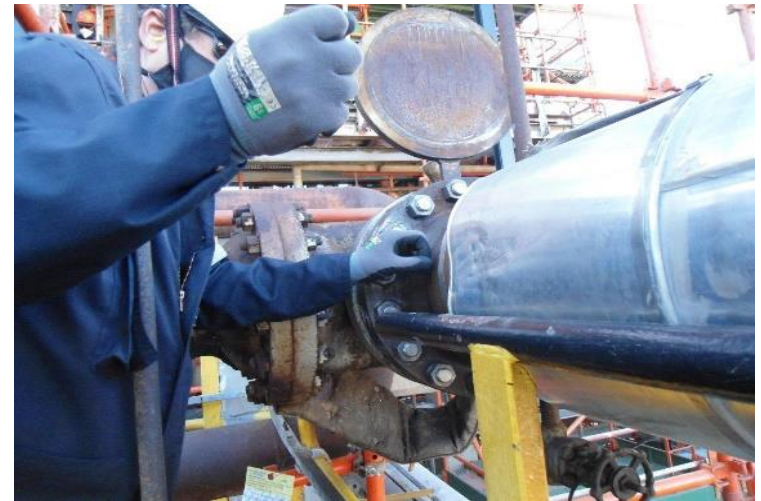
- On Thursday, 4th June 2020 at approximately 14h30, a mechanical fitter was removing bolts on a 10" flange on top of (60C-5) Desalter.
- The bolts were stuck in place and the mechanical fitter was removing the bolts by using a process called "mushrooming". The "mushrooming" allows the nut to remain in place by locking the other nut with a spanner.
- The mechanical fitter is then able to remove the bolt and the remaining nut drops on the other side of the flange. As the mechanical fitter was "mushrooming" the bolt using a chisel and a six-pound hammer, a piece of metal dislodged from the bolt and struck the mechanical fitter on the lower left side of his abdomen

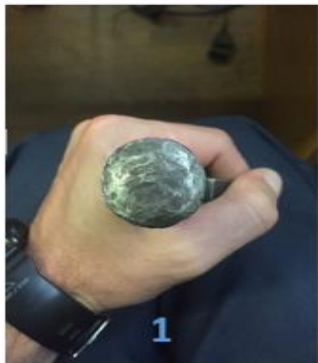
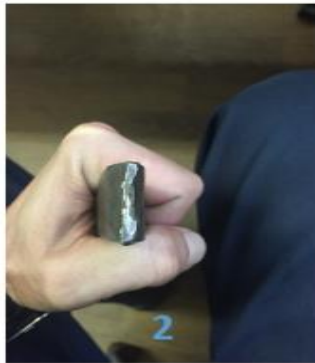
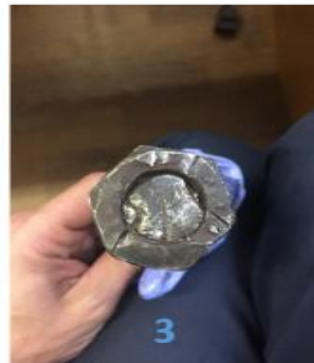
Piece of metal dislodged from either:

1. Head 2. Tip 3. Bolt

*Not clear where piece of metal dislodged from, awaiting final investigation*

- Develop a procedure /SOP that clearly identifies the different scenarios of unbolting rusted bolts.
- Use the Pre Job briefing process to clearly outline the agreed method to be used and the clear communication process to follow if agreed methodology is no longer feasible to execute
- Develop a procedure to prevent the distribution of poorly maintained equipment (Chisel head was mushroomed) at collection from stores.
