# Incident Learning: What happened?

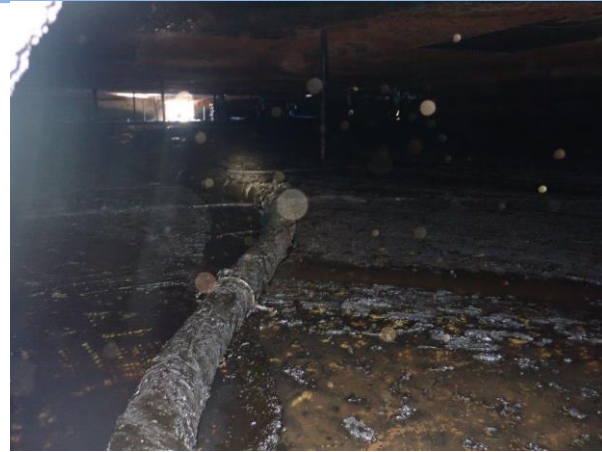
1: 6-Inch Suction Rubber Hoses that was lifted.

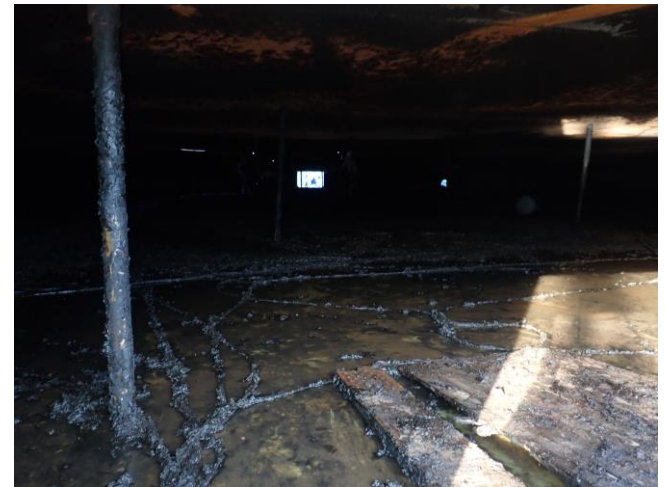
2: Slippery substance on the tank floor

| Casual Factors | Root Causes | Corrective Actions |
|---|---|---|
| Slippery floor due to mixed product of crude oil and water in combination with the coated tank floor | <b>No mitigations identified to reduce the slipperiness based on the change in condition.</b> This is the first time we cleaned a crude oil tank with internal floor coating. Normally, when cleaning crude oil tanks, to reduce the slipperiness of the sludge mixture, peatsorb and lime are added. However, due to the product (Crude oil mixed with water) being recycled back into tank C12 | Tank team needs to improve the standard of risk identification for all tank cleaning activities by reviewing and assessing the following aspects; <ul style="list-style-type: none"> <li>✓ Prep and plan</li> <li>✓ Safety plan.</li> </ul> |
