# LFI: Road Curb Trip & Fall @ Voorbaai Tank Farm

# IOD **LTI** – 19 January 2024

- Voorbaai Tank Farm @ 16H30 -

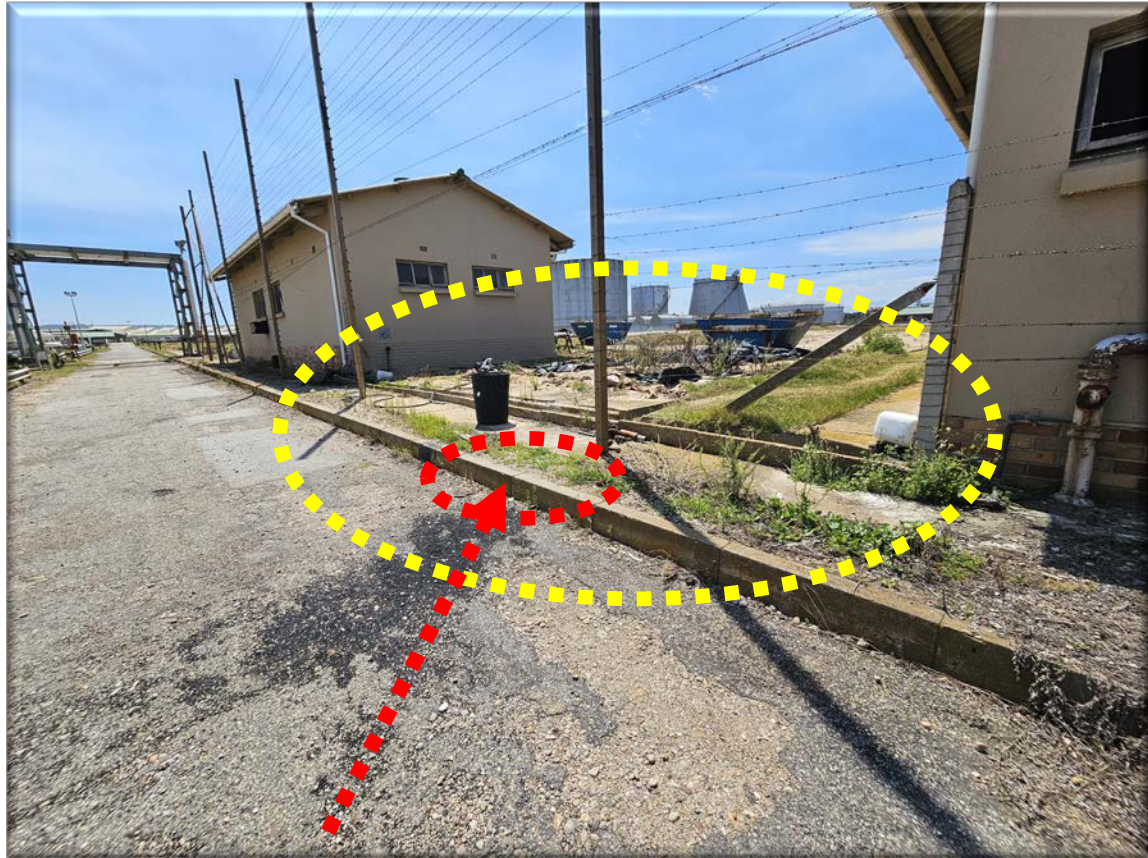
- o Security Officer patrolling the perimeter fence in anti-clockwise direction from the gate office.
- o *Route crosses the road to pass through to the maintenance workshops.*
- o Safety Hazard – required to safely negotiate the curb to check the workshop building.
- o *Right foot tripped against top edge of the road curb.*
- o Security Officer fell down towards the left and cushioned fall with left hand.
- o *Left Hand muscles torn. Injured wrist. No fracture. Booked off by OMP. Injury > 13 days – thus more serious than normal LTI.*

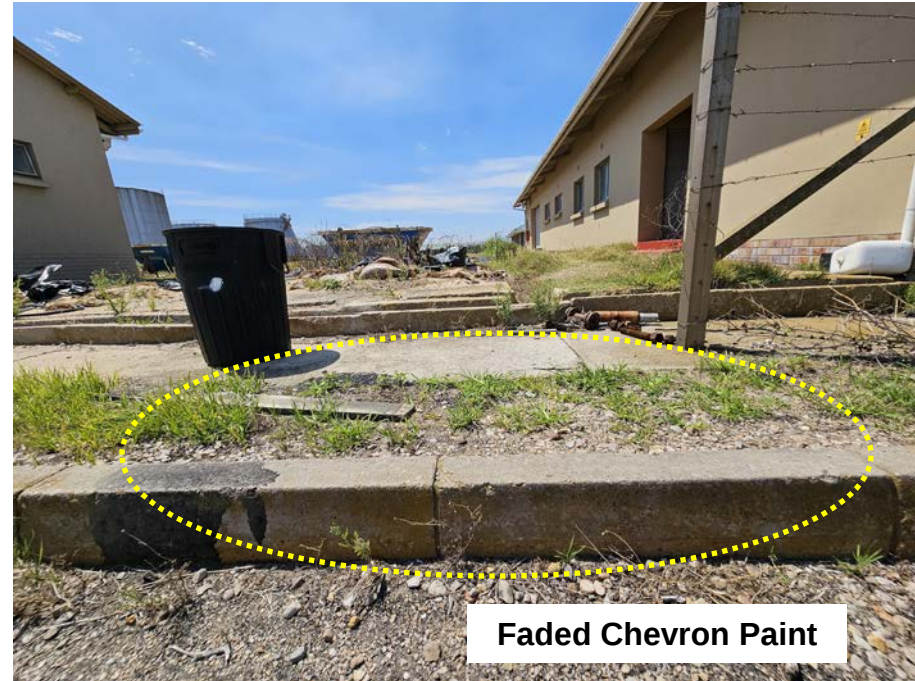
- o A defined security patrol route is used – thus needs to be assessed as safe for use.
- o Slip and Trip hazards has been the main contributor to IODs of security personnel – the other being physical injuring when apprehending thieves.
- o Causal factor: STF hazards created by waste material from the fence refurbishment project was littering the patrol route – not removed to waste skips as safe location prior to disposal.

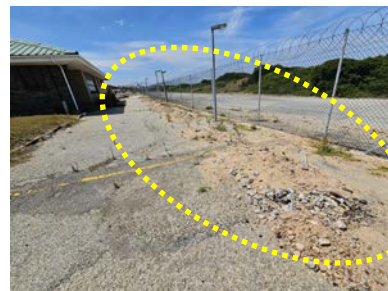
Faded Chevron Paint

**Contractor did not clear out fence project rubbish. Presents STF risks on the patrolling route.**
