# Incident Learning: What happened?

| <b>Location</b> | Refining west Unit 32 (32FE-1F021) |

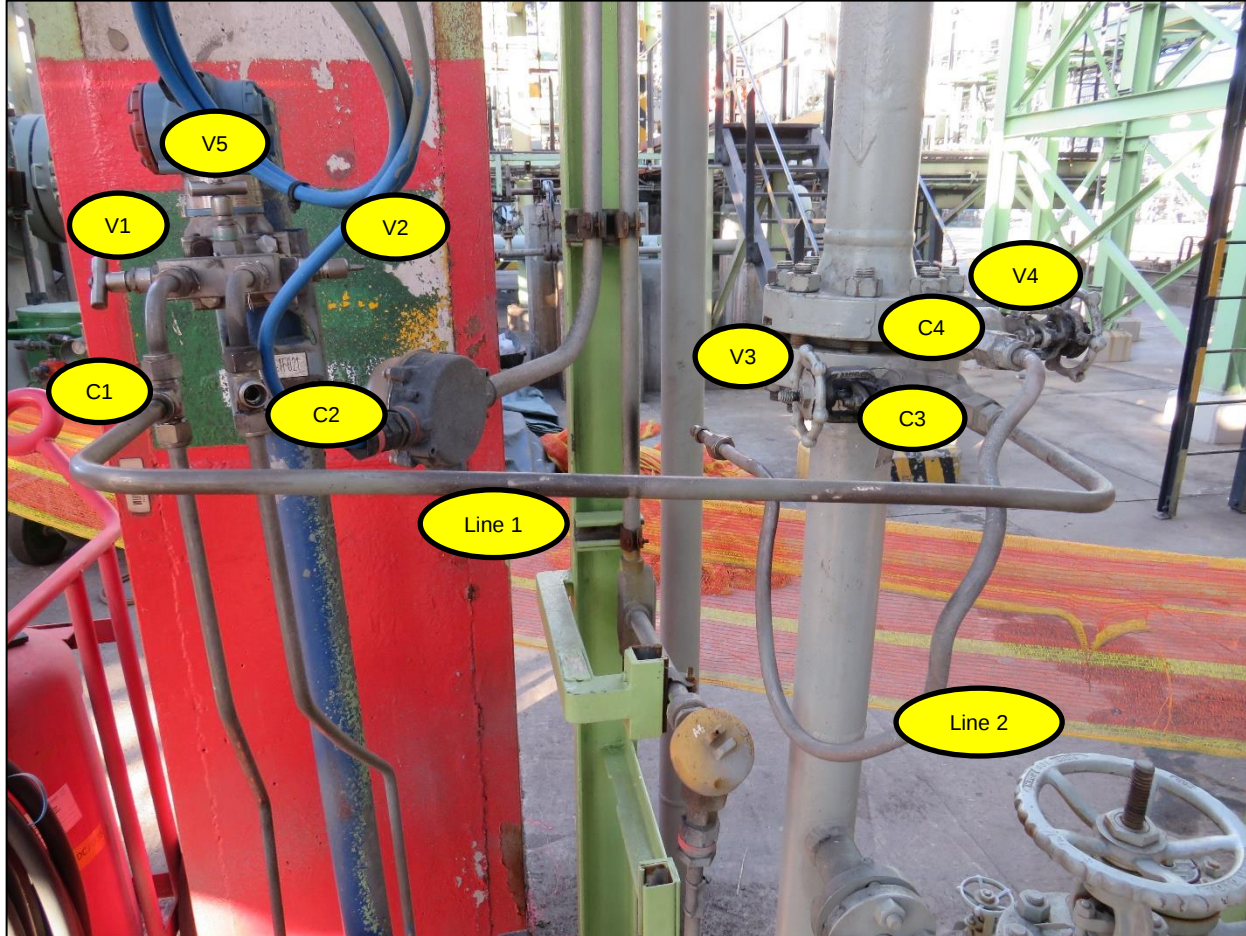
# Site overview / orientation

| <b>Description</b> | While commissioning the hydrogen line the inside senior process controller noticed no hydrogen flow on the DCS. The inside senior process controller tasked the outside personnel to investigate. During their investigation the flow transmitter impulse line dislodged resulting in one person being partially exposed to released hydrogen and two persons injured while incident occurred |
| <b>Consequences</b> | One learner process artisan was injured sustaining thermal burns to side of face and ear. One process controller (PC) sustained an abrasion to his left knee and one senior process controller sustained an injury to his right knee (total of 3 Restricted work day cases).<br>HP impulse line of the flow meter damaged |
