## Title: BVO Head Injury

Reference: ALERT- branch-zone or business-year-order number (ex: ALERT-RC-RBE-2017-001) Date: 29 July 2022

Country: South Africa

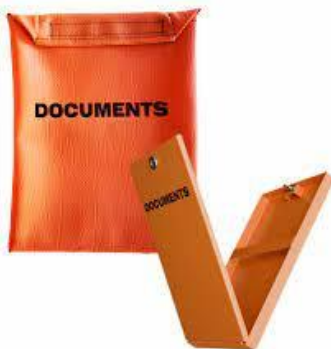
For this vehicle, the orange box was mounted on the ceiling of the cab, and that is what contributed to the incident.

- *For all vehicles fitter with orange document box holders (weather metal or plastic), it is recommended that the boxes be relocated to the center of the cab between the driver and the passenger side in line with the recommendations of the SANS standards.*
- *For all orange document holders with sharp edges, after relocation, it is further recommended that edge protection be in place to avoid contact with persons in the cab*
- *Furthermore, it is also recommended that consideration be given to the replacement of such boxes with the alternatives available in the market (such as PVC type bags)*

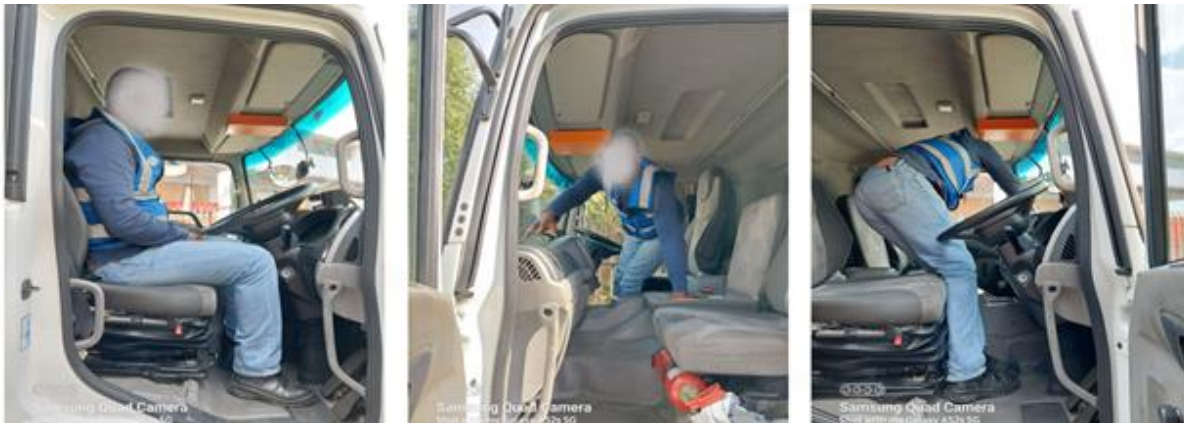
Driver side view

- Position of orange box
- How the Driver was injured – Driver's side view
- Impact

*Situational awareness by the BVO at the time of the incident coupled with the location of the orange box*

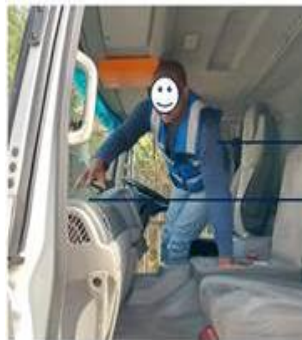
Passenger side view

- How the Driver was injured – Driver's side view
- Position of documents
