OME SHE Learning

Operating Entity Secunda Operations, LVCE, Unit 086

Date of incident 05 September 2024

Description of the incident A fire occurred in the sump, 086CB-502, resulting in an overpressure, causing damage to sump auxiliary equipment, cabling, and instrumentation.

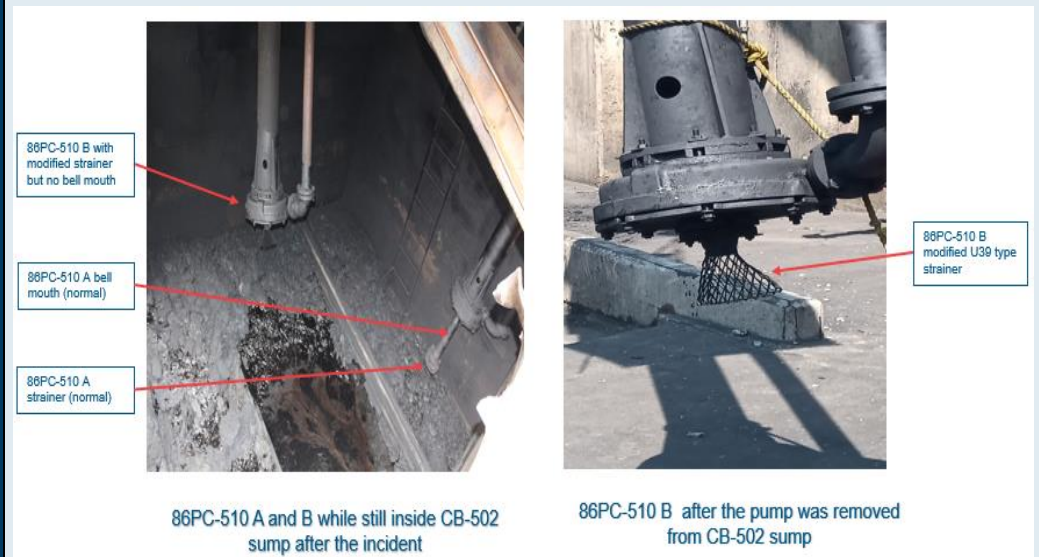
At the time of the incident, the sump level was below the suction nozzle of the B-pump due to its shorter height compared to the A-pump. The minimum operating level for the pump, based on the OEM should be above the pump casing (77% of current measurement range) to ensure proper lubrication of the internal components of the pump

- During HAZOP review for pump testing, the correct minimum operating level in the sump relative to pump minimum operating level was not considered.
 - The existing calibration of the sump level is inadequate for the pumps currently in operation. The low level must be raised to the minimum operating level for the pump and should not fall below the suction port of the pump.
