# LEARNING FROM SUMP INCIDENT

2024

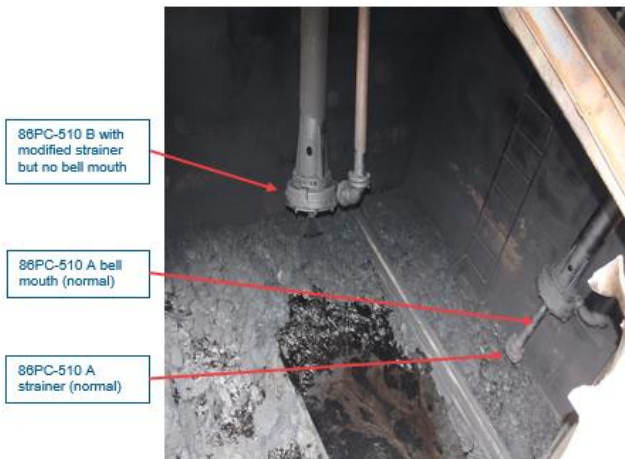
86PC-510 A and B while still inside CB-502 sump after the incident

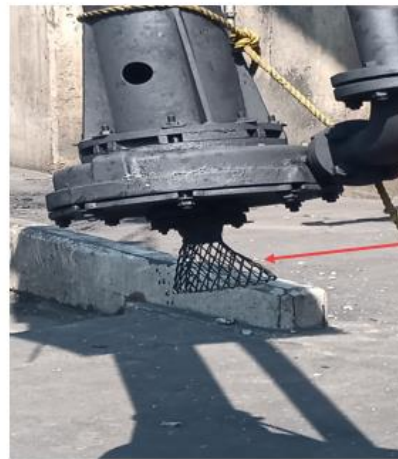
86PC-510 B after the pump was removed from CB-502 sump

Throttle bush – the throttle bush was measure for eccentricity and was acceptable. From visual inspections slight signs of wear can be noticed on the inner walls of the bush

Shaft sleeve – the shaft sleeve shows signs of mechanical wear.

Impeller – All six vanes of the impeller show signs of mechanical wear, specifically rub marks. Furthermore, severe signs of cavitation can be observed across the surface of the impeller

Suction liner plate – the suction liner plate showed signs of localized rubbing.

Pump shaft – a run out was performed on the shaft and it was proven to be eccentric.
