LFI: Flange Fire at the Catalyst Reduction Unit

1. What happened?
2. Why did it happen?
3. What were the learnings?

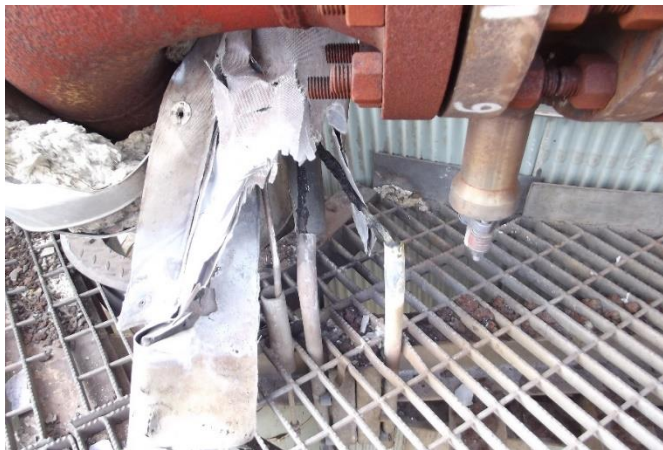
On the 3rd of October 2020 at approximately 09:40 after the completion of catalyst reduction cycle, during the cooling down period, a flame was noticed at the bottom flange of one of the butterfly control valves X on the hydrogen reactor. The outside production operator activated the manual fire alarm and the unit was shut down as per emergency procedure. It took approximately 10 minutes to extinguish the fire with a fire extinguisher and water. The unit was then swept with high pressure nitrogen. There were no injuries nor major equipment damage that occurred.

Fire damage to Instrumentation lines and fire blanket at 11-KV1030D

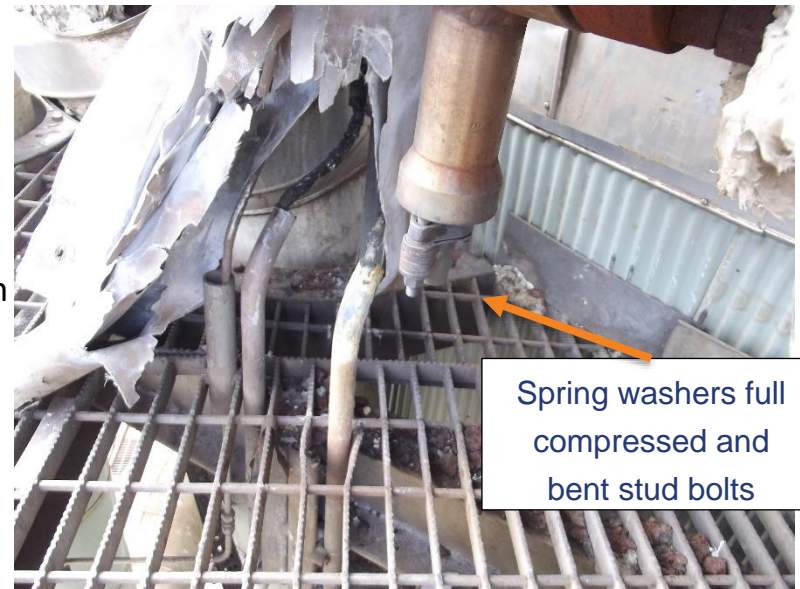
Spring washers full compressed and bent stud bolts

Upon the removal and stripping of the valve, it was observed that the bolting of the valve was compromised. The washer packing was also very tight (no spring memory resistance). There was also no consistency on the valve installation and upon inspection it was found that one of the bolts was still loose after the valve was reinstated in the plant.

Mechanical failure on the gland packing of the valve resulted in hydrogen leak and ultimately the fire.

1. Review and update the installation procedure for the unit control valves.

The installation process of the above mentioned valves needs improvement. An installation checklist needs to be drafted to ensure that all requirements are met.
