# LFI: Flange Fire at the Distillate Hydrotreating Unit

On 26<sup>th</sup> September 2020 at approximately 23:13, while commissioning the Distillate Hydrotreater Unit, there was a leak and a fire on the Reactor Charge Heater flange. A mixture of hot hydrogen and distillates escaped through a leaking flange into the atmosphere and auto-ignited.

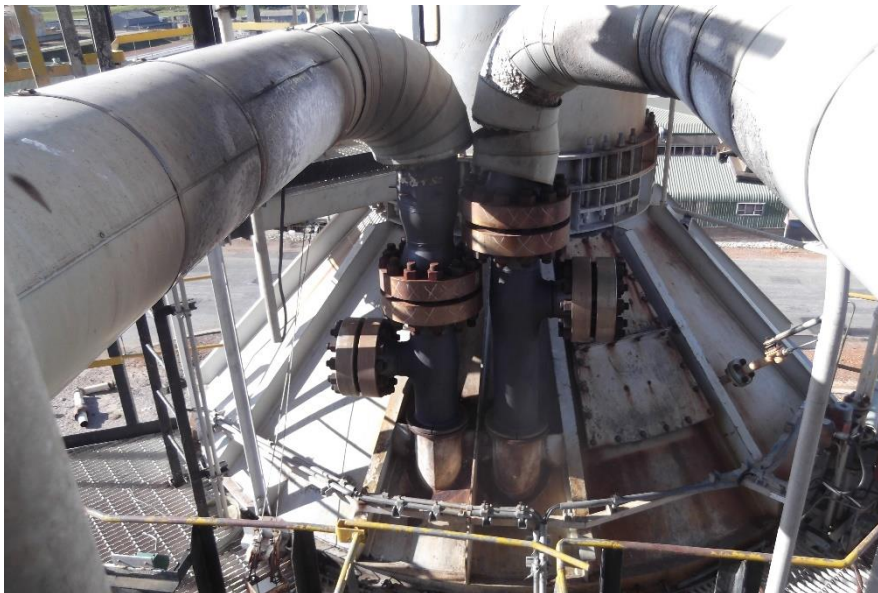
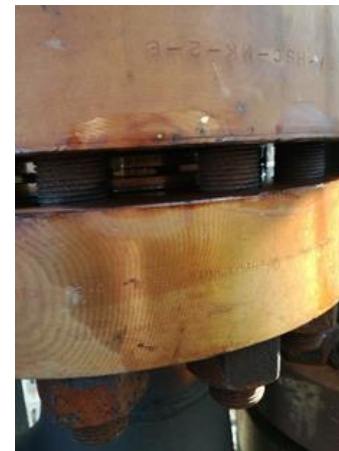
An outside operator noticed the fire and immediately informed the Panel operator and activated the fire alarm. The furnace was tripped and the reactor circuit was depressurized according to the Emergency Response procedure. The fire was extinguished within minutes using fixed fire monitors. There were no injuries reported and no major equipment damage.

The high heat input into the furnace by the operator resulted in fast increase in process temperature. This resulted in inner pipe and flange expanding (thermal expansion) while the bolts remained relatively cold, putting a load on the bolts.

The Unit Process Engineer to recommend the required heat up/cool down rate to protect the flange integrity and the catalyst.

Identify and record critical flanges on the reactor loop to allow for QC monitoring and documentation.

The current reactor inlet temperature alarm is much higher than the EOR reactor inlet temperatures.

Re-rationalise the reactor section alarms considering the recent fire incident and reactor design changes. This includes reviewing the priority on rate of change alarms.
