# LFI – April 2020: Leak on S&T Exchanger Flange

# LFI: Incident Description

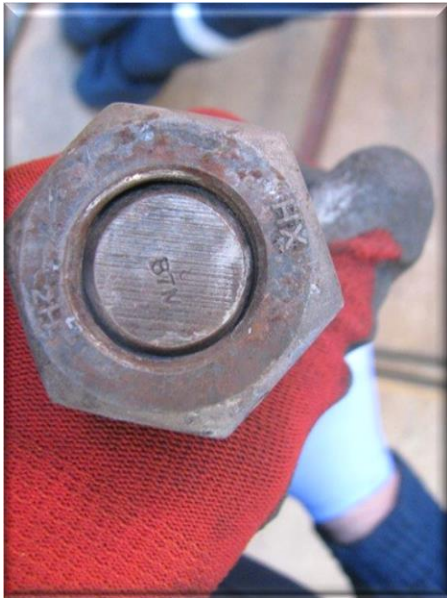
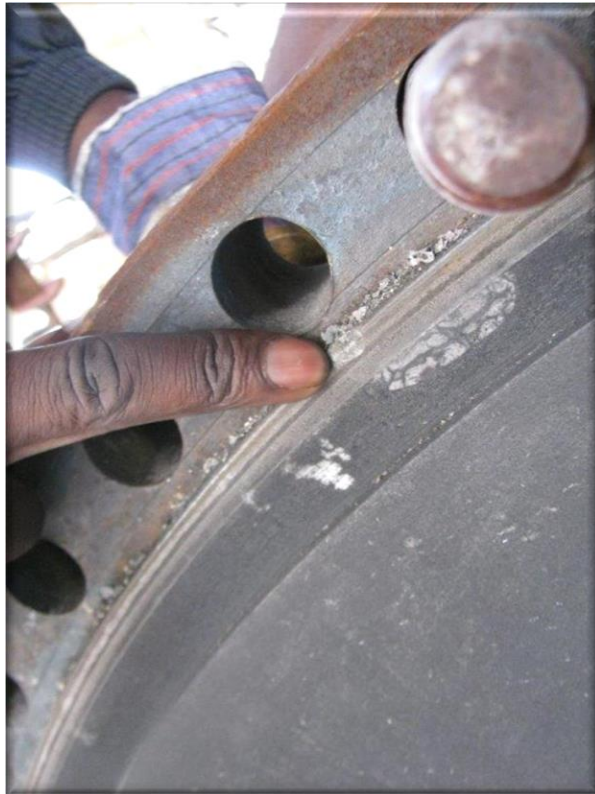
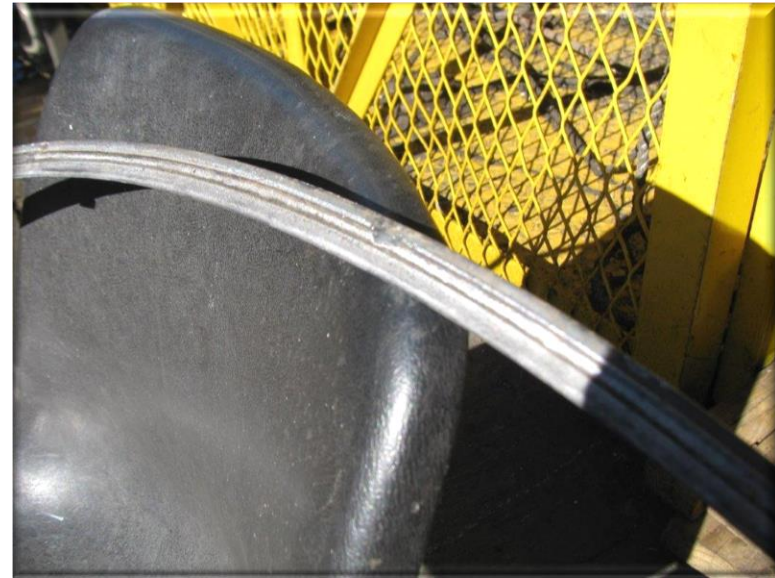
- During plant inspection of operator, he noticed a gas leak and fire onto XES102 dome flange. He informed the Supervisor.
- The situation was investigated and the decision was to shutdown the Unit X, depressurised and purged it with HPN.
