## LFI - 3: Tank Overflowed into Bund Area

# LFI: Incident Description

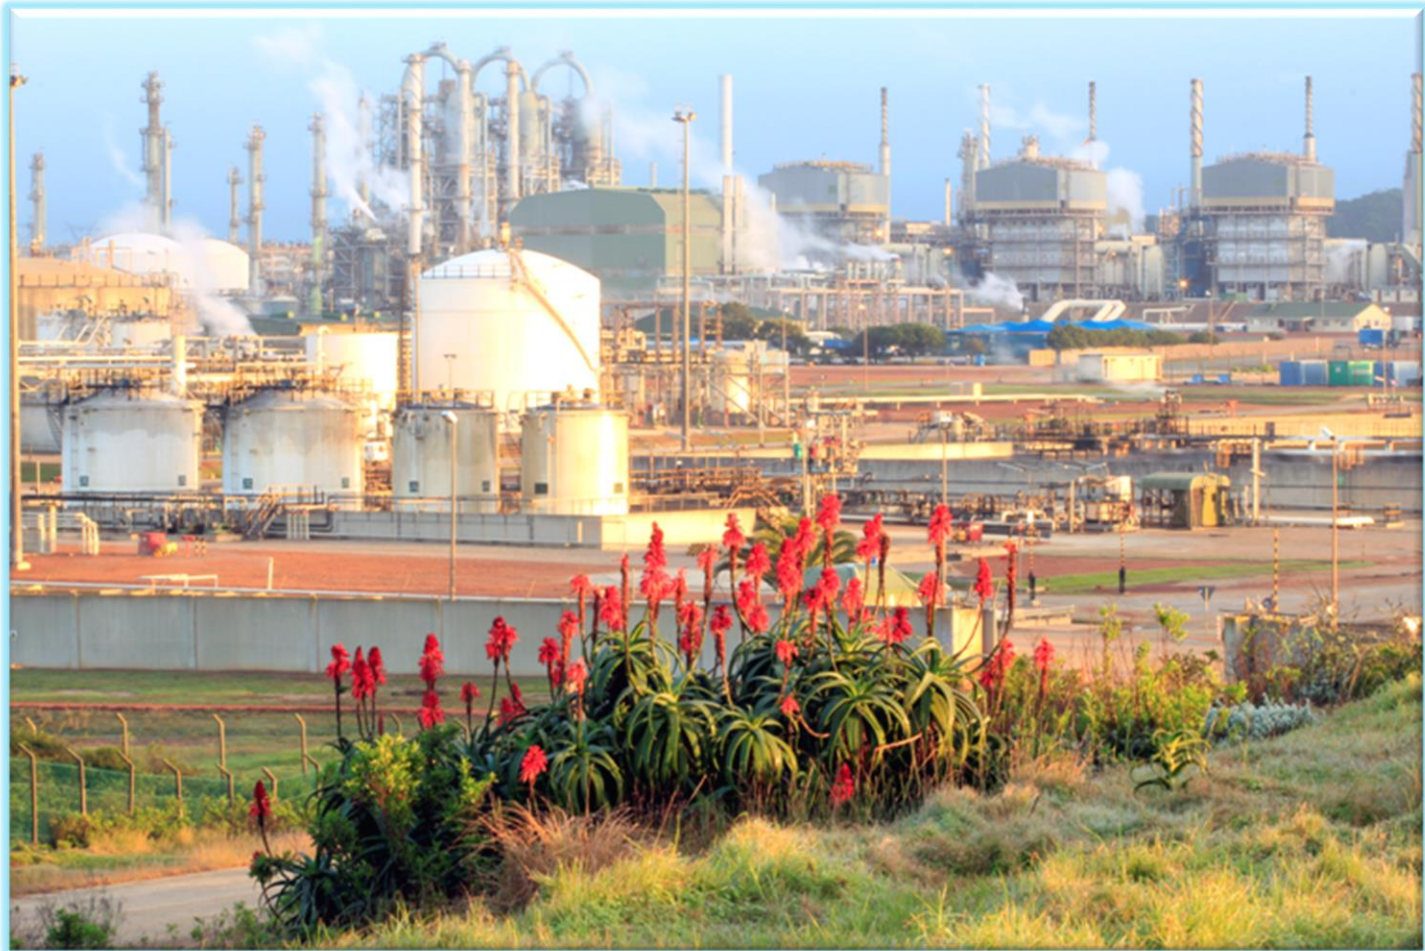
- June 2020, shift was on duty during nightshift. The level on 51TK123A was at 78.2%.
- The panel operator asked the outside operator to change the rundown from 51TK123A to 51TK123B after seeing the level in the tank suddenly decrease.
- The outside Operator that went to the site discovered that product in 51TK123A had overflowed through the bursting disc of the foam pourer.
- No high high level alarm had activated. Spray water was opened to dissipate the fumes and washed to the API Separator.

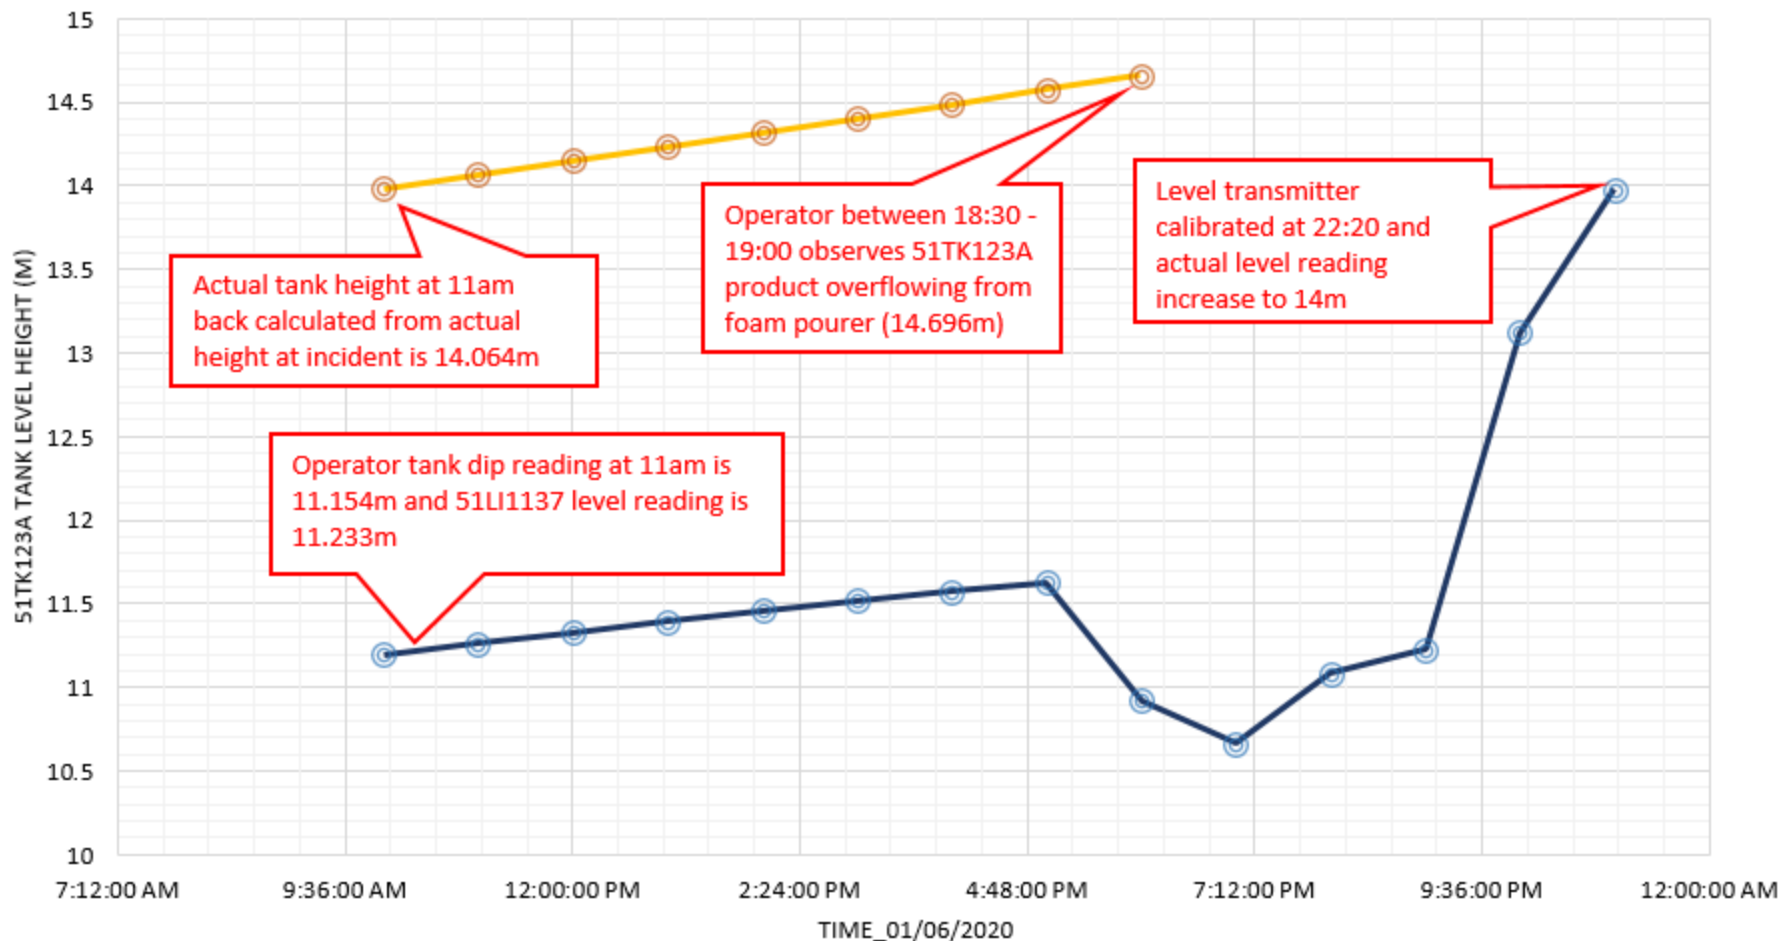
# LFI Incident: Event Sequence

| Date & Time | Activity / Event | Condition |
|---|---|---|
| 01/06/20 @ 18h40 | The outside Operator went onto the plant and saw that the tank had overflowed. | Although it was dark and misty he saw the penexate spilling from near the top of the tank out of the aeration holes of the foam pourer and onto the bund. |

- The physical Dip reading of 11.155m taken at 11h00 on the 1st June 2020 was incorrect by 3m.
- Maintenance Plan scheduled trip tests for 51LSHH1175 were found to be overdue.
- The Penex leaked through the foam pourers - this has raised concerns of possible fire-fighting foam contamination. Fire Department is busy with the investigation to ascertain the condition of the foam.
