# PetroSA LFI: Non-Availability of FireWater on Demand

# PetroSA LFI: Pump Bearing Failure (Linked Prelim)

## Technical Findings: Stripping of Pump Around Pump

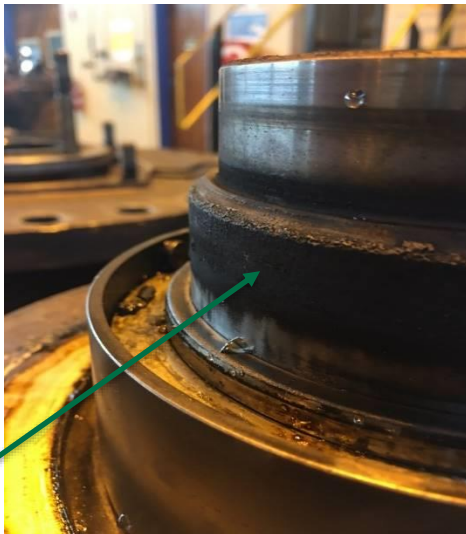
- Definite indications of heat transfer to the seal coming from the overheated & failed bearing.
- No specific damage to the inboard seal detected
- Outboard seal radically worn with signs of overheating.... this seal has possibly been installed for approx. 2 years.

Carbonization  
formation due  
to heat

The mechanical seal suffered no catastrophic failure or damage but cannot be re-installed as is. Standard reconditioning is required to bring the seal back to its operating spec.

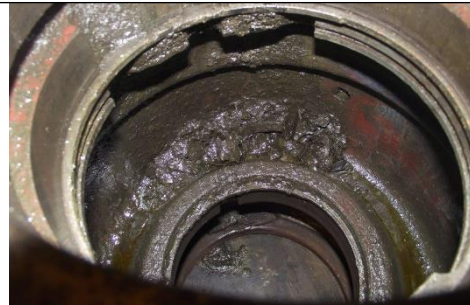
Sludge inside bearing housing

- Cooling water supply and return lines not commissioned, leading to overheating of bearing and causing premature failure of the bearing and pump. The excessive heat from the bearing lead to overheating of the oil causing smoke/fumes and then activating the fire alarm.

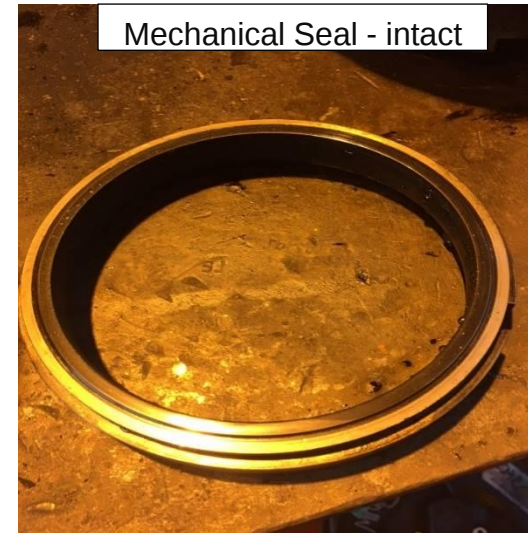
- Definite indications of heat transfer to the seal coming from the overheated & failed bearing.
- No specific damage to the inboard seal detected
- Outboard seal radically worn with signs of overheating.... this seal has possibly been installed for approx. 2 years.

Mechanical Seal - intact

The mechanical seal suffered no catastrophic failure or damage but cannot be re-installed as is. Standard reconditioning is required to bring the seal back to its operating spec.

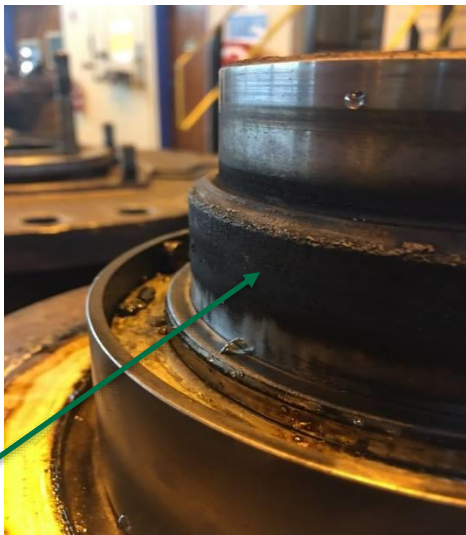
Carbonization  
formation due  
to heat

Failed ball bearing cage
